REVISION A Supercedes previous versions  
July 19,2013 Updated to latest software numbers

**TITLE: ACM PROGRAMMING & RELAY ADDITION**  
Prevost vehicles

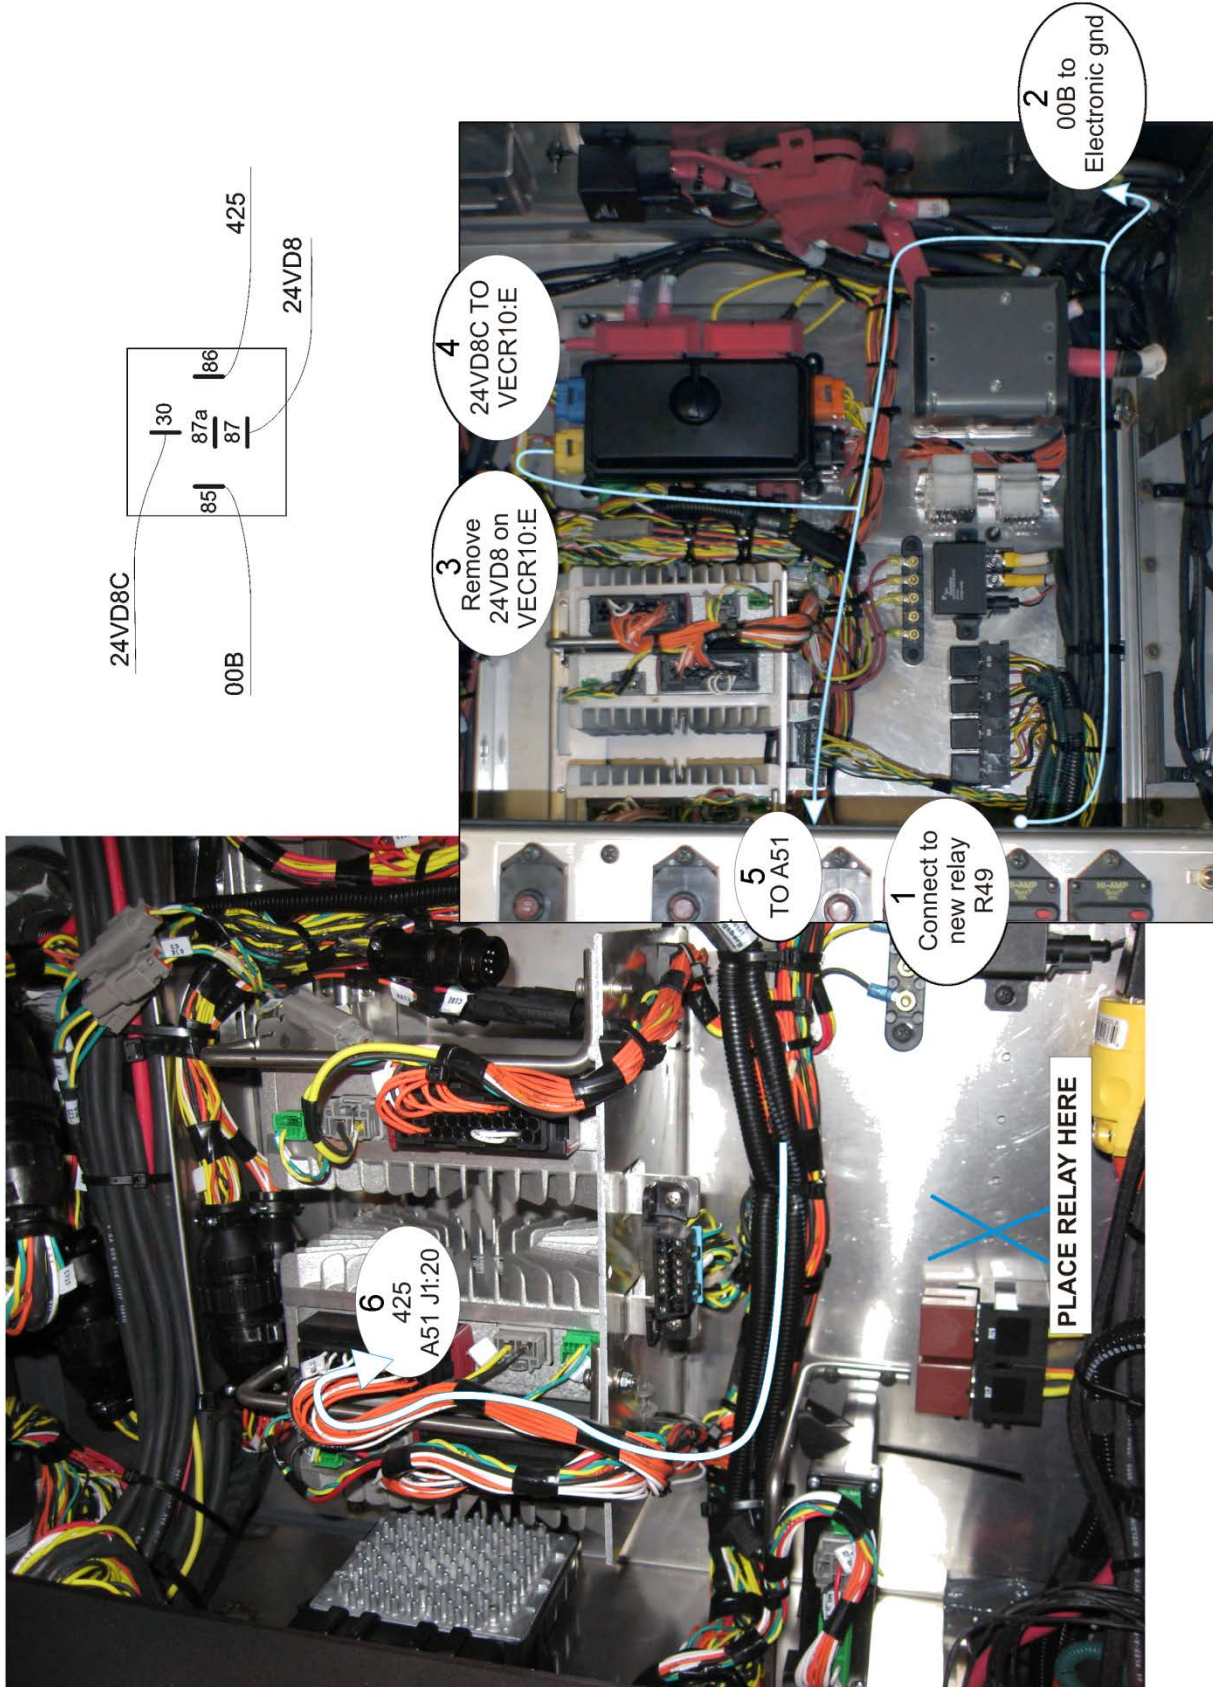
### X-SERIES for ref only.

On the vehicles affected by this bulletin, a relay needs to be added to allow the DEF to return to the tank after turning the key to the OFF position. In addition, the ACM & MCM need to be reprogrammed to the latest version.
