PREVOST

**WARRANTY
BULLETIN**

WB13-29

DATE :	MAY 2013	SECTION :	05 - Cooling
EXPIRATION:	MAY 2015		
SUBJECT :	LOOSENING BOLT ISSUE - COOLING FAN CLUTCH TRIPOD

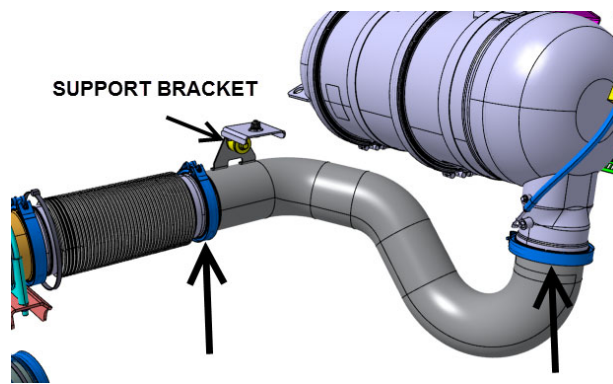
On the vehicles affected by this bulletin, a corrective measure is required due to bolts coming loose at the radiator fan clutch tripod attachment to the radiator. Bolts tend to get loose because they are tightened on a part made of rubber. Addition of four (4) locknuts (jam nuts) will prevent bolts to loosen and consequently, the radiator fan from striking the radiator core if the assembly fails.

a. Clear the two (2) V-band clamps hidden under the insulating blanket at the junction with the DPF and at the junction with the exhaust flexible section.

b. Undo the two (2) V-band clamps identified on the image.

c. Unscrew the nut at the support bracket.

d. Remove this section of exhaust pipe.
