SP13-44 LIGHT SWITCH IN BAGGAGE COMPARTMENT  
REFER TO SAP FOR CODES AND VEHICLES  
VEUILLEZ VOUS RÉFÉRER AU RETROFIT R13056 POUR LA VERSION FRANCAISE

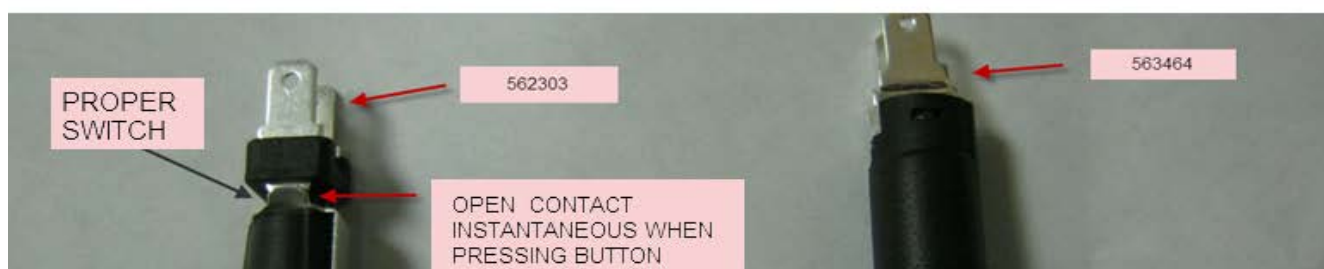
LIGHT SWITCH MAY OPERATE INCORRECTLY WHEN DOORS ARE CLOSED.

LIGHTS REMAIN "ON" INDEFINITELY.

MUST MOVE 4-5 mm  
BEFORE CONTACT  
OPENS

IN THE BAGGAGE COMPARTMENTS CHANGE ALL 563424 SWITCHES BY 562303 (6 TOTAL), EXCEPT FOR THE WCL DOOR (ALREADY HAS THE NEW SWITCH).

CHECK PROPER OPERATION AFTER REPLACING THE SWITCHES
