SP13-52 WELD INSPECTION OF TOP FAN SUPPORT

RISK OF PREMATURE FAILURE OF TOP FAN SUPPORT DUE TO ABSENCE OF WELD.
REFER TO SAP FOR VEHICLES AND CODES.
POUR LA VERSION FRANCAISE DE CETTE PROCÉDURE, VEUILLEZ VOUS REFERER AU RETROFIT
PRODUCTION R13072.

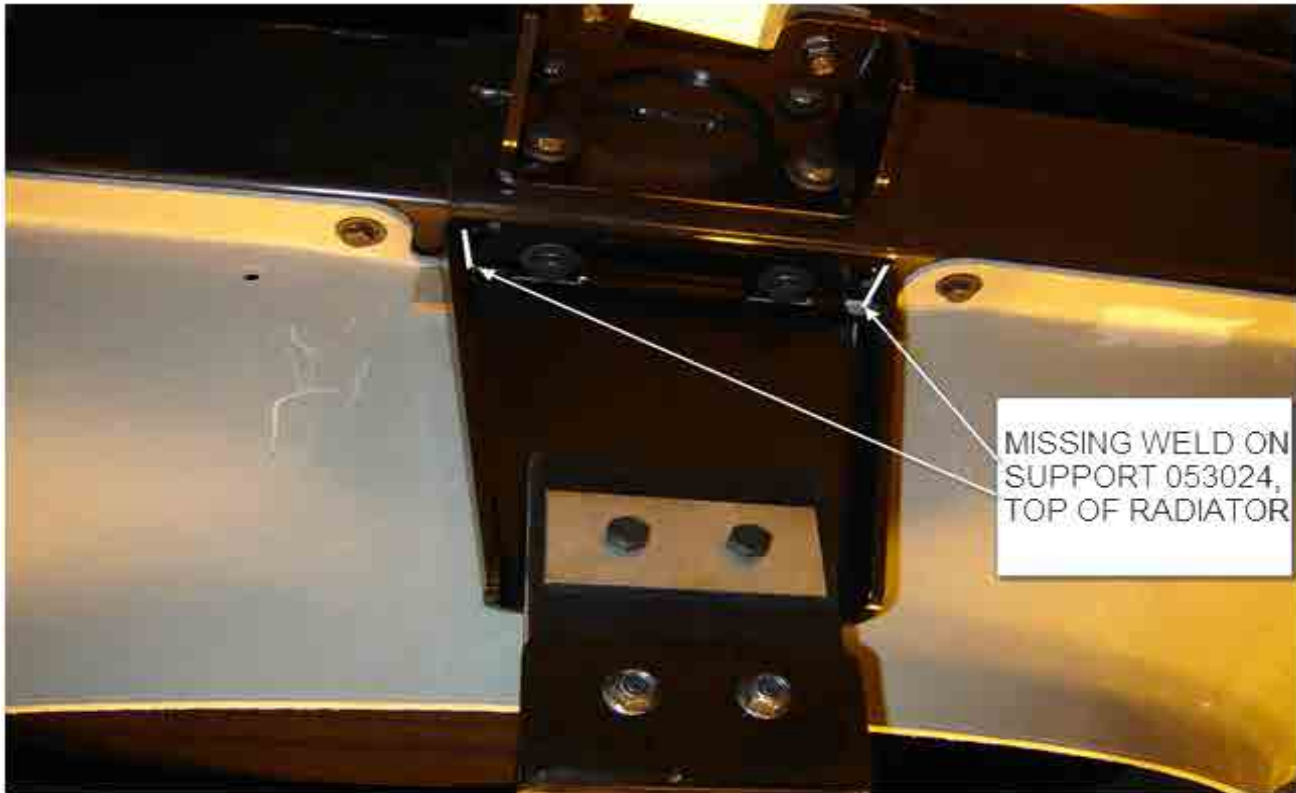
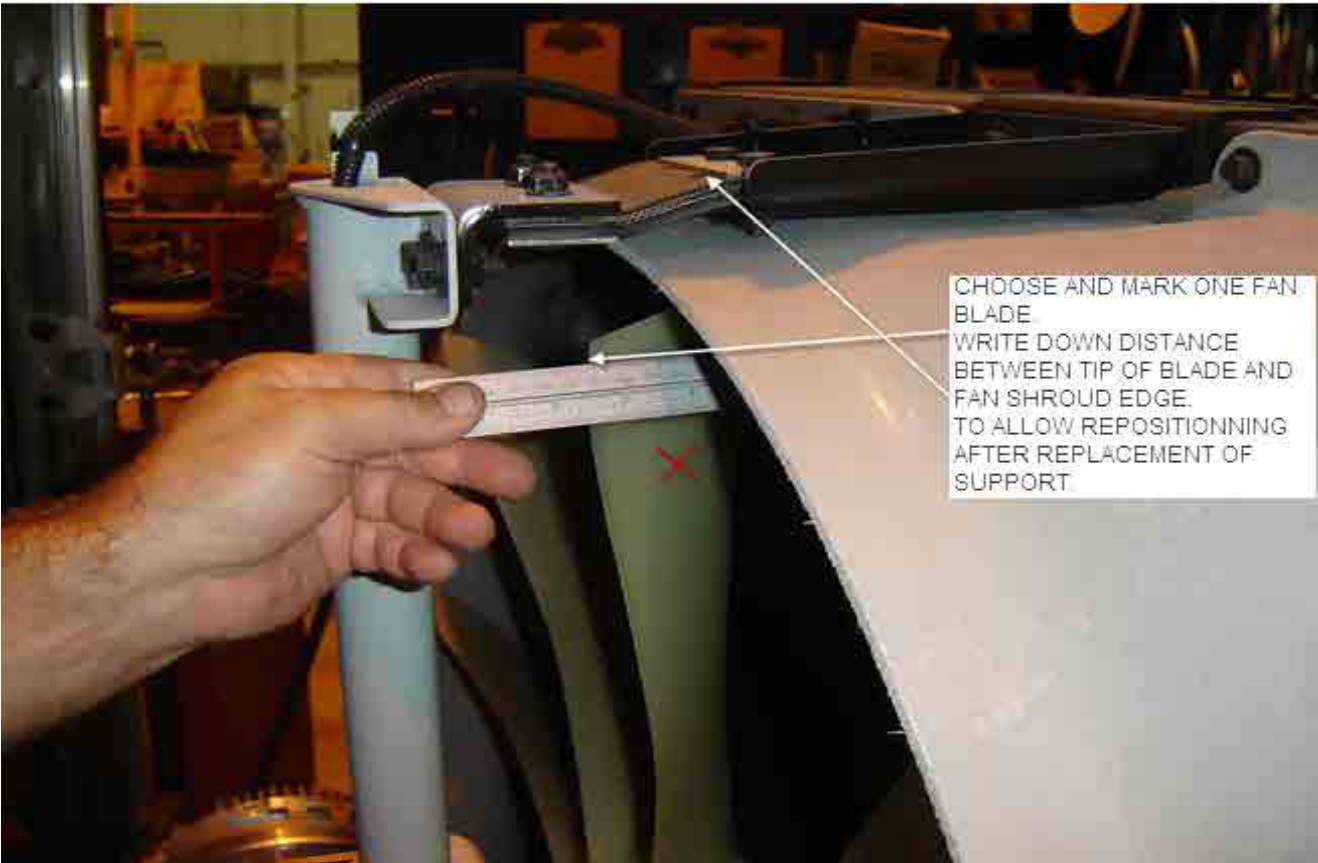
IN THE ENGINE COMPARTMENT ABOVE RADIATOR, INSPECT SUPPORT TO MAKE SURE SUPPORT
HAS TWO WELDS IN THE CORNERS (SEE PHOTO)

USE A TELESCOPIC MIRROR TO INSPECT. IF THERE IS NO WELD, REPLACE **053024**
