Ticking Noise from Rear Package Tray

Service Category Vehicle Exterior

Section Body Structure

YEAR(S)	MODEL(S)	ADDITIONAL INFORMATION
2013	FR-S	WMI(s): JF1

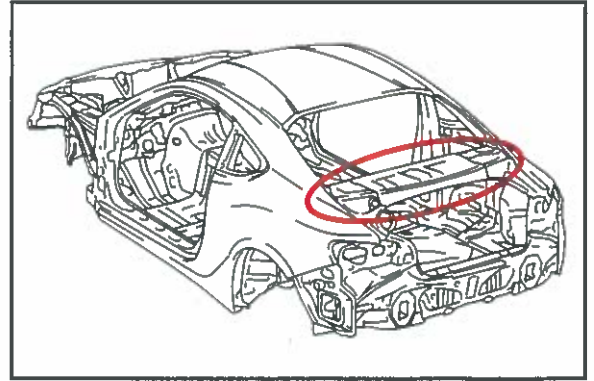
Figure 1.

Some 2013 model year FR-S vehicles may experience a ticking noise coming from the driver or passenger side of the rear package tray sheet metal while driving over rough surfaces. This is caused by spatter that is created during the weld process rubbing in between the sheet metal layers at specific weld points. Follow the Repair Procedure in this bulletin to reduce the gap between the sheet metal layers to address this condition.

1. Test drive the vehicle to confirm that a noise is coming from the rear package tray area circled in Figures 2 and 3.
