Service Bulletin

Subject: Engine Oil Consumption on Aluminum Block/Iron Block Engines with Active Fuel Management (AFM)
(Install AFM Oil Deflector and Clean Carbon from Cylinder and/or Install Updated Valve Cover)

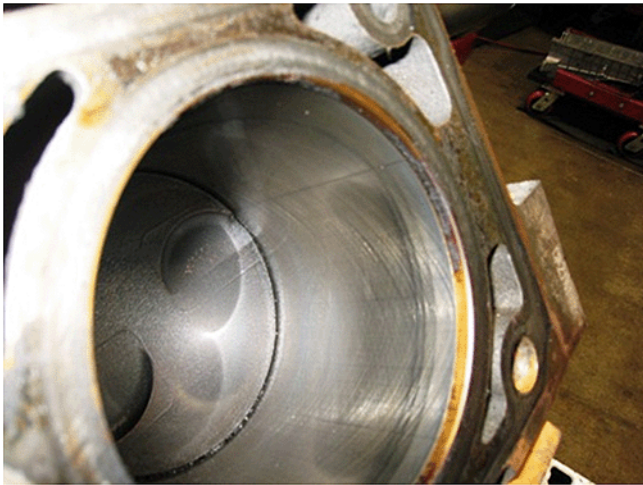
Important: Some minor scratches may be noticed on the cylinder walls during piston and ring replacement. If the scratch cannot be felt when running your finger nail over it, the scratch is considered normal wear and the block or engine should not be replaced.

Note: It is not necessary to hone or deglaze the cylinder walls. Honing may induce unnecessary cylinder wall and / or piston ring damage if it is done incorrect and/or not cleaned thoroughly. Cylinder walls should be cleaned thoroughly with brake cleaner before installation of the new pistons and rings. Numerous engines replaced for oil consumption have been inspected. The cross hatch has been consistently good and is in specification. As a result, it should not be necessary to measure the cylinders if they pass the visual inspection.
