# Repair Manual Supplement: Vehicle Pulling to One Side

**Service Category** Suspension

**Section** Alignment/Handling Diagnoses

YEAR(S)	MODEL(S)	ADDITIONAL INFORMATION
2002 – 2014	4Runner, Avalon, Camry, Corolla, Highlander, Land Cruiser, Prius, RAV4, Sequoia, Sienna, Solara, Tacoma, Tundra	
2007 – 2014	Camry HV, FJ Cruiser	
2002 – 2005	Celica, Echo, MR2 Spyder	
2006 – 2014	Highlander HV	
2003 – 2014	Matrix	
2002 – 2008, 2010	Solara	
2009 – 2014	Venza	
2004 – 2014	Yaris

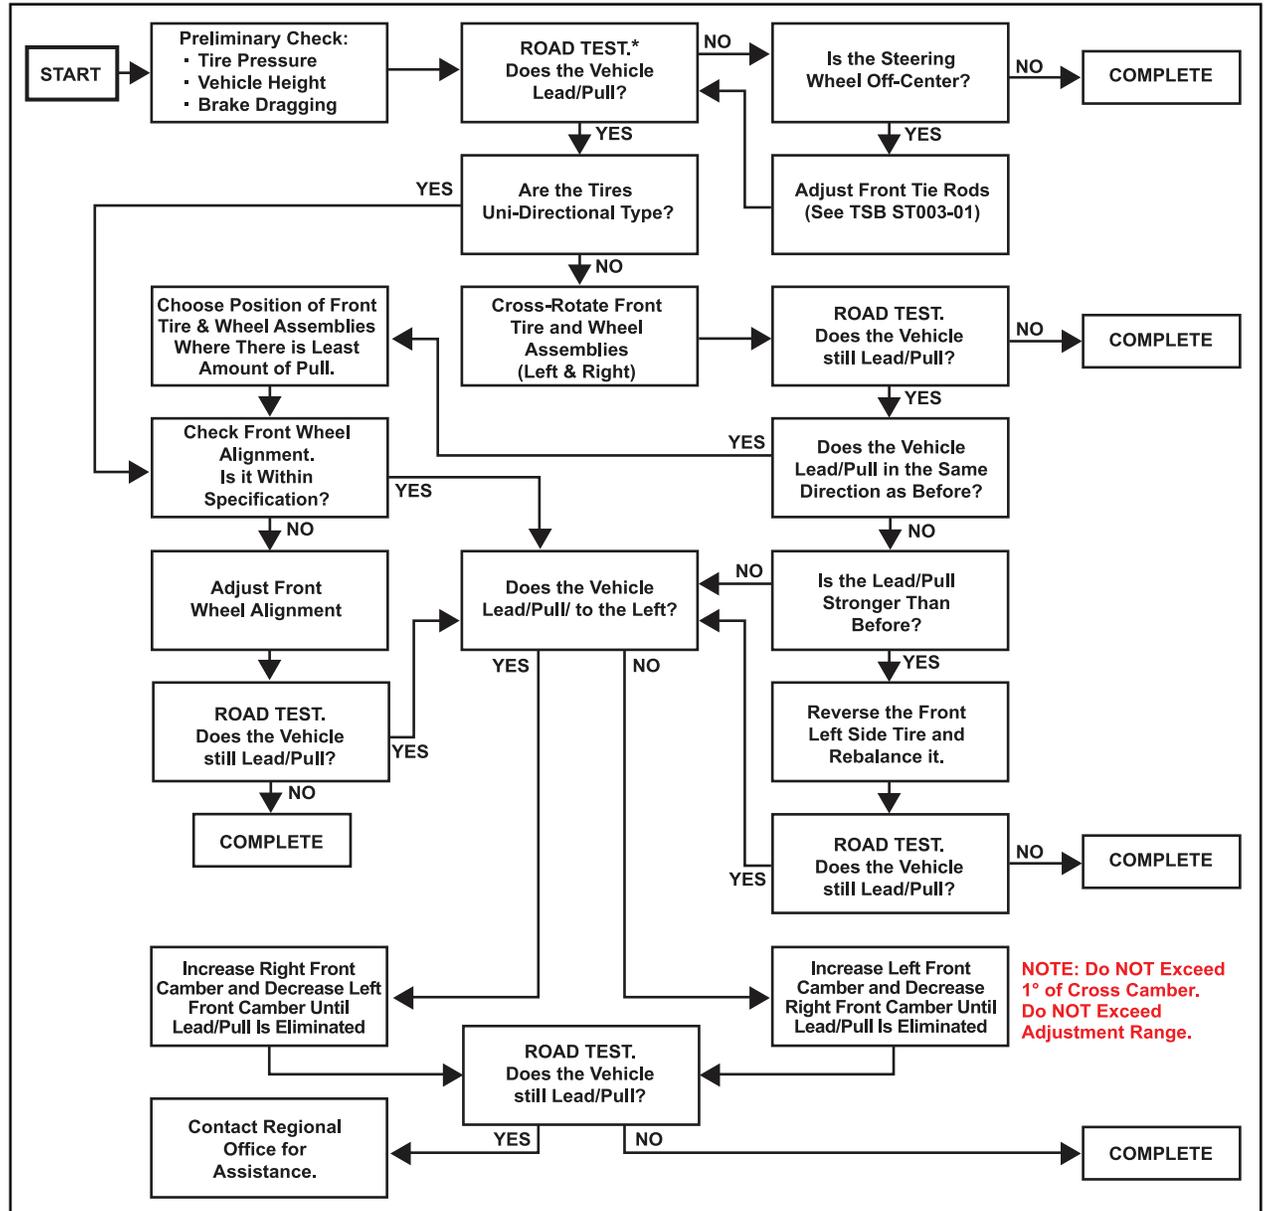
Figure 5.

- **Steering Off Center:** The vehicle goes straight but the steering wheel has some angle.
- **Steering Pull:** The vehicle does NOT go straight.

\* Select a flat road where the vehicle can be driven in a straight line for 109 yards (100 meters) at a constant speed of 35 mph (56 km/h). Please confirm safety and set the steering wheel to its straight position. Drive the vehicle in a straight line for 109 yards (100 meters) at a constant speed of 35 mph (56 km/h) without exerting steering effort on the steering wheel.
