Title: MaxxFace DT, 9 & 10 electric fuel pump diagnostic tips

Applies To: EPA 2010 MaxxFace DT, 9 & 10

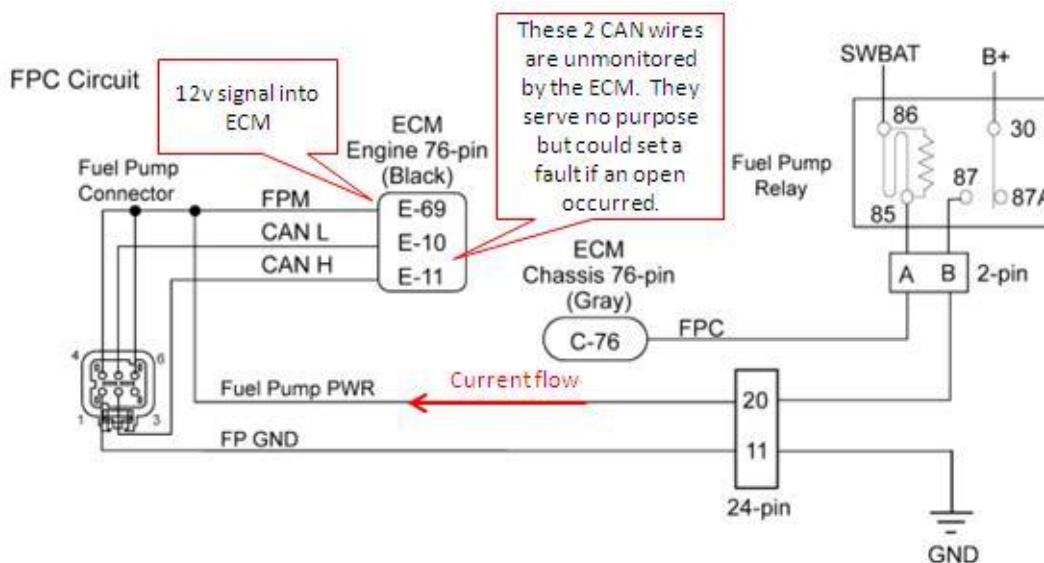
At key ON, the ECM closes the fuel pump relay (provides ground via pin [C-76](#)) and battery voltage is supplied to the pump. The pump will run for ten seconds (time varies with coolant temperature) and then shuts off. During the run time if the ECM does not detect crankshaft rotation it switches the fuel pump relay off. **The key must be OFF for at least 10 seconds and then cycled ON before the ECM will restart the fuel pump.**

The ECM receives a 12 volt signal on pin [E-69](#) that informs it that power is being provided to the fuel pump.
