Freightliner
Service Bulletin

Description of Revisions: *This bulletin replaces the version dated December 2012. The list of symptoms and troubleshooting diagnostics have been revised.*

Cascadia vehicles equipped with Eaton manual transmissions may experience no-start faults that are associated with the clutch position combination switch (clutch control switch). Recent investigations have exposed two possible causes, and this bulletin should be used to determine the cause of the problem. Use the procedure in this bulletin, and service information published on www.AccessFreightliner.com and www.RoadRanger.com, to diagnose and repair the problem, if the following symptoms are present:

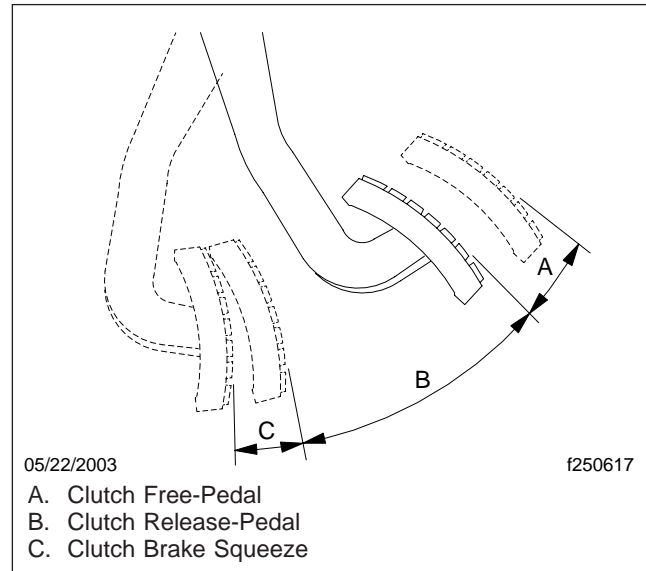
Fig. 2, Clutch Pedal Movement

5. Continue to monitor the SAM Cab ECU while having an assistant open the bleed valve on the slave cylinder (see Fig. 4), allowing the pedal to travel all the way to the floor. Have the assistant close the valve. Does the actuation of the pedal switch register on the "Bottom of Clutch Circuit" indicator? If necessary, top off fluid with DOT 4 brake fluid.
