This Service Information bulletin supersedes SI M17 08 12 dated **October 2012**.

Service Action: Retrofit of the Engine Coolant Temperature Sensor

This Service Action involves R55, R56, R57 and R58 MINI Cooper/Cooper S vehicles with the N16 or N18 engine which were produced from 8/2010 to 3/2012.

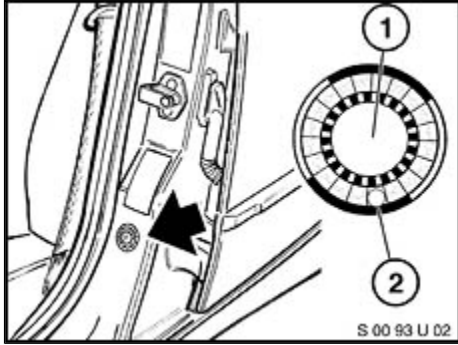
This Service Action has been assigned code number **53**. After the vehicle has been checked and/or corrected, obtain a label (MD20-040) and:

- A. Emboss your MINI dealer warranty number in the middle of the label (1);
- B. Punch out code number **53** (2), printed on the label; and
- C. Affix the label to the B-pillar as shown.
