Title: DPFDP Sensor Tube Thread Repair Procedure

Applies To: 2007 and Later MaxxForce DT, 9, 10

Preliminary DPFDP Sensor Tube Thread Repair Procedure

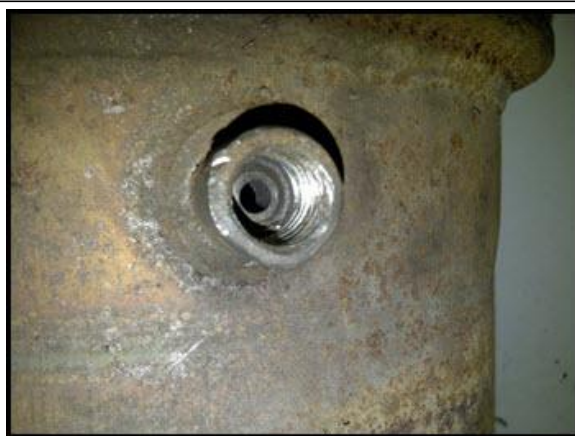
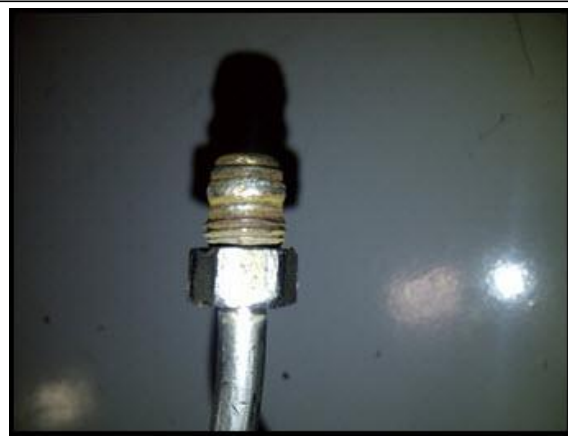
Issue: When removing DPFDP sensor tubes, threads from the fitting may strip.

1. Coat the flutes of an M14X1.5 Bottoming Tap with a high temp (2000F) anti-seize compound (*Figure 1*). This will help keep metal debris from falling in the DOC or DPF and ease the thread repair procedure.
