Countries: CANADA, UNITED STATES Document ID: IK1200655  
Availability: ISIS, Bus ISIS, FleetISIS Revision: 8  
Major System: ENGINES Created: 10/7/2011  
Current Language: English Last Modified: 2/4/2013  
Other Languages: NONE Author: Gregory Stone  
Viewed: 6103

Title: Injection Pressure Regulator (IPR) Pigtail

Applies To: MaxxForce 07-09 and 2010 DT, 9, & 10 engine builds and later (ESN 3000000 to 3999999)

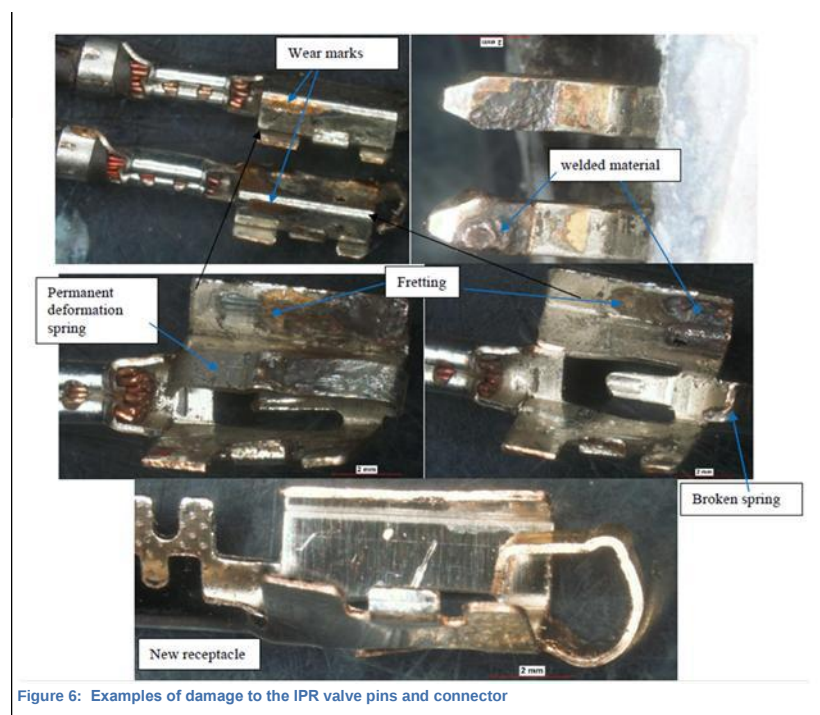
**IPR Pigtail Part Number: 2501107C1\***

**\*NOTE: New Pigtail Part Number. All pigtails now have Green wires.**

- Replace IPR valve and/or pigtail; leave generous length of wire to allow movement. The IPR pigtail service part must have a 90mm wire tail between the IPR connector and the wiring harness. See Figure 5 below.
  - Use a generous amount of Dielectric Grease.
