2014 Outlander

TECH TALK

Volume 194, February, 2013

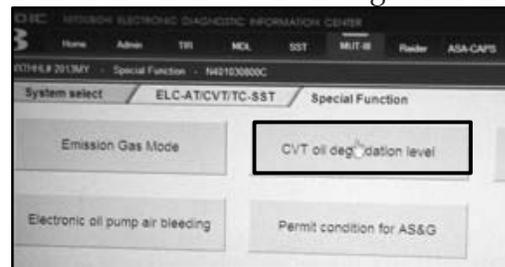
RESETTING CVT FLUID DEGRADATION COUNTER — All 2008 & later with CVT. TCMs in subject vehicles calculate how much the CVT oil degrades over time. These vehicles require the "CVT oil degradation level" be reset whenever the CVT fluid is replaced. To complete the reset procedure, from the MUT-III main page, choose "System Select." On the System page confirm the "From2006MY" button is selected, click the car icon at the bottom of the page and confirm/input your vehicle information (VIN, etc.) Then select "ELC-AT/CVT/TC-SST" and click the check mark at the bottom of the page. Select "Special Function" then "CVT oil degradation level."

When the "CVT oil degradation level" screen appears, click the check mark to begin the reset procedure and follow on-screen instructions.

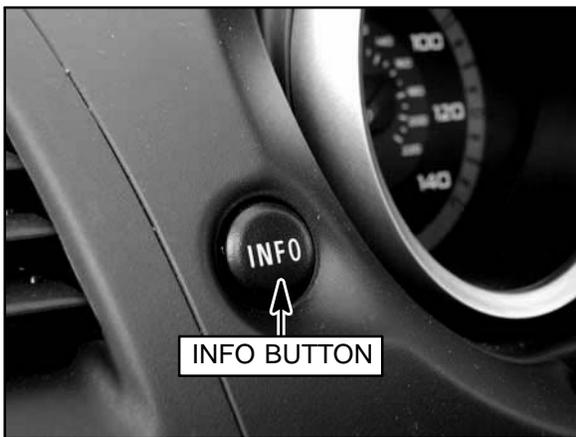
CHANGING THE TURN SIGNAL FUNCTION SOUND — 2007-later Outlander, 2008 & later Lancer Based vehicles, 2011 & later Outlander Sport (RVR). The sound heard when the turn signal functions can be changed between an alternating beep tone and a traditional clicking sound. If you want to change from one to the other, use the following instructions:

1. Press the “INFO” button repeatedly until the the “Setting Menu” is displayed.
2. Press and hold the “INFO” button for 2 seconds again. This changes the display to the “Menu Screen.”

3. Repeatedly press the “INFO” button until the <—> icon is displayed.
4. Press and hold the “INFO” button for 2 seconds. The sound will toggle between the alternating beep tone and the traditional clicking each time the button is pressed and held.
