# SERVICE CAMPAIGN BULLETIN

**CAMPAIGN REF:** 01P

**TITLE :** Vehicle software update to platform 10.2

**DOCUMENT # :** 11 M 041

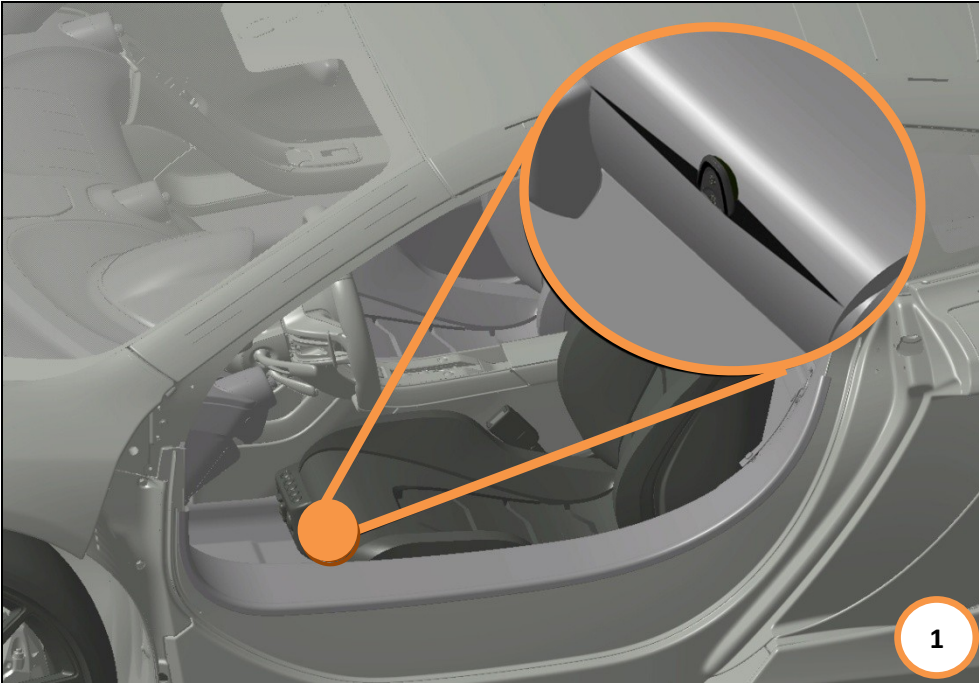
**Care point:** The key must be positioned in the driver's seat front pocket, picture below (1).

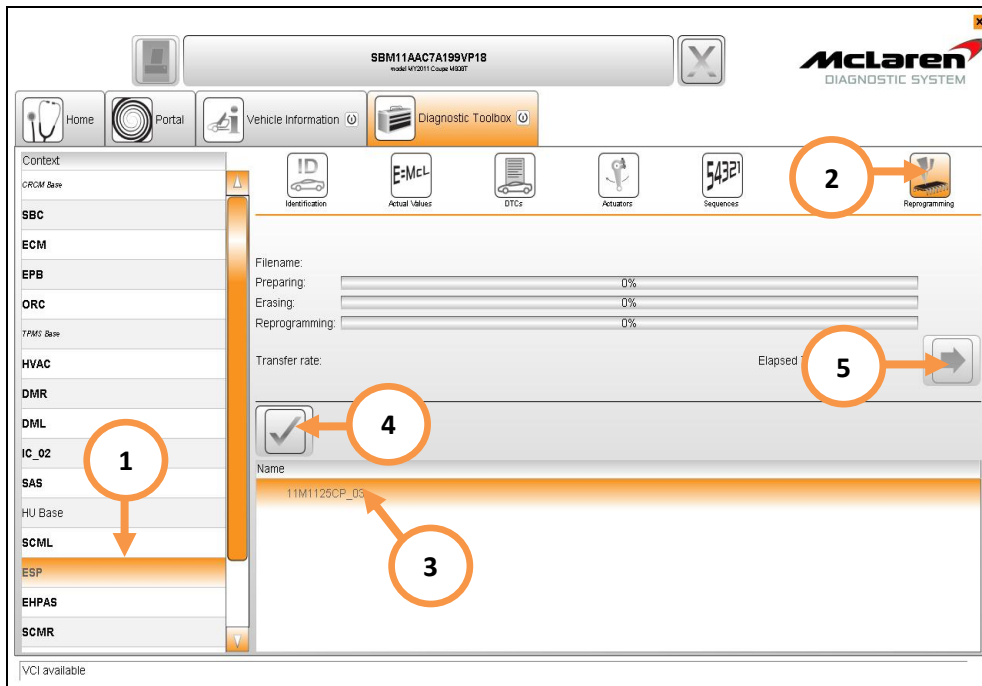
56. Select ESP (1), then Reprogramming (2), select the software level 11M1125CP.04 (3), then proceed to the software download by selecting the tick button (4), followed by the arrow button (5). Select 'YES' to initiate programming.

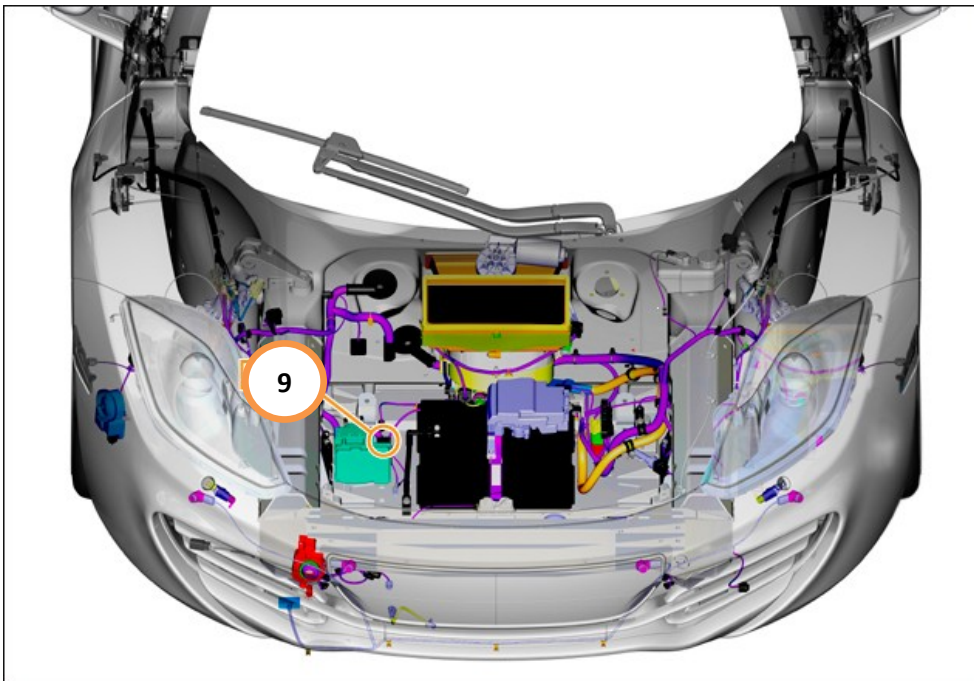
61. Disconnect the ESP connector (9) and wait for 5 seconds before reconnecting.

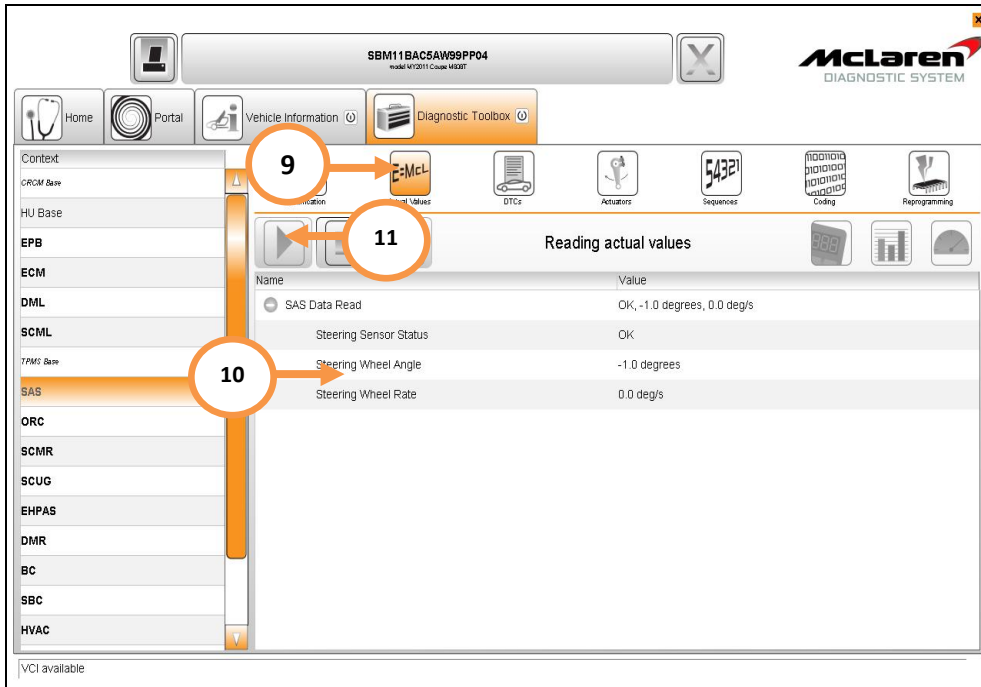
66. Start the engine, select Actual Values (9), followed by SAS Data Read (10), select the play button to access the required data screen (11), turn the steering wheel left and right to full lock. Check that the value reading is zero when the steering is central. Check the fault memory to identify if the DTC's have repeated.

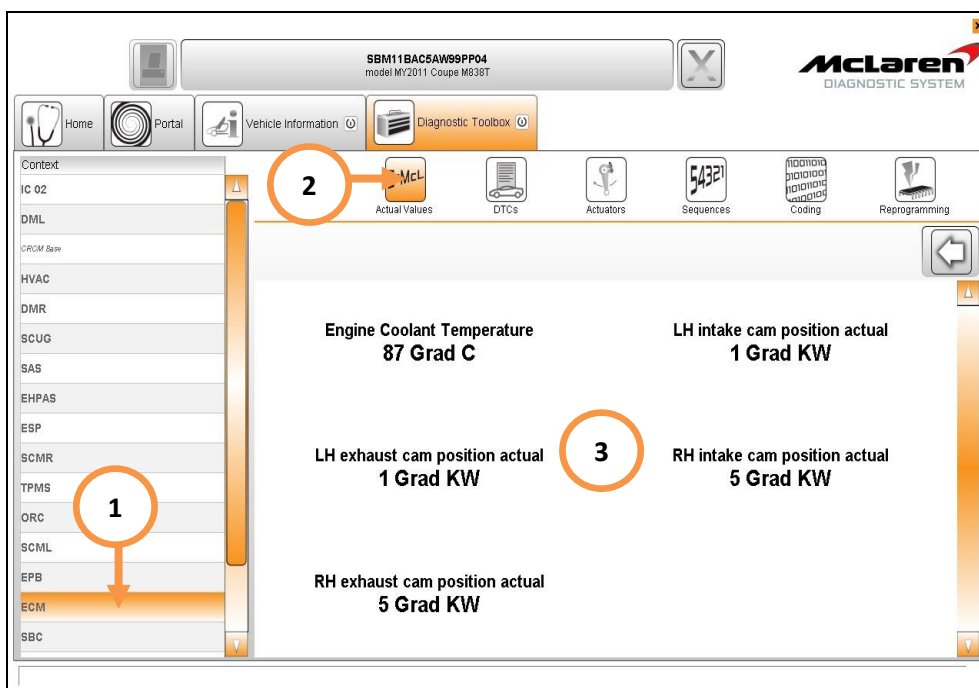
98. The inlet and exhaust camshaft values should be between 1 and 4, both values will fluctuate slightly. If all values are correct no further action is required proceed to step 100. If any values are incorrect proceed to step 99 to carry out the camshaft adaption.

99. Switch the engine off, wait 30 seconds, restart the engine and recheck the values. Repeat this procedure until the target values are achieved.

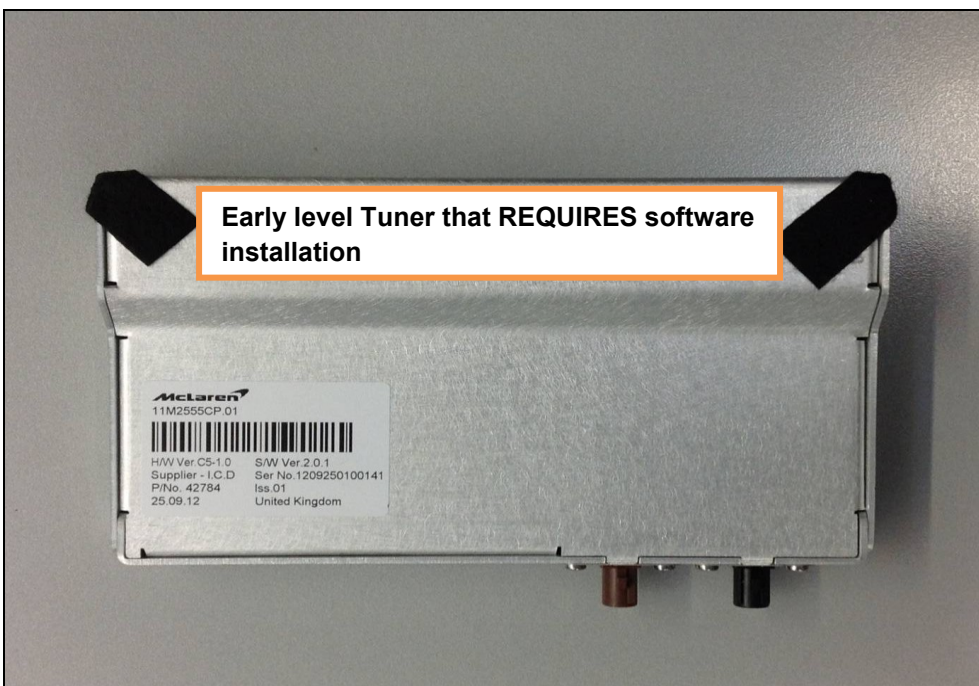
**Care Point:** Different level of Tuners will be supplied to dealers. Early level Tuners will require software installation, later level Tuners **do not**. The different levels of Tuners can be seen in the pictures below and should have been noted which level was fitted during initial installation.

**Care point:** If the vehicle has been fitted with an early level Tuner, read steps 123 to 125 and then return to step 115 before you proceed with software installation. If a later level Tuner is installed proceed to step 127.

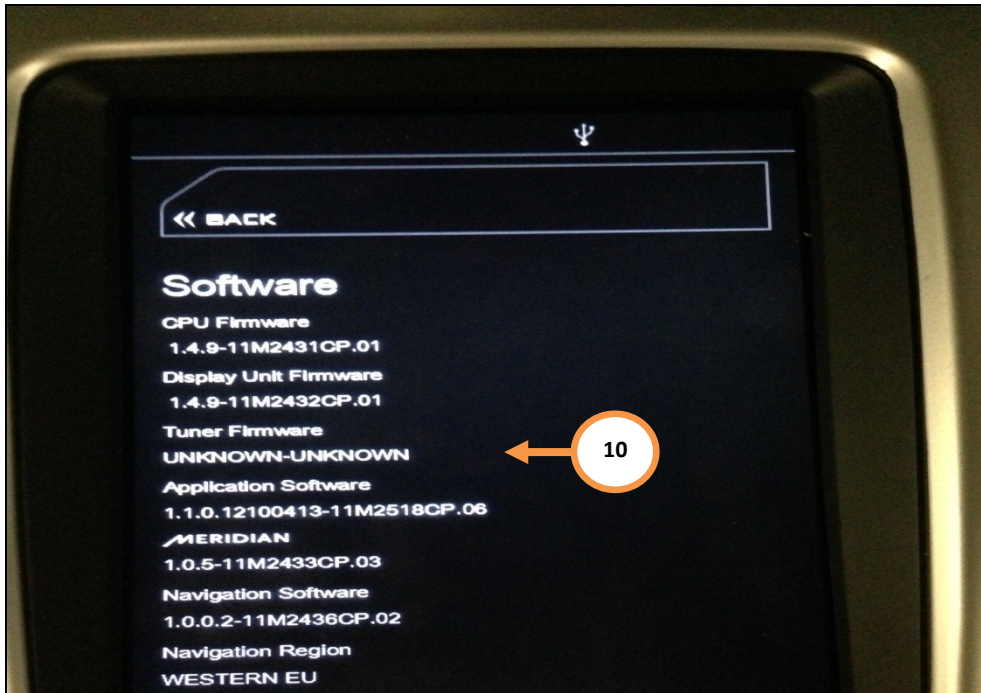
116. Proceed to Home/Settings/About/Software and check the Tuner Firmware is displayed and does not display UNKNOWN-UNKNOWN(10). If Ok proceed to step 123, If UNKNOWN-UNKNOWN is displayed proceed to step 117.
