BT12-018a

January 16, 2013

## 2013 JX35; SQUEAKS AND RATTLES FROM INSTRUMENT PANEL

2013 JX35 (L50)

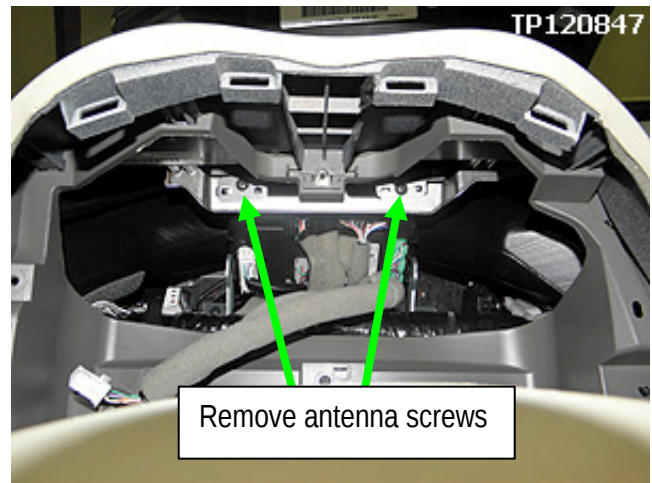
Figure 13

GPS and telephone antenna brackets may contact Body Control Module (BCM) and may make a noise.

1. Remove Cluster Lid and Meter assemblies, and then remove screws holding GPS and telephone antennas.

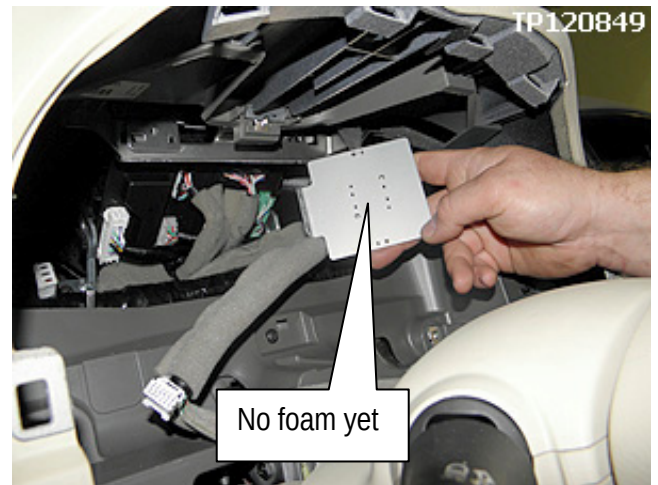
Figure 15

Foam will be applied to the side of both antennas shown in figure 16.

3. Apply 90 mm of "EPDM SEMI CLOSED CELL" foam (J-50397-2) to back of telephone antenna.
  - Figure 16 shows antenna with foam applied.

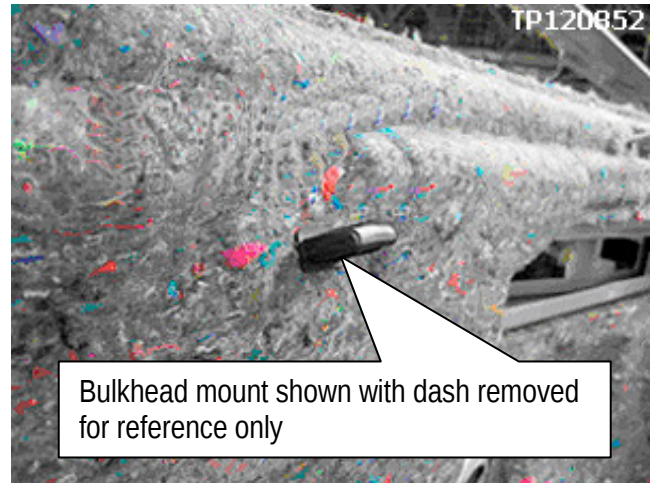
Figure 18

The Instrument Panel Assembly may not be completely aligned with bulkhead mount and could rub, and may make noise.

1. While lying on driver's floor reach between the brake and throttle peddles and upwards with **right hand**, along bulkhead at a 45° angle toward the center of the Instrument Panel.

2. Pull down firmly on Instrument Panel Assembly “nozzle” with 20 – 40 lbs of downward force to align bulkhead mount and Instrument Panel Assembly.

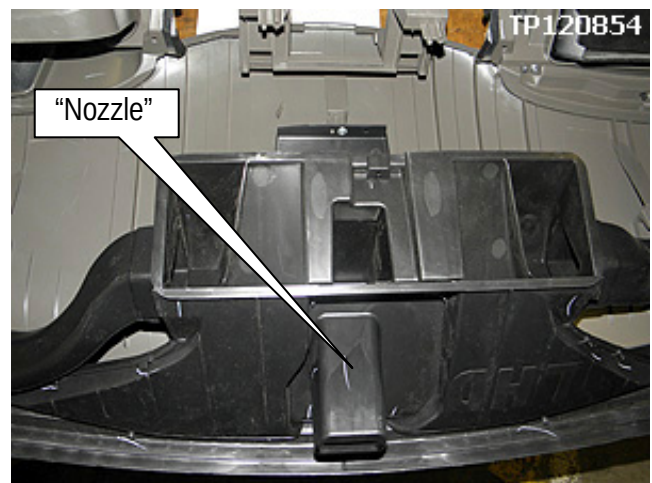
Figure 20 is for reference only and shows the Instrument Panel Assembly removed, upside down and from the bulkhead side.
