# SERVICE BULLETIN

Classification: EC12-028a	Reference: NTB12-093a	Date: January 25, 2013
------------------------------	--------------------------	---------------------------

## 2009-2013 MAXIMA, ALTIMA; HARD TO START WHEN AMBIENT TEMPERATURE IS NEAR FREEZING

**APPLIED VEHICLES:** 2009-2013 Maxima (A35) **with VQ35 only**  
 2009-2012 Altima Coupe (CL32) **with VQ35 only**  
 2009-2012 Altima Sedan (L32) **with VQ35 only**

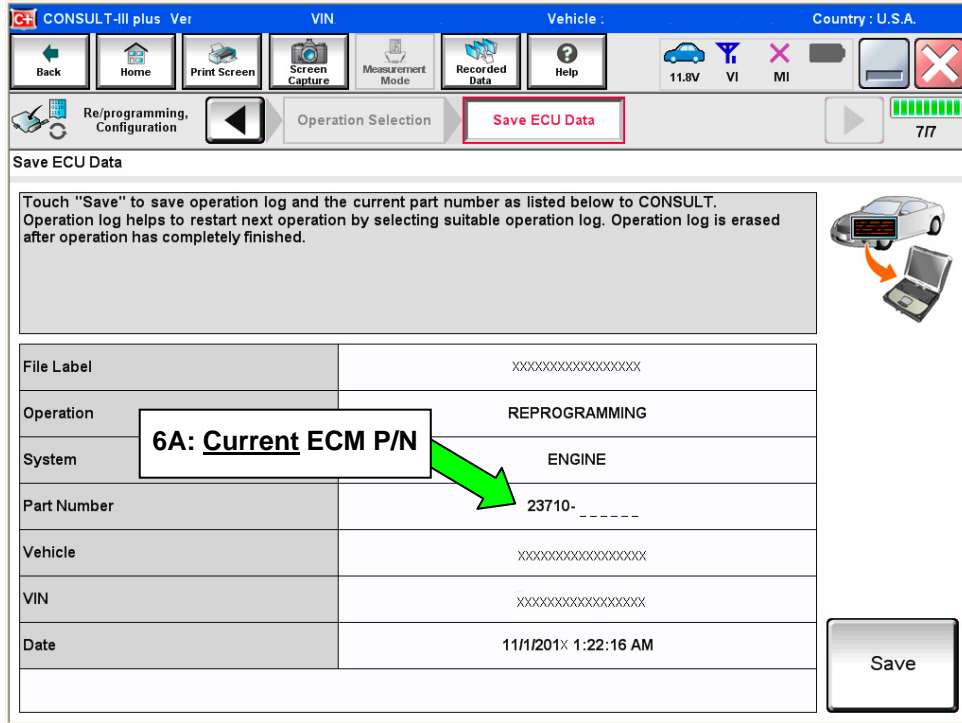
Figure 2

6. When you get to the screen shown in Figure 2, confirm this bulletin applies as follows.
- A. Find the ECM **Part Number** and write it on the repair order.

**NOTE:** This is the current ECM Part Number (P/N).

- B. Compare the P/N you wrote down to the numbers in the **Current ECM Part Number** column in **Table A** on the next page.
- If there is a match, this bulletin applies. Continue with the reprogramming procedure.
  - If there is not a match, this bulletin does not apply. Close C-III plus and refer to ASIST for further diagnostic information.

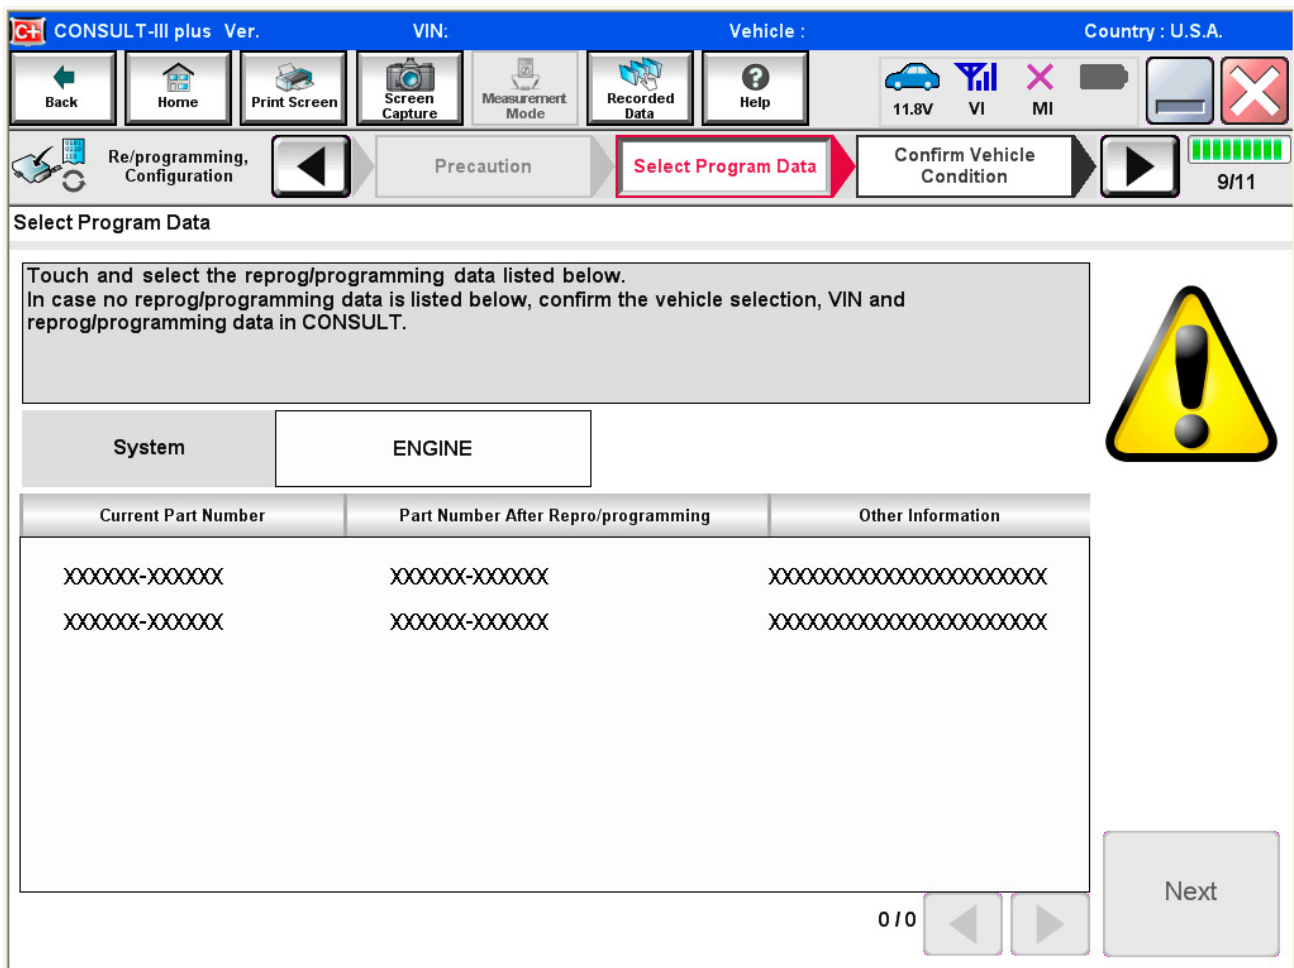
- In some cases, more than one new P/N for reprogramming is available.
  - In this case, the screen in Figure 3 displays.
  - Select and use the reprogramming option that **does not** have the message “Caution! Use ONLY with NTBXX-XXX”.
- If you get this screen and it is blank (no reprogramming listed), it means there is no reprogramming available for this vehicle. Close C-III plus and refer back to ASIST for further diagnosis.

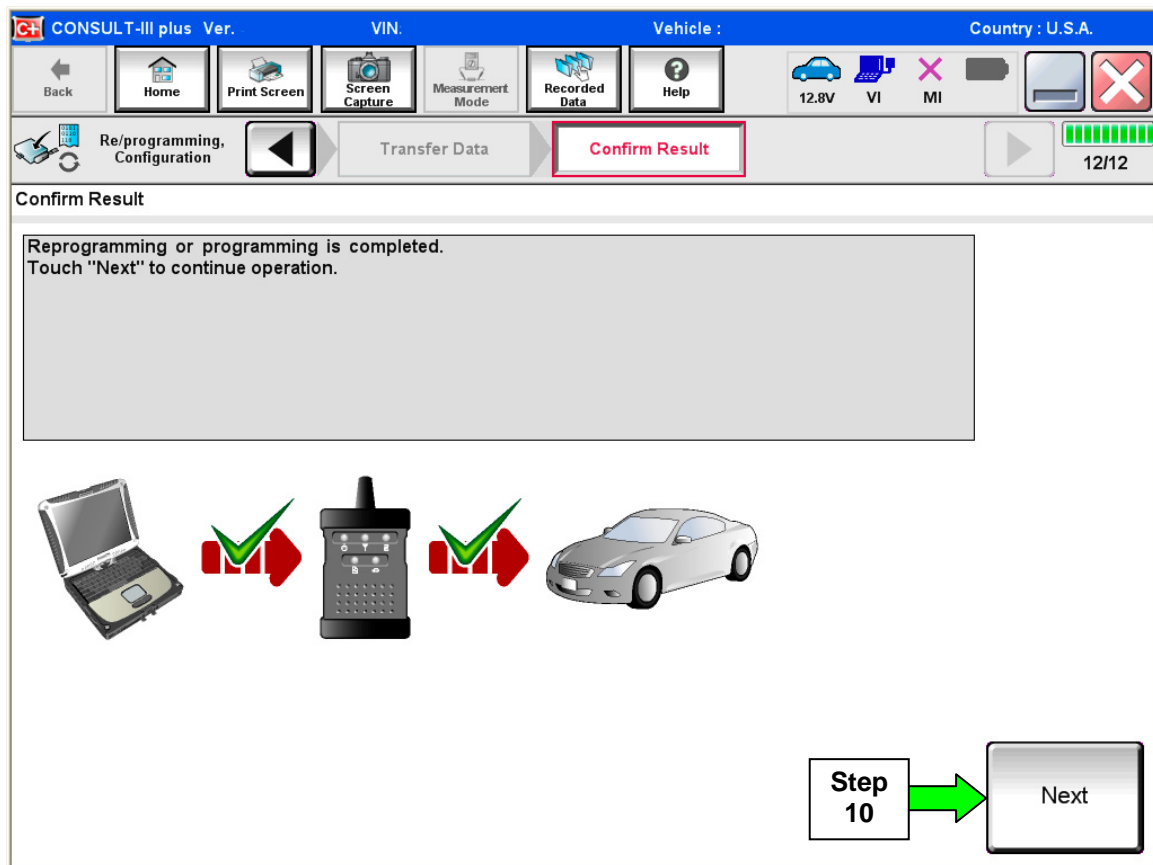
8. When the screen in Figure 4 displays, reprogramming is complete.

**NOTE:** If the screen in Figure 4 does not display (reprogramming does not complete), refer to the information on page 8.

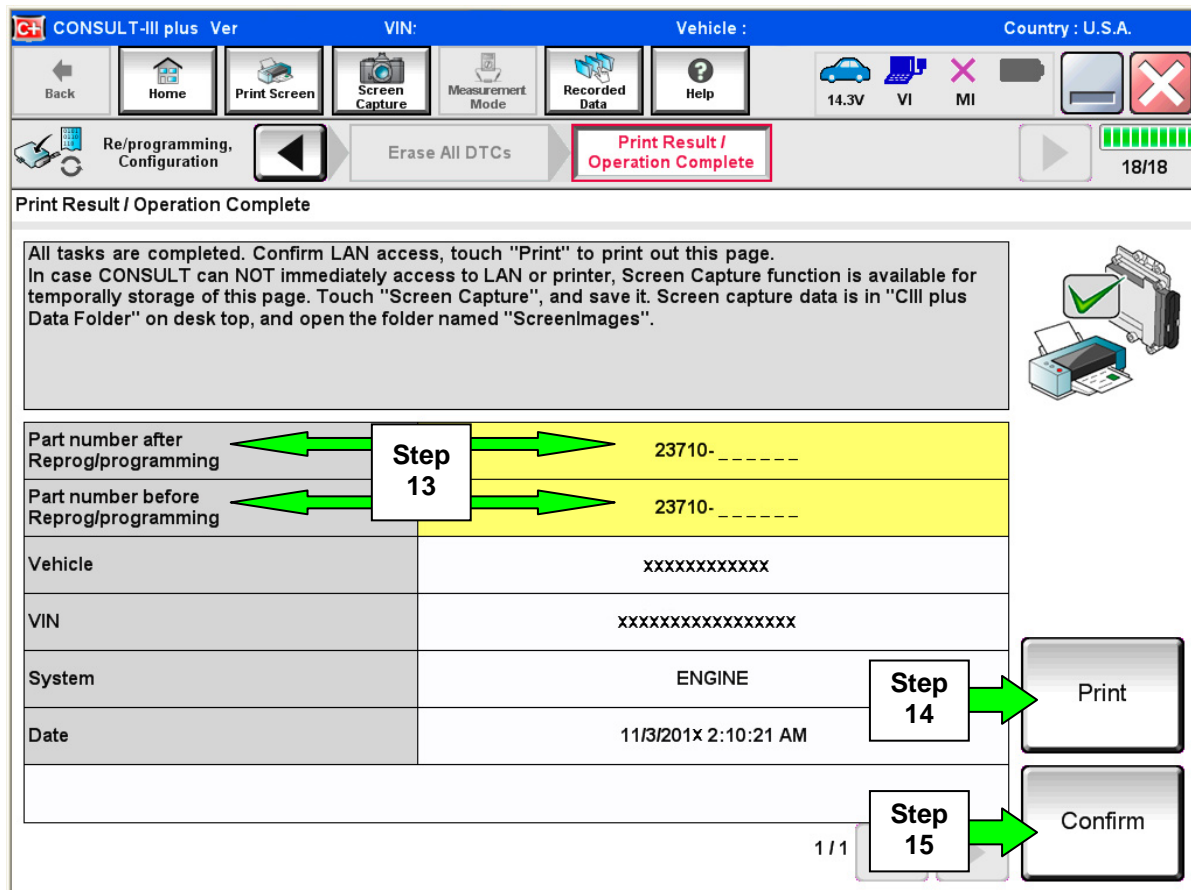
12. When the entire reprogramming process is complete, the screen in Figure 7 will display.
13. Verify the before and after part numbers are different.
14. Print a copy of this screen (Figure 7) and attach it to the repair order for warranty documentation.
15. Select **Confirm**.
