SERVICE CAMPAIGN BULLETIN

NTB13-020

VOLUNTARY SERVICE CAMPAIGN 2013 ALTIMA SEDAN WITH V6 ENGINE; AIR FUEL SENSOR

CAMPAIGN ID #: PC218

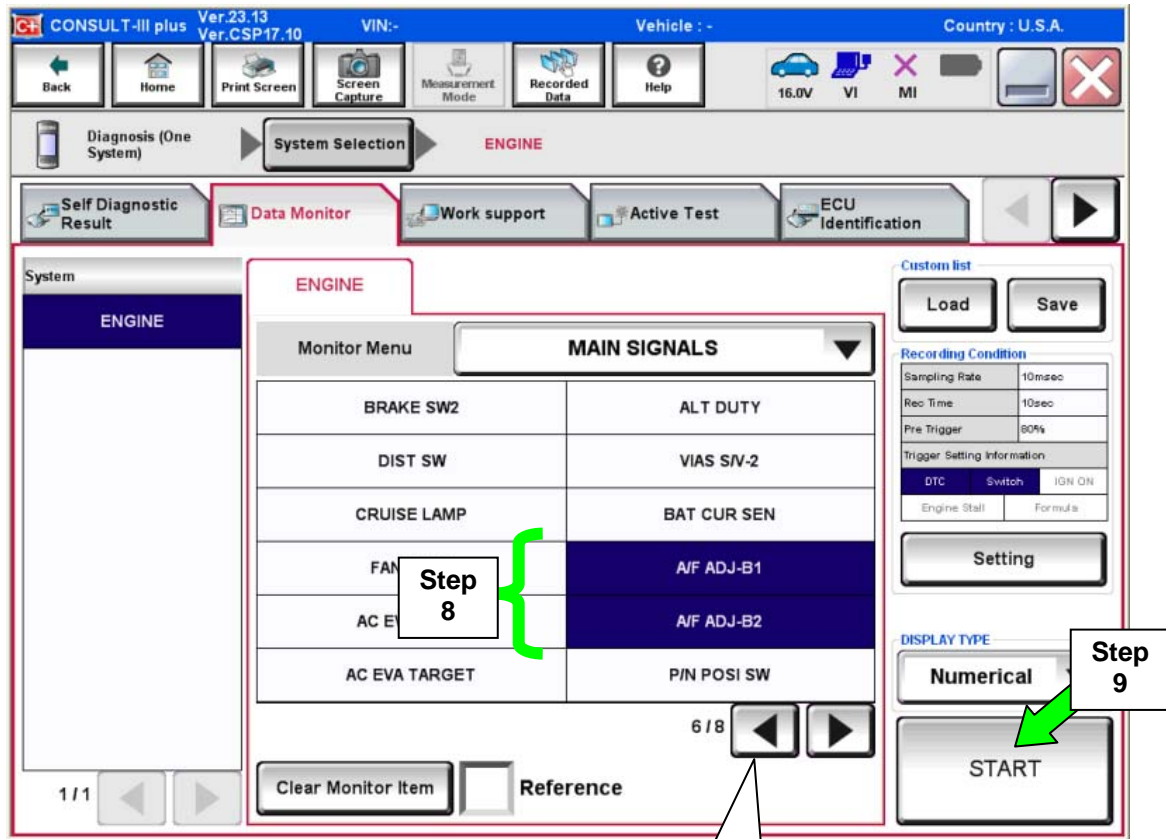
Figure A4

- Value for each sensor should be between **- 0.300** and **0.300**.
- If a sensor (one or both) is out of the above specified range, make a note of it.
- Sensor(s) that are out of the specified value will be replaced later in this procedure.

1. If needed, replace A/F Sensor(s).
 - a. Refer back to your notes from Check Air Fuel (A/F) Sensor Adjustment on page 6.
 - If **A/F ADJ-B1** value was out of specification, replace Bank 1 A/F sensor (bank 1 is toward the rear of the vehicle).
 - If **A/F ADJ-B2** value is out of specification, replace Bank 2 A/F sensor (bank 2 is toward the front of the vehicle).

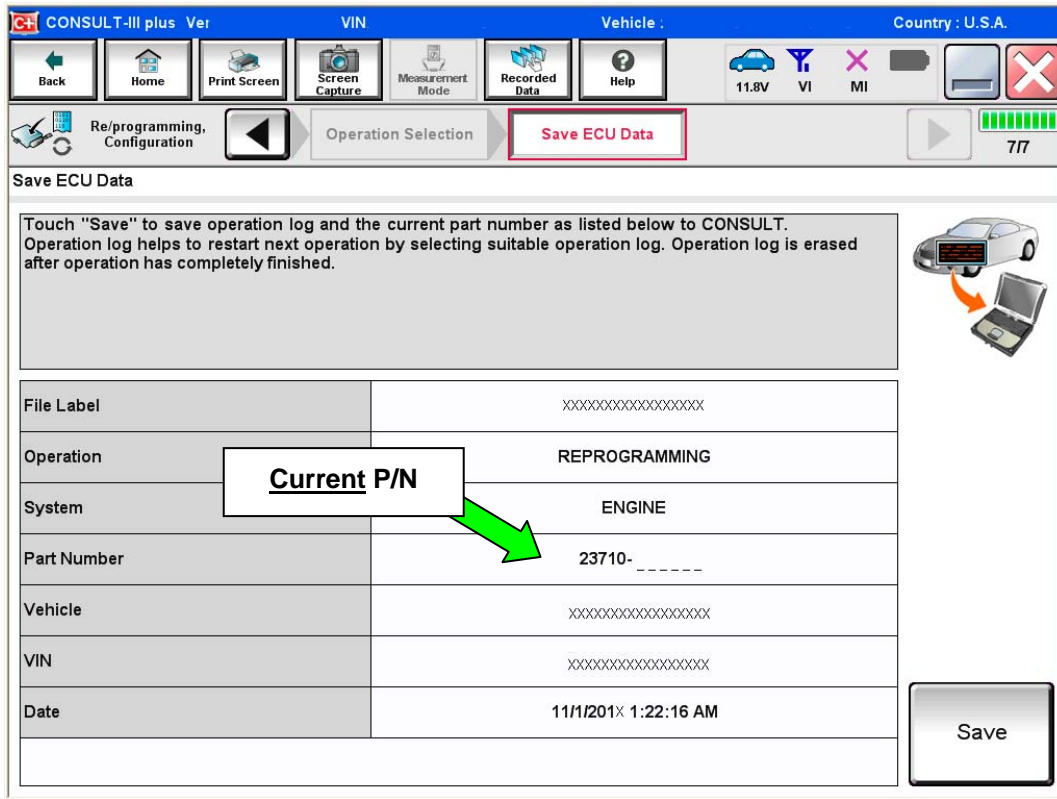
Figure 3

A. Find the ECM **Part Number** and write it on the repair order.

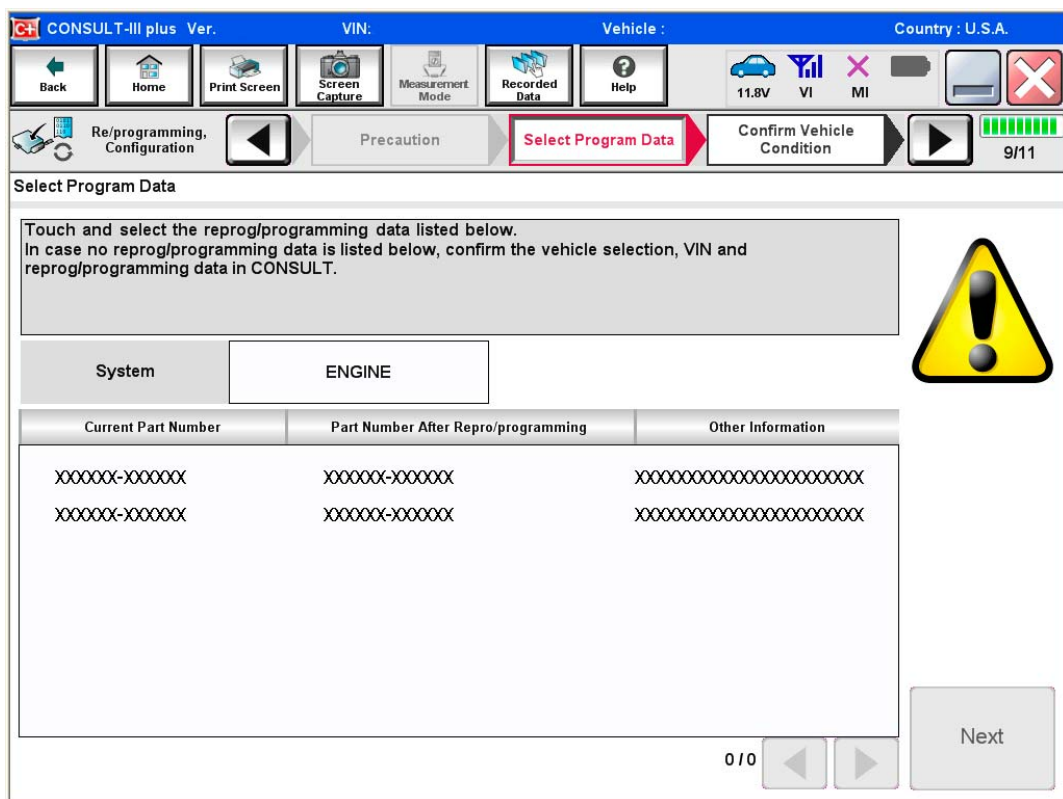
- In some cases, more than one new P/N for reprogramming is available.
 - In this case, the screen in Figure 4 displays.
 - Select and use the reprogramming option that **does not** have the message “Caution! Use ONLY with NTBXX-XXX”.
- If you get this screen and it is blank (no reprogramming listed), it means there is no reprogramming available for this vehicle.
