SERVICE BULLETIN

Classification: EC13-007	Reference: NTB13-054	Date: May 16, 2013
-----------------------------	-------------------------	-----------------------

2013 ALTIMA SEDAN; ENGINE STOPS ON ACCELERATION FROM A STOP AFTER 15 MINUTE IDLE, OR AFTER REFUELING

APPLIED VEHICLE: 2013 Altima Sedan (L33) with QR25DE (4-cyl) engine **ONLY**

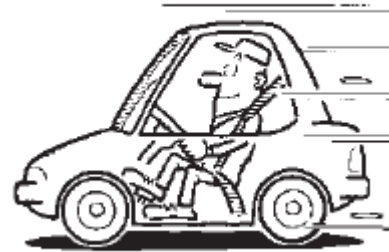
Figure A

- Take the vehicle for a 10 minute drive in order to meet the following Idle Air Volume Learn (IAVL) conditions:
 - Engine coolant temperature: 70 -100°C (158 -212°F)
 - Battery voltage: More than 12.9V (At idle)
 - Transmission: Warmed up
