SERVICE BULLETIN

Classification: AT13-005	Reference: NTB13-059	Date: May 30, 2013
-----------------------------	-------------------------	-----------------------

2013 ALTIMA SEDAN AND PATHFINDER MIL "ON" WITH DTC P062F

APPLIED VEHICLES: 2013 Altima Sedan (L33)
2013 Pathfinder (R52)

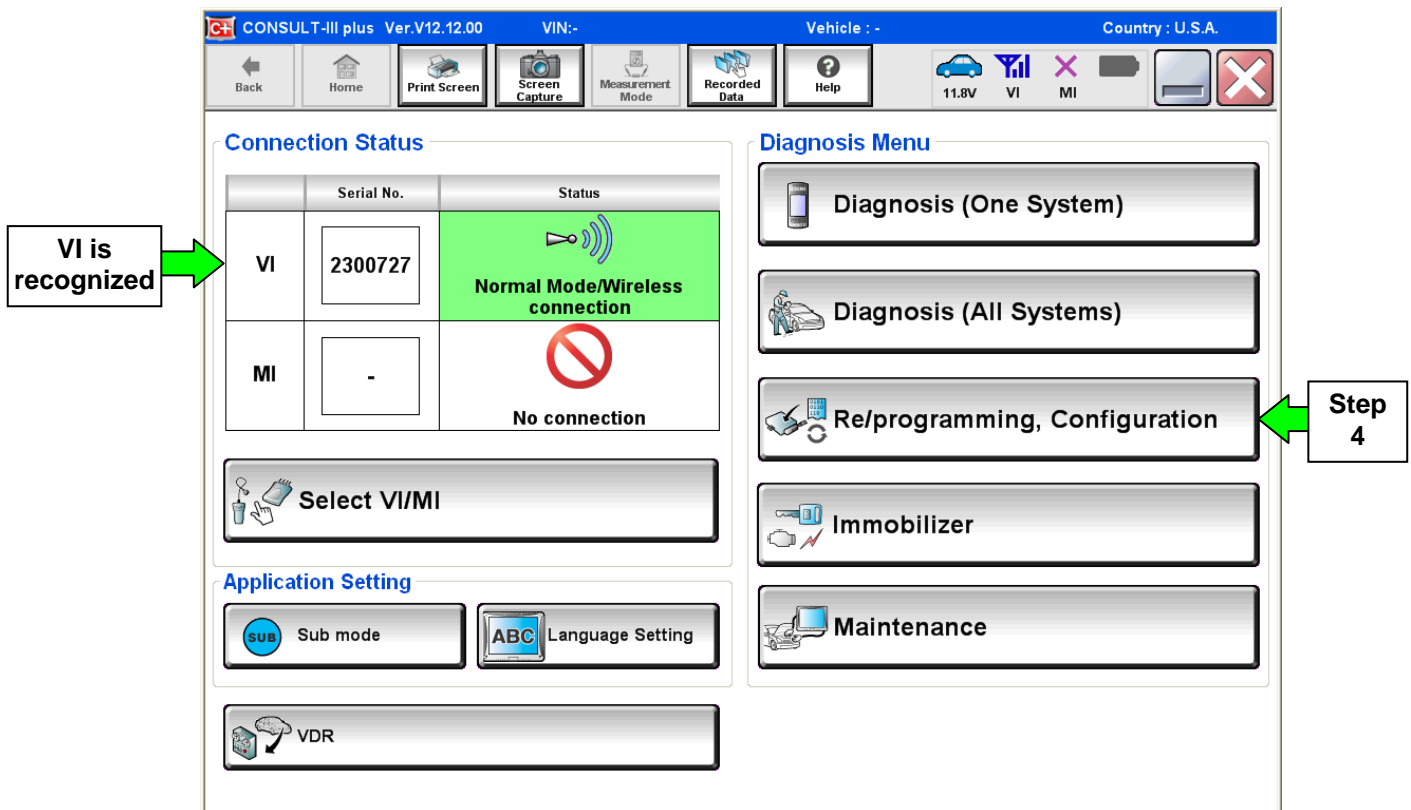
Figure 1

1. Connect the CONSULT PC to the vehicle to begin the reprogramming procedure.
2. Open ASIST on the CONSULT PC and start C-III plus.
3. Wait for the plus VI to be recognized.
 - The serial number will display when the plus VI is recognized.
4. Select **Re/programming, Configuration**.

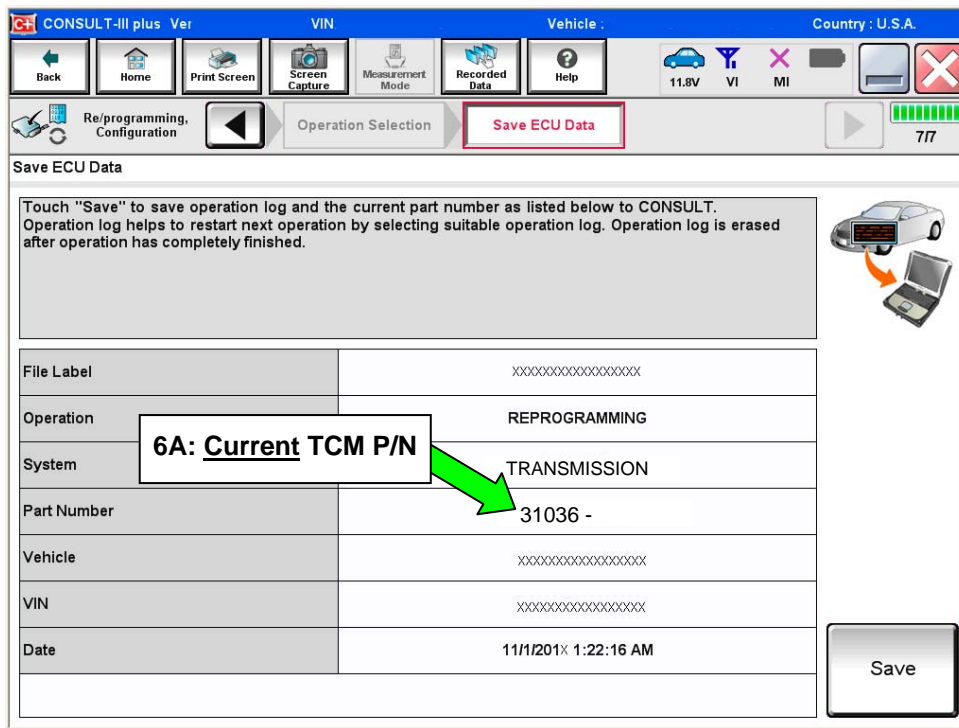
Figure 2

6. When you get to the screen shown in Figure 2, confirm this bulletin applies as follows.

A. Find the TCM **Part Number** and write it on the repair order.

NOTE: This is the current TCM Part Number (P/N).

B. Compare the P/N you wrote down to the numbers in the **Current TCM Part Number** column in **Table A** below.

- If there is a match, this bulletin applies. Continue with the reprogramming procedure.
- If there is not a match, this bulletin does not apply. Close C-III plus and refer to ASIST for further diagnostic information.

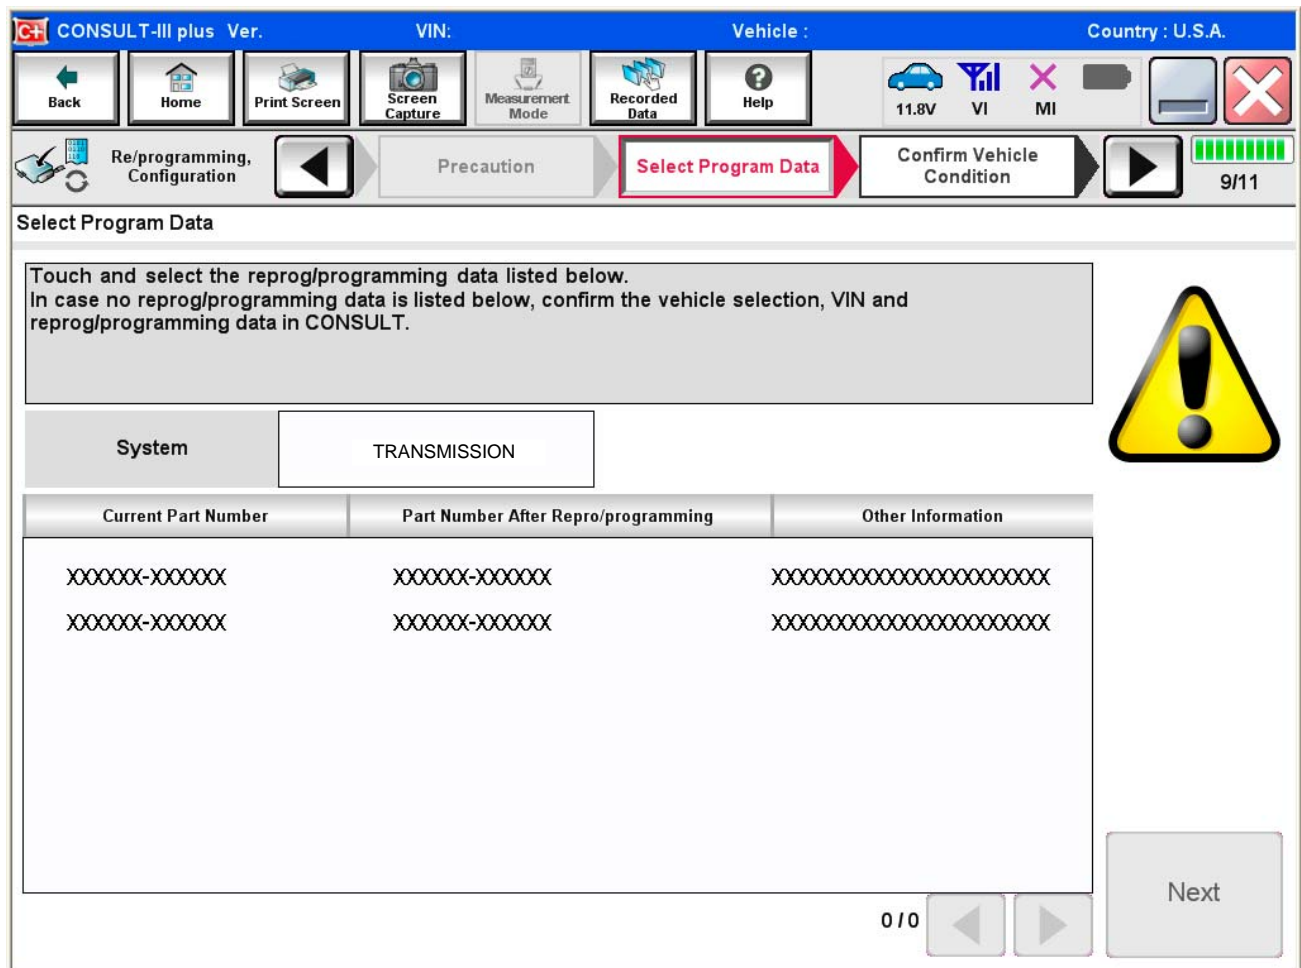
- In some cases, more than one new P/N for reprogramming is available.
 - In this case, the screen in Figure 3 displays.
 - Select and use the reprogramming option that **does not** have the message “Caution! Use ONLY with NTBXX-XXX”.
- If you get this screen and it is blank (no reprogramming listed), it means there is no reprogramming available for this vehicle. Close C-III plus and refer back to ASIST for further diagnosis.

7. Follow the on-screen instructions to navigate C-III plus and reprogram the TCM.

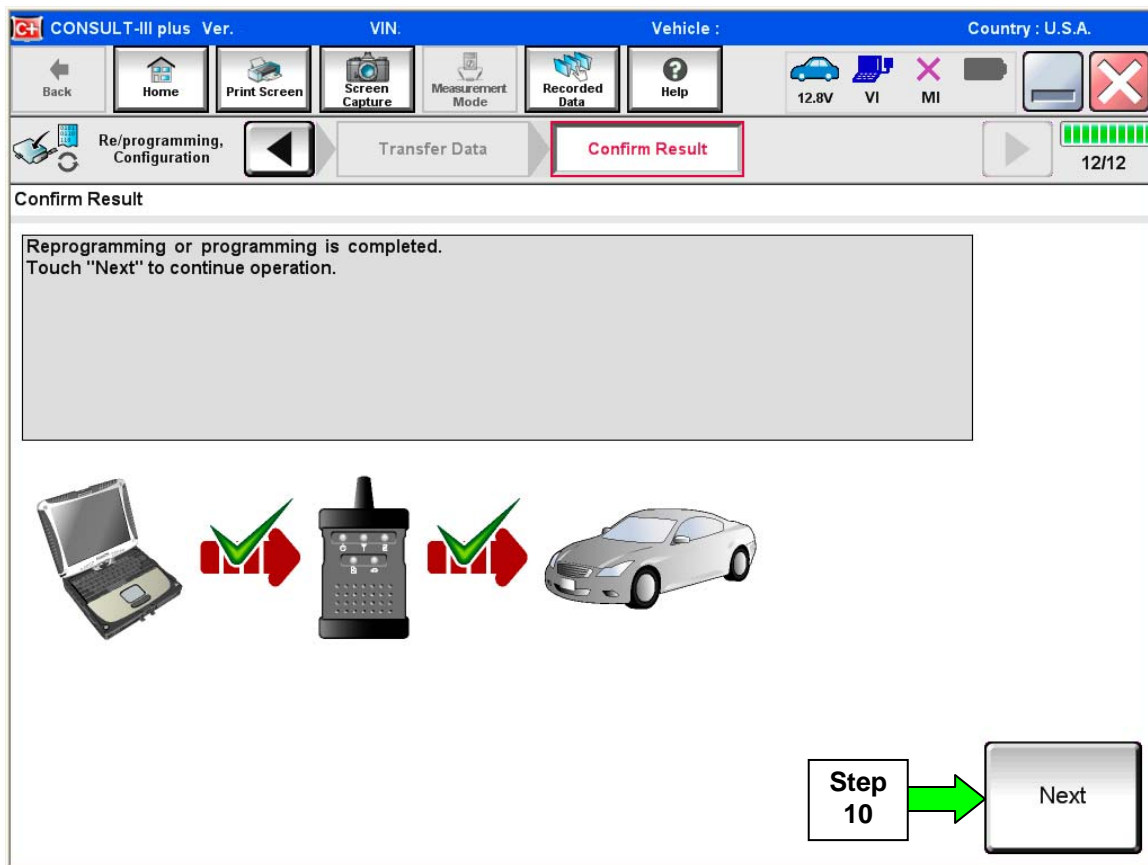
8. When the screen in Figure 4 displays, reprogramming is complete.

NOTE: If the screen in Figure 4 does not display (reprogramming does not complete), refer to the information on the next page.

9. Disconnect the battery charger from the vehicle.

10. Select **Next**.

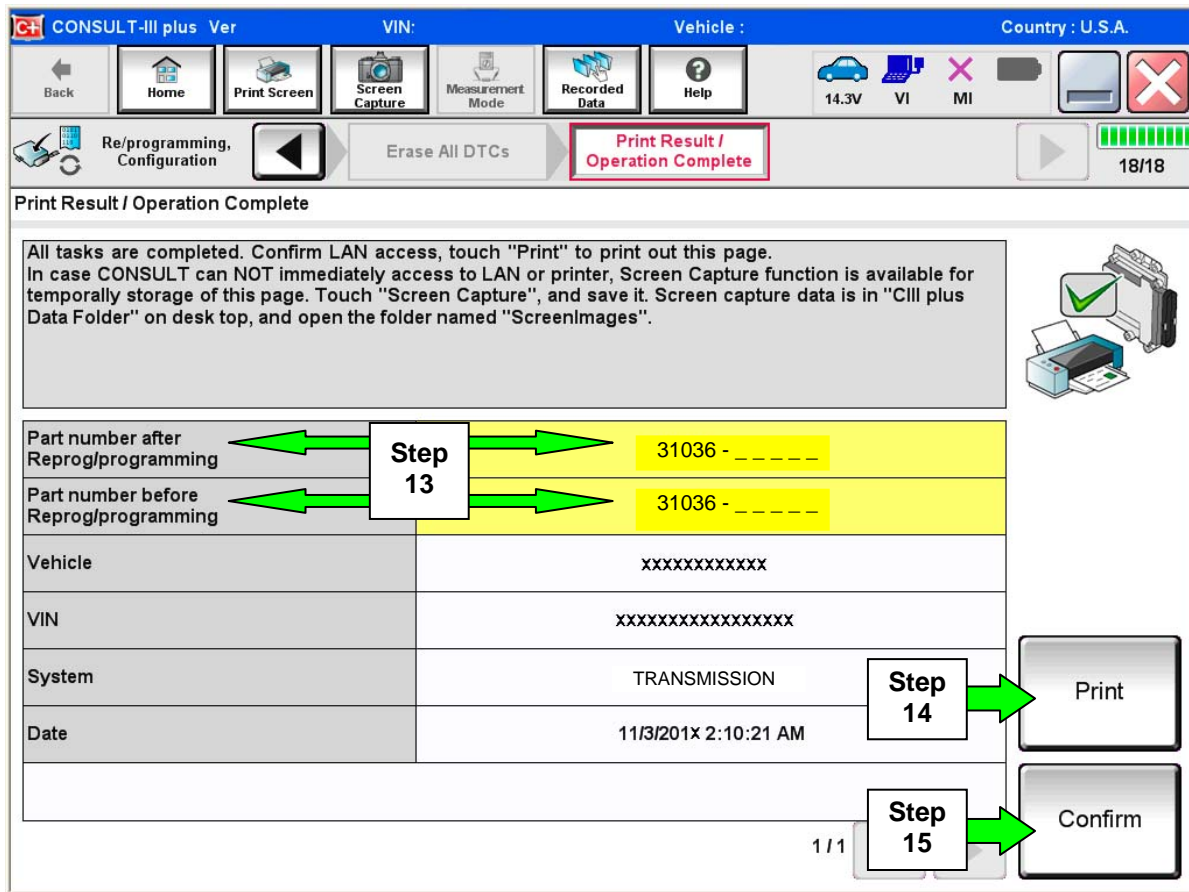
11. Follow the on-screen instructions to **Erase All DTCs**.
12. When the entire reprogramming process is complete, the screen in Figure 7 will display.
13. Verify the before and after part numbers are different.
14. Print a copy of this screen (Figure 7) and attach it to the repair order for warranty documentation.
15. Select **Confirm**.

16. Close C-III plus.
17. Turn the ignition OFF.
18. Disconnect the plus VI from the vehicle.
19. Make sure the vehicle operates correctly and the MIL is OFF.
 - If the MIL comes ON, go back to ASIST for further diagnostic information.
 - Diagnosis and repairs beyond TCM reprogramming are not covered by this bulletin.
