SERVICE CAMPAIGN BULLETIN

NTB13-022a

VOLUNTARY SERVICE CAMPAIGN 2013 SENTRA COLD IDLE ECM AND TCM REPROGRAM

CAMPAIGN ID #: P3212

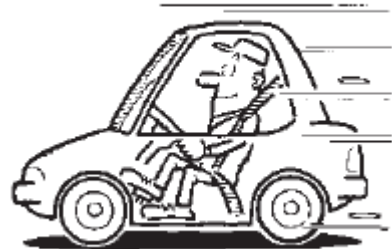
Figure A

- Take the vehicle for a 10 minute drive in order to meet the following Idle Air Volume Learn (IAVL) conditions:
 - Engine coolant temperature: 70 -100°C (158 -212°F)
 - Battery voltage: More than 12.9V (At idle)
 - Transmission: Warmed up

- After ECM reprogramming is complete, you will be required to perform Throttle Valve Closed Position, Idle Air Volume Learn (IAVL), and Accelerator Closed Position.
- The above conditions are required for the IAVL to complete.
