# SERVICE BULLETIN

Classification: EC13-003a	Reference: NTB13-021a	Date: July 2, 2013
------------------------------	--------------------------	-----------------------

## 2010-2012 FRONTIER, PATHFINDER AND XTERRA; VIBRATION WHILE IDLING

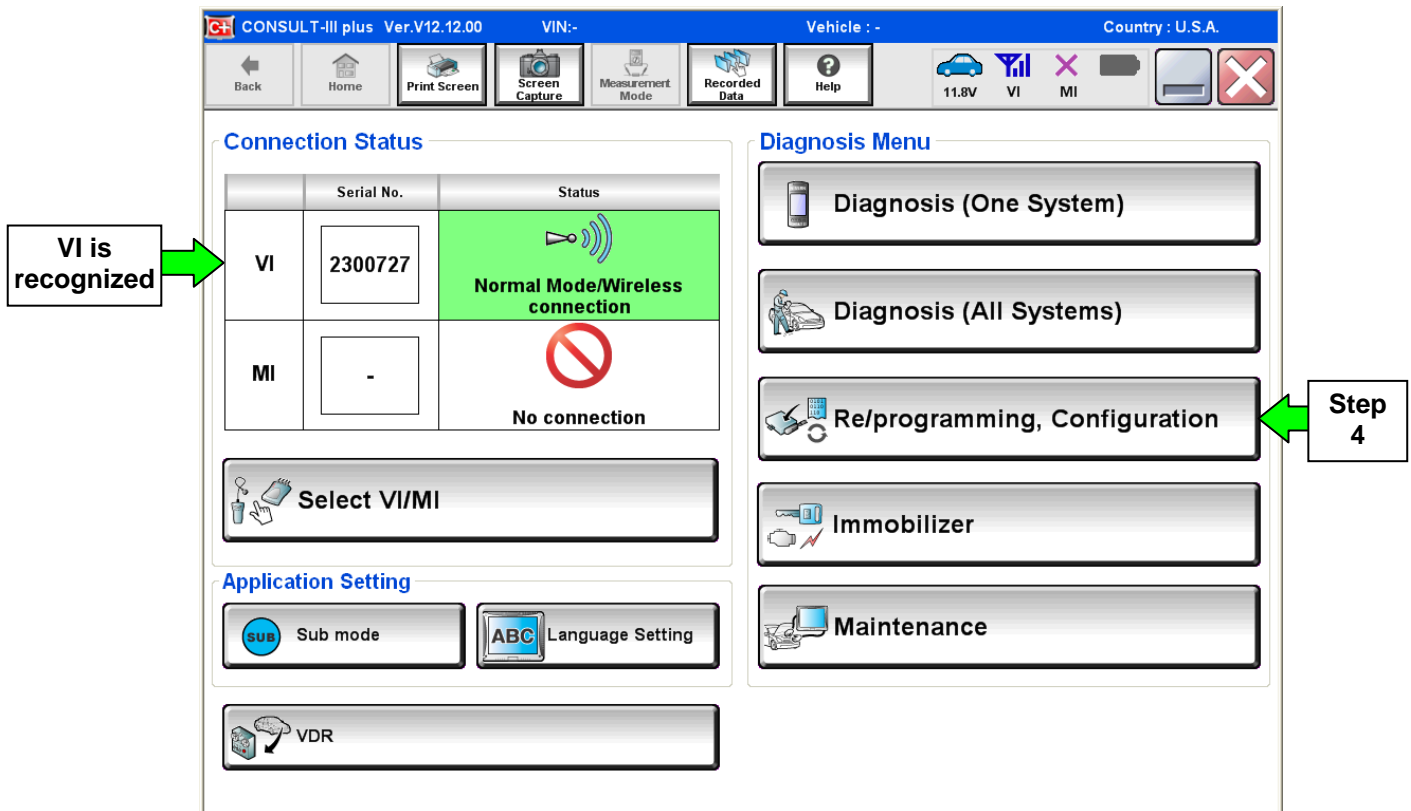
Figure 1

1. Connect the CONSULT PC to the vehicle to begin the reprogramming procedure.
2. Open ASIST on the CONSULT PC and start C-III plus.
3. Wait for the plus VI to be recognized / connected.
  - The serial number will display when the plus VI is recognized / connected.
4. Select **Re/programming, Configuration**.

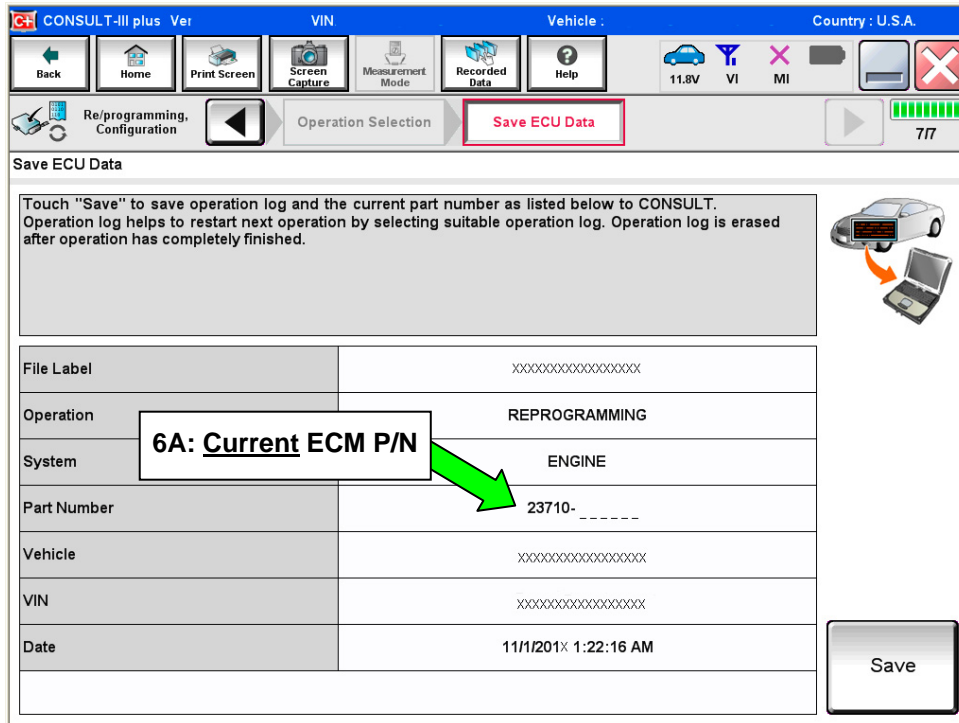
Figure 2

6. When you get to the screen shown in Figure 2, confirm this bulletin applies as follows.
- A. Find the ECM **Part Number** and write it on the repair order.

**NOTE:** This is the current ECM Part Number (P/N).

- B. Compare the P/N you wrote down to the numbers in the **Current ECM Part Number** column in **Table A** on the next page.
- If there is a match, this bulletin applies. Continue with the reprogramming procedure.
  - If there is not a match, this bulletin does not apply. Close C-III plus and refer to ASIST for further diagnostic information.

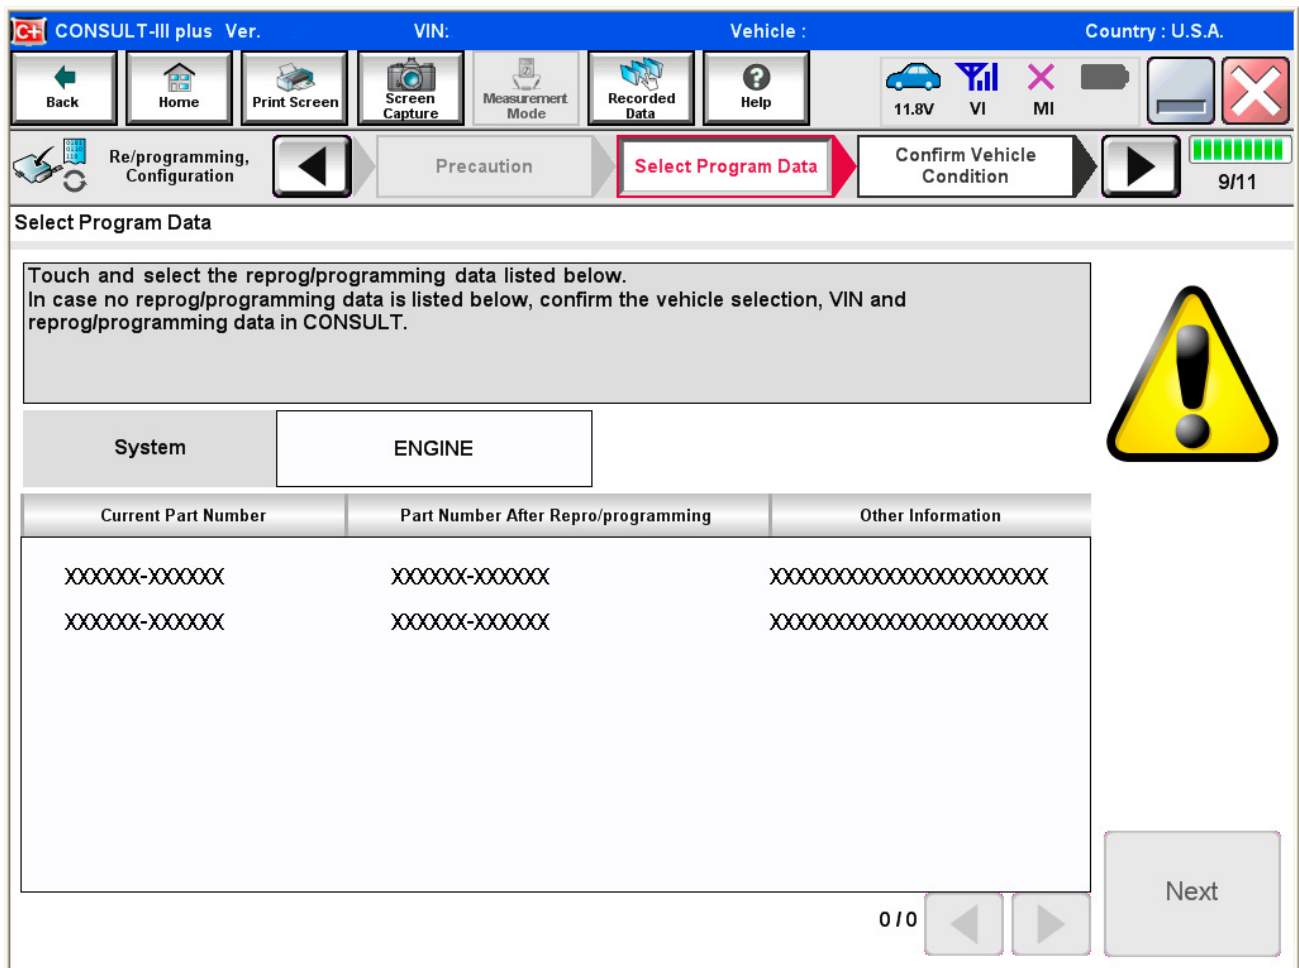
- In some cases, more than one new P/N for reprogramming is available.
  - In this case, the screen in Figure 3 displays.
  - Select and use the reprogramming option that **does not** have the message “Caution! Use ONLY with NTBXX-XXX”.
- If you get this screen and it is blank (no reprogramming listed), it means there is no reprogramming available for this vehicle. Close C-III plus and refer back to ASIST for further diagnosis.

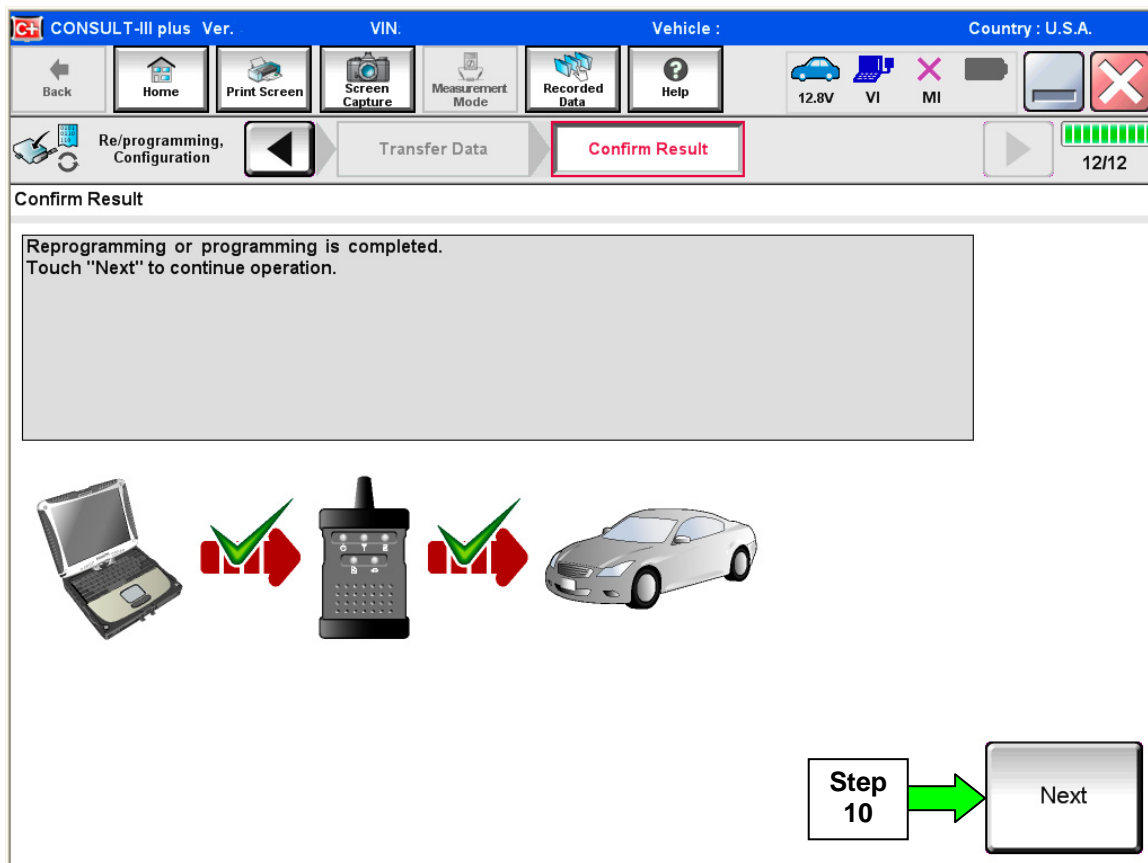
8. When the screen in Figure 4 displays, reprogramming is complete.

**NOTE:** If the screen in Figure 4 does not display (reprogramming does not complete), refer to the information on page 9.

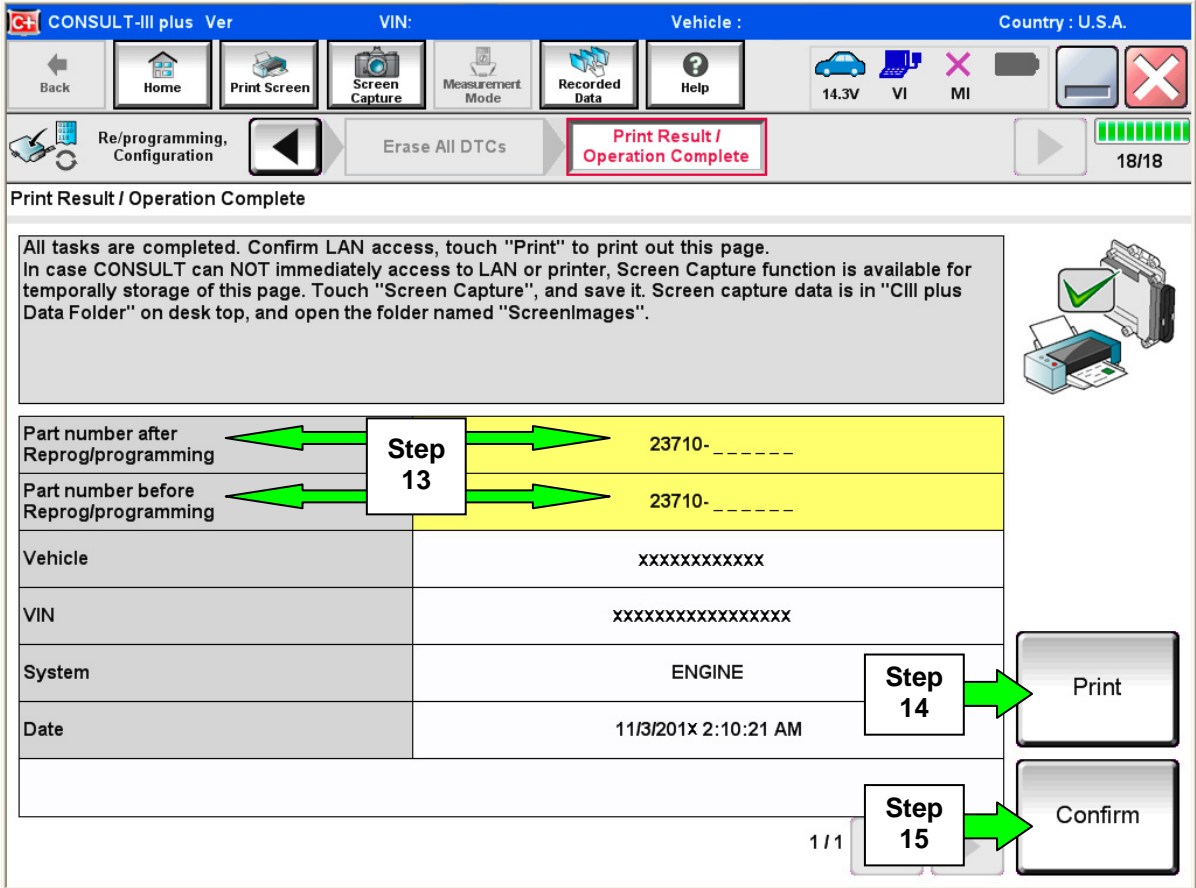
- 12. When the entire reprogramming process is complete, the screen in Figure 7 will display.
- 13. Verify the before and after part numbers are different.
- 14. Print a copy of this screen (Figure 7) and attach it to the repair order for warranty documentation.
- 15. Select **Confirm**.
