SERVICE BULLETIN

Classification: EL13-022	Reference: NTB13-067	Date: July 3, 2013
-----------------------------	-------------------------	-----------------------

2013 ARMADA; COMFORT AND CONVENIENCE SETTINGS MISSING

APPLIED VEHICLE: 2013 Armada (TA60) equipped with Navigation **ONLY**

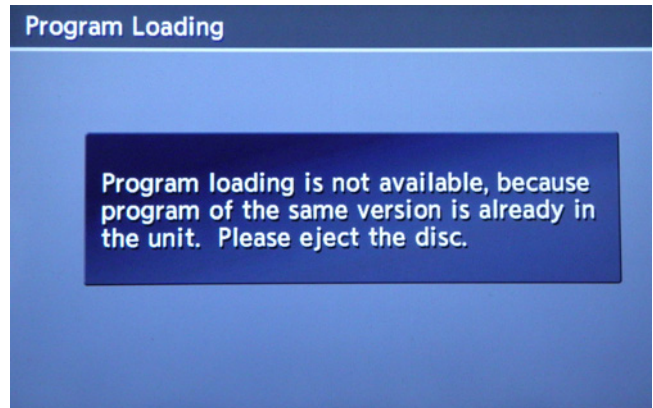
Figure1

- If the screen in Figure 1 is displayed, this update has already been performed and this bulletin does not apply.
 - Refer to ASIST for further diagnostic information.
 - Remove the DVD from the CD slot.

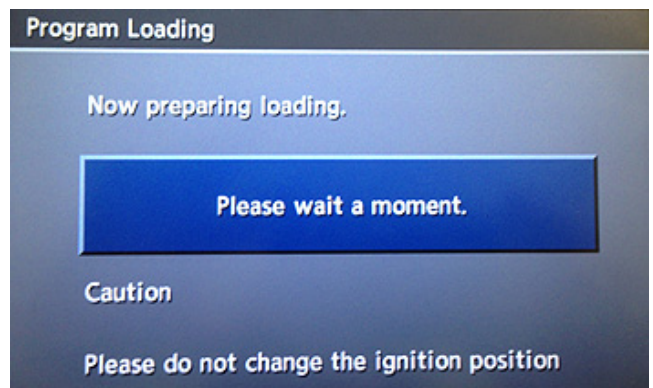
- If “Now preparing loading” shown in Figure 2 is displayed, follow the on screen Caution while the Navigation is updated.

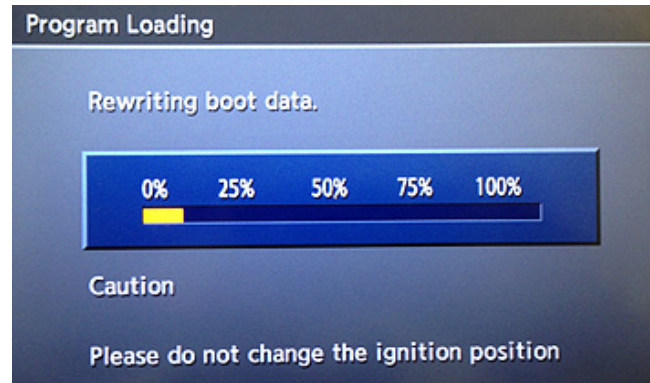
Figure 3

6. During the first part of the update process 3 more screens will be displayed along with a percentage of completion (progress) bars:
- Rewriting boot data. (Figure 3)
 - Rewriting program data (Figure 4)
 - Rewriting language data (Figure 5)

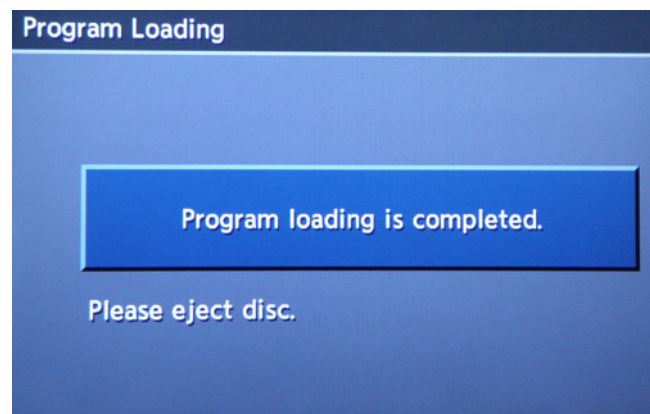
Figure 6

7. When the first part of the program has finished loading:
- "Program loading is completed" will be display (Figure 6).
 - The Re-programming Software DVD will automatically eject.
8. Remove the DVD and continue to the second part of the update in step 9.

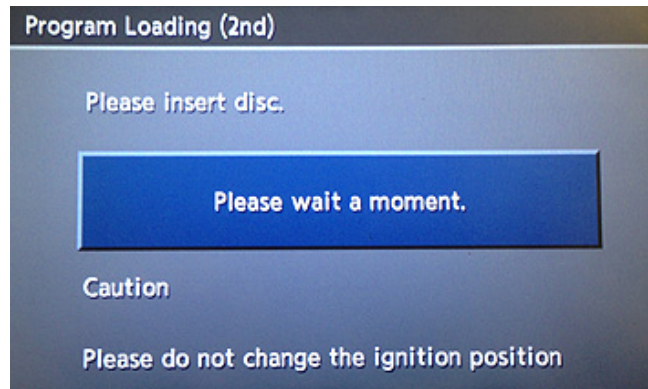
9. After the DVD is removed, the screen in Figure 7 “Please insert disc” may ask to reinstall the **same** Re-programming Software DVD for a second time.

- If not, the re-programming is complete. Proceed to step 12.
- If so, re-insert DVD disc.
 - At the top of the screen “Program Loading (2nd)” will be displayed.

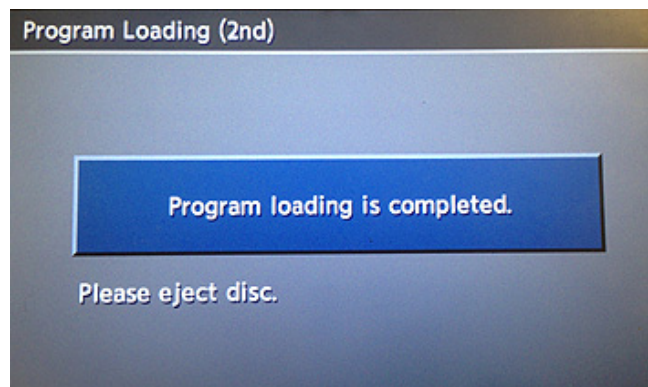
Figure 10

- “Program loading is completed” will be display (Figure 10).
- The Re-programming Software DVD will automatically eject.
- The Navigation system will restart.

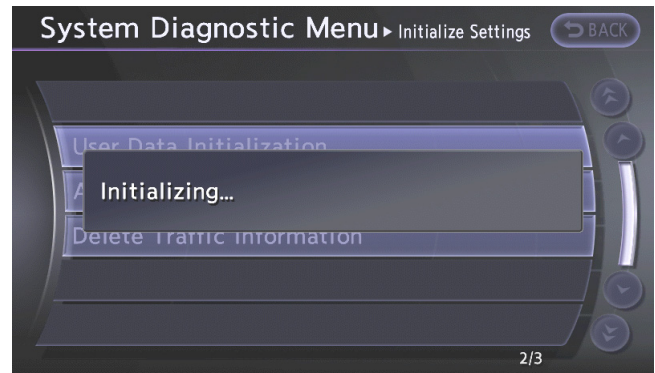
8. The screen in Figure 17 will display while initializing.

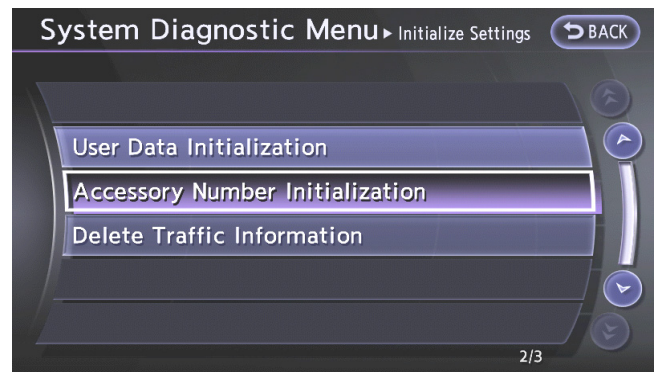
9. The screen in Figure 18 will display when initializing is complete.

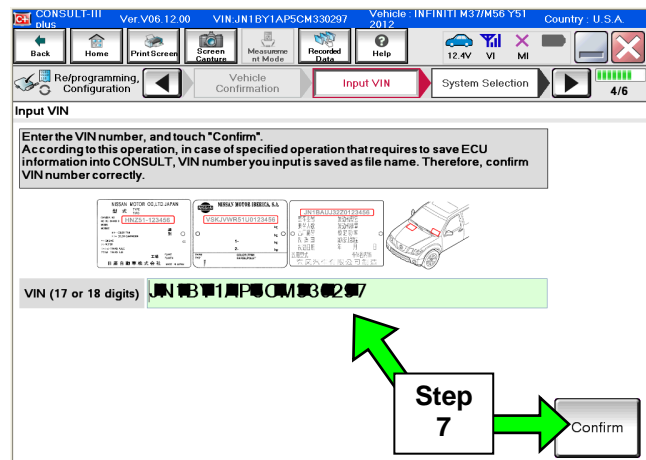
NOTE: If the **VIN** is not correct, the **VIN** Field in Figure 23 can be changed before selecting **Confirm**.

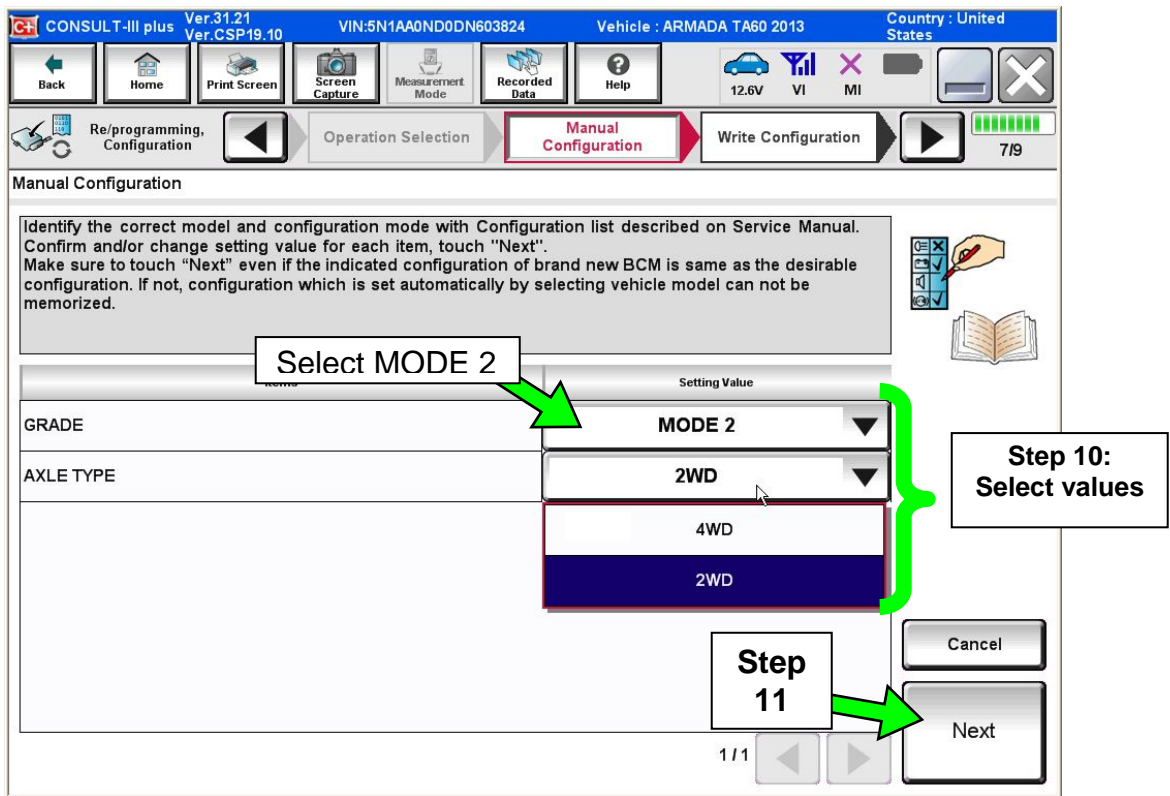
Figure 26

10. Use the drop down arrows to select the values.

- Select “MODE 2” only.

- Choose either 2WD or 4WD depending on how the vehicle is equipped.
