# SERVICE CAMPAIGN BULLETIN

NTB13-052b

## VOLUNTARY SERVICE CAMPAIGN 2013 ALTIMA SEDAN HEATED SEATS

**APPLIED VEHICLE:** 2013 Altima Sedan (L33)

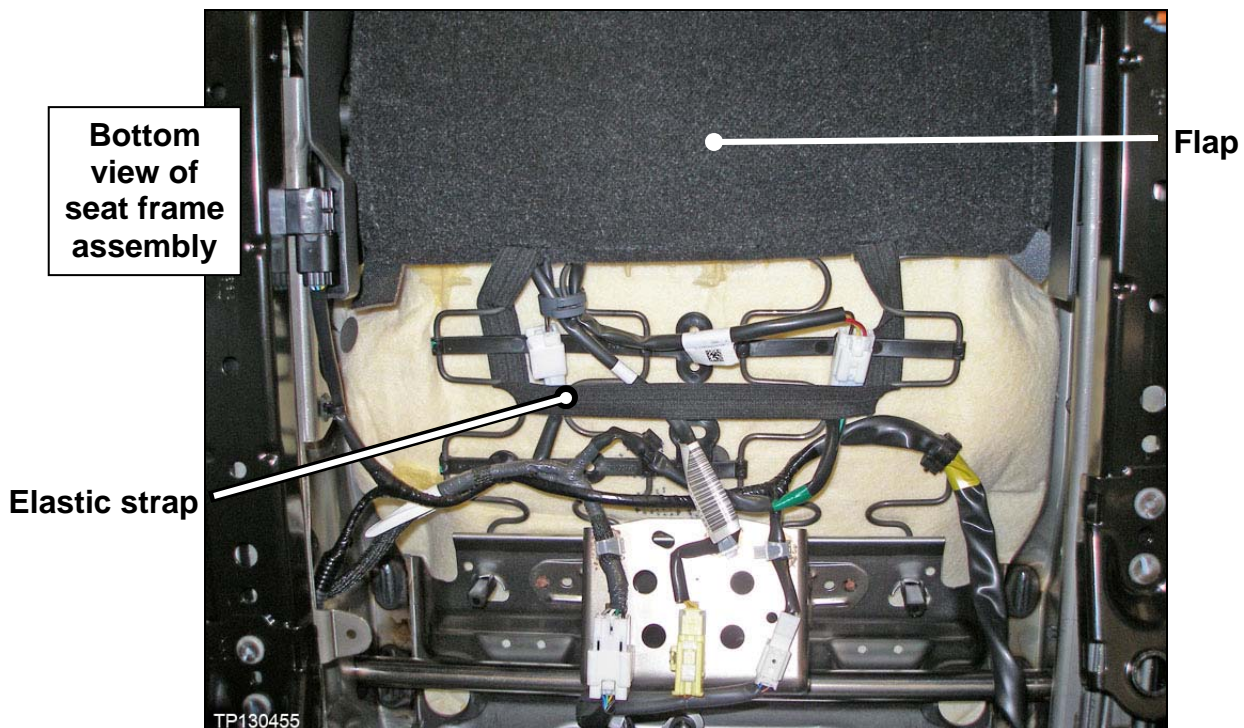
Figure 4; seat viewed from bottom

**NOTE:** Pictures are taken with the front passenger seat lifted for easier viewing. **Do not remove** the seat(s) for this repair.

1. Turn the ignition switch OFF and wait for at least three (3) minutes.
2. Move the front seat(s) forward, and then adjust the seatback(s) forward.
3. From the rear of the front seats: Unfasten the elastic strap(s), and then pull back the seat cushion flap(s).
  - This will allow better access to the bottom side of the seat(s).
  - Remember the routing of the elastic strap(s) so they can be re-secured the same way.

4. Unplug the seat harness(es) where noted in Figure 5.
