### Contents

### Item 1.

**Description:** Sliding Selector Shaft and Detent Assembly

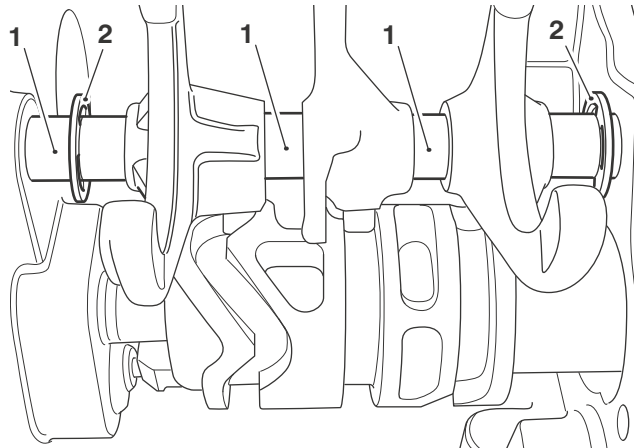
The selector forks can be fitted incorrectly. Ensure the position and orientation of the selector forks are marked prior to removal. Incorrect fitting of the selector forks will cause gearbox damage.

- 
- Remove the E-clips from the selector shaft.

**1. Selector shaft**

**2. E-clips**

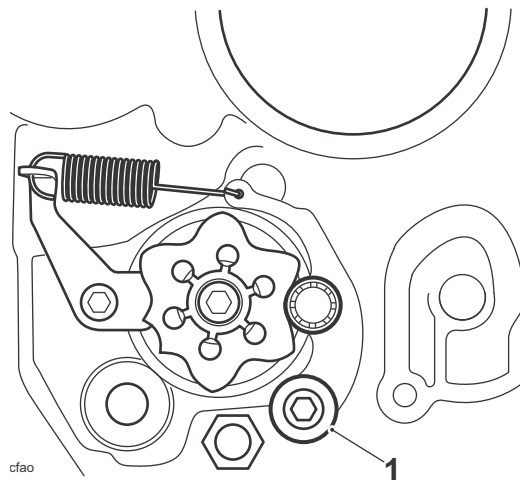
- The detent arm is held in position under spring pressure. Prior to removal, note the orientation of the detent arm, fixing, spring and washer. The same orientation must be retained on assembly.**
- Release and remove the fixing securing the detent arm.
  - Withdraw the detent arm complete with its spring and washer. Discard the fixing.

**1. Fixing**

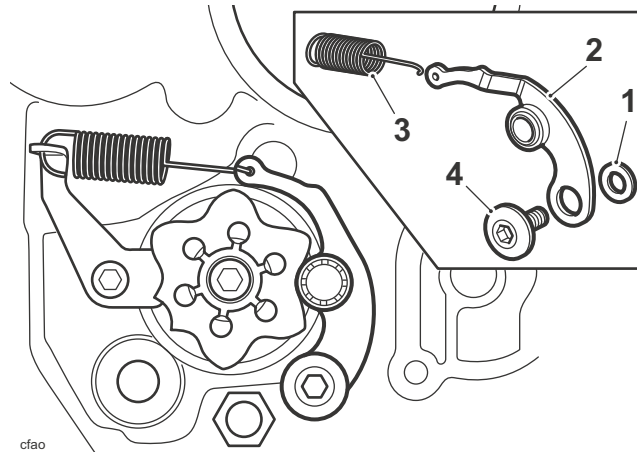
- Remove the fixing from the centre of the detent wheel (discard the fixing) and withdraw the wheel.

1. Washer
2. Detent arm
3. Spring
4. Fixing

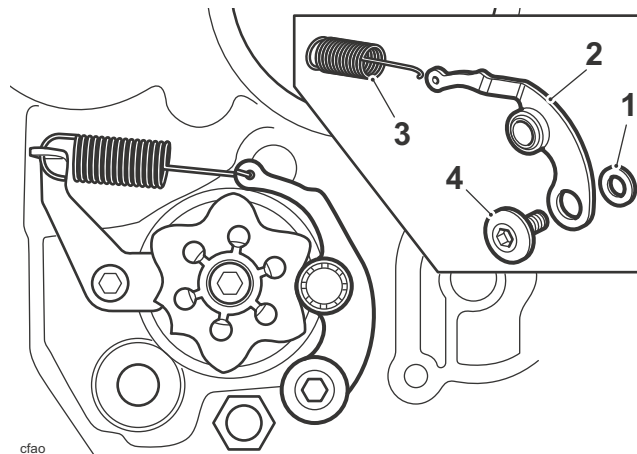
- Lubricate with clean engine oil and fit the detent wheel engaging the wheel with the locator pin in the selector drum. Tighten a new fixing to **12 Nm**.
- Assemble the detent arm as noted on removal and place up to the crankcase.

1. Washer
2. Detent arm
3. Spring
4. Fixing

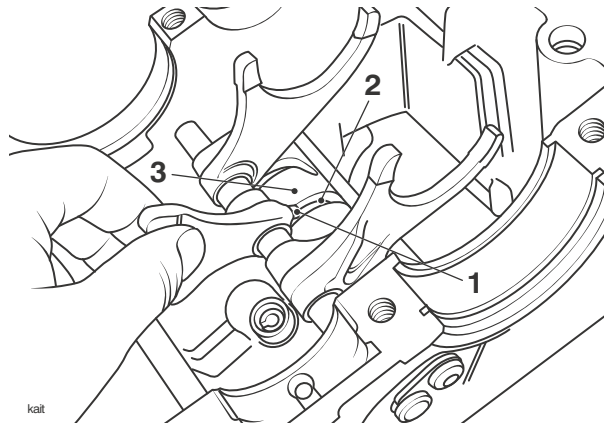
- **The centre selector fork locates in the selector drum as shown below:**

1. Selector fork stop
2. Selector drum track
3. Selector drum

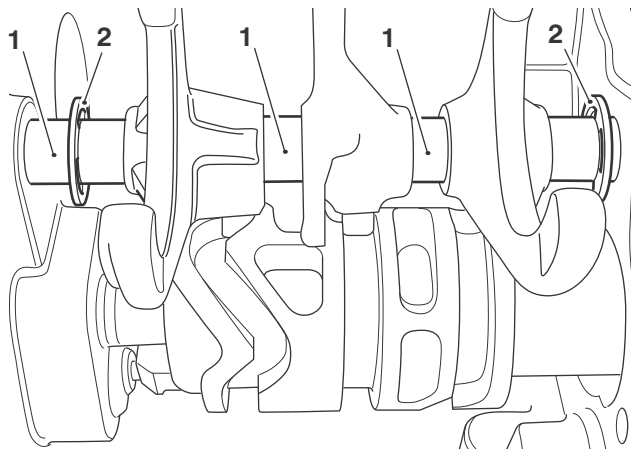
- **If the blanking screw is removed for any reason, clean and apply one drop of ThreeBond 1305 to the threads. Tighten the screw to 22 Nm.**
4. Refit the E-clips to the selector shaft.

1. Selector shaft
2. E-clips
