# Technical News

Issue 142

March 2013

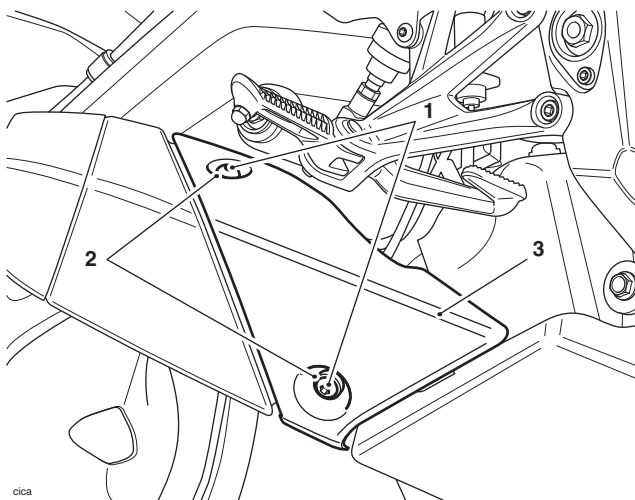
1. Fixings
2. Shouldered washers
3. Heat shield

- **The adjustment procedure must be followed to give a preliminary cable setting. Correct cable adjustment must be confirmed by the diagnostic software.**
1. Release the fixings, collect the shouldered washers and remove the silencer's rear heat shield.

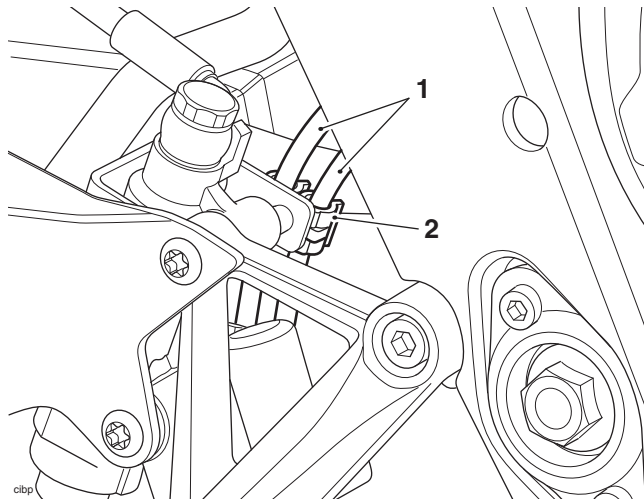
**1. Cables**

**2. Clip**

- **For easier access to the adjusters on the exhaust butterfly valve cables, the right-hand control plate should be detached from the frame and exhaust silencer.**
6. Detach the cables for the exhaust butterfly valve from their clip near the rear brake master cylinder.

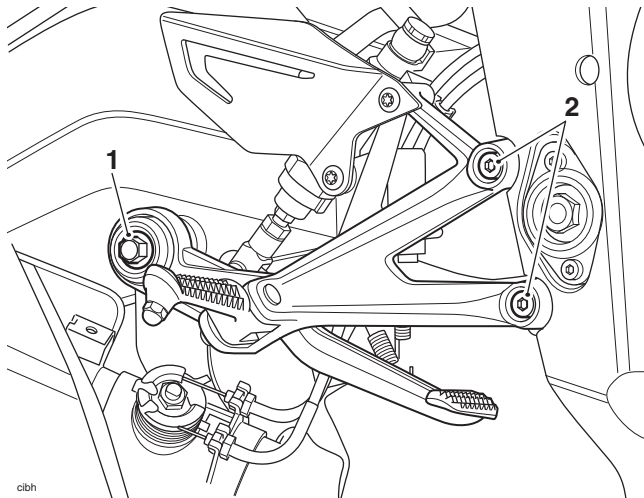
**1. Nut and bolt, silencer mounting**

**2. Fixings**

7. Remove the nut and bolt securing the silencer to the right-hand control plate.
8. Remove the two fixings securing the right-hand control plate to the frame.

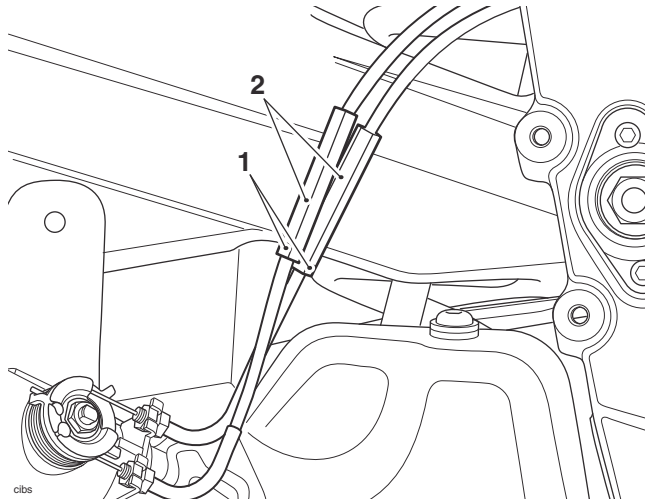
- 1. Lock nuts**  
**2. Adjusters, control plate removed for clarity**

- 
9. Taking care not to scratch the frame with the control plate, release the adjuster lock nut on each exhaust butterfly valve cable.

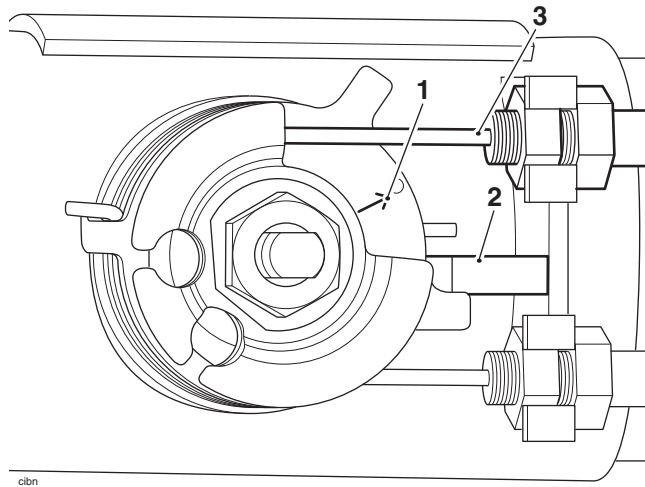
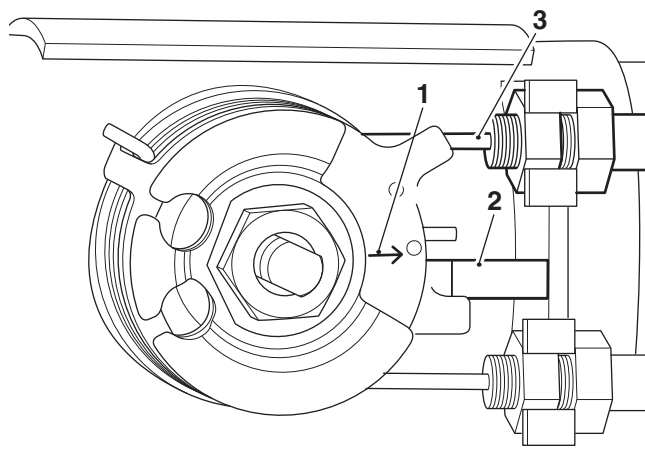
- 1. Arrow, before adjustment**  
**2. Butterfly valve stop**  
**3. Closing cable**

- 1. Arrow, after adjustment**  
**2. Butterfly valve stop**  
**3. Closing cable**

- 
10. Adjust the closing cable adjuster until the arrow on the butterfly valve pulley is aligned with the upper edge of the butterfly valve stop.

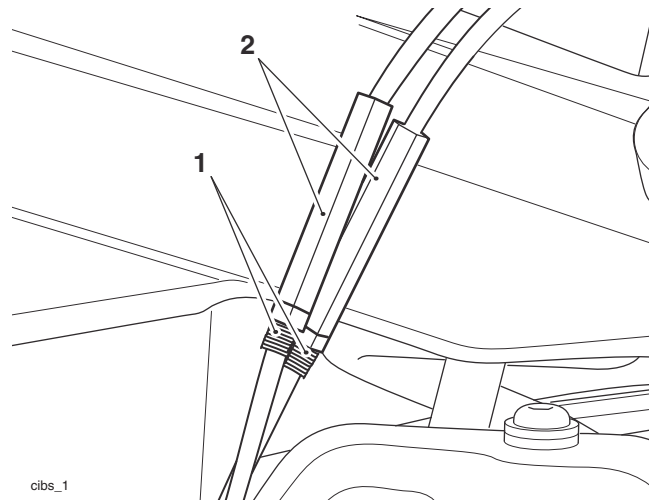
1. Threaded area

2. Adjusters, control plate removed for clarity

11. With the arrow aligned with the upper edge of the butterfly valve stop, adjust the opening cable until it has the same amount of thread showing as the closing cable.

12. When the adjustment of the cable is complete, click the 'OK' button. The exhaust butterfly valve will now move to the closed position and then the fully open position.
13. Click the 'OK' button again to finish.
14. If the adjustment is not correct, 'Cables too loose - Adjust cables' or 'Cables too tight - Adjust cables' will be displayed. Repeat steps 10 to 13 to tighten or loosen the cables evenly as required.
15. On the diagnostic software, click the 'Adjust' button to check the cable adjustment. If necessary, repeat the adjustment procedure.
16. Once adjustment is correct, tighten the adjuster lock nuts to **5 Nm**.
