TECHNICAL BULLETIN
LTB00557NAS1
27 SEP 2013

Knock Sound From Front Suspension

Range Rover (LG)

Model Year: 2013-2014

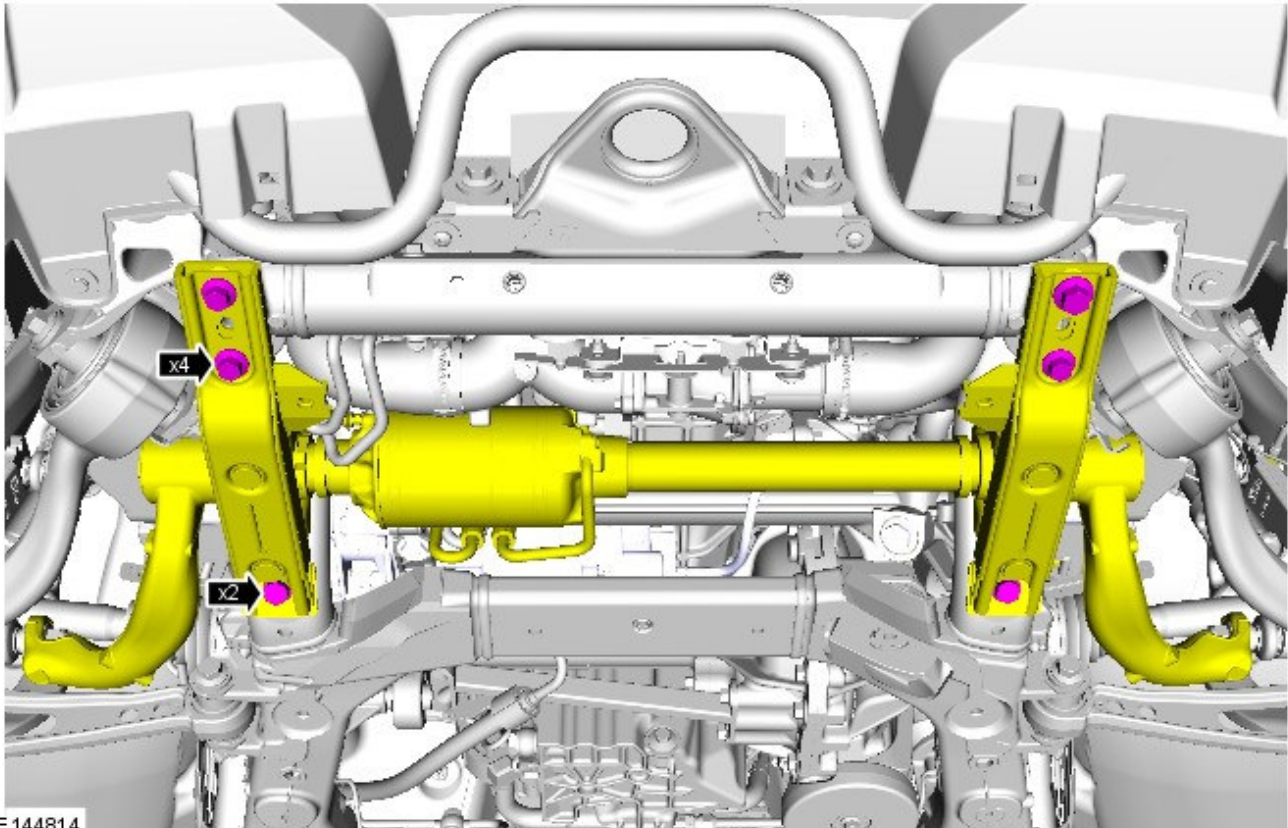
E144814

Dynamic Response front actuator Ski Bracket

- If the measured torque is less than the minimum residual torque shown, the fixing should be replaced with new and torque with reference to TOPIX 204-01: Front Suspension.
