## SERVICE BULLETIN

**APPLICABILITY:** 2013 Legacy & Outback Models with 2.5L  
 FB Engines

**NUMBER:** 02-143-13R

**SUBJECT:** Surface Treatment Change To Oil Control  
 Piston Rings

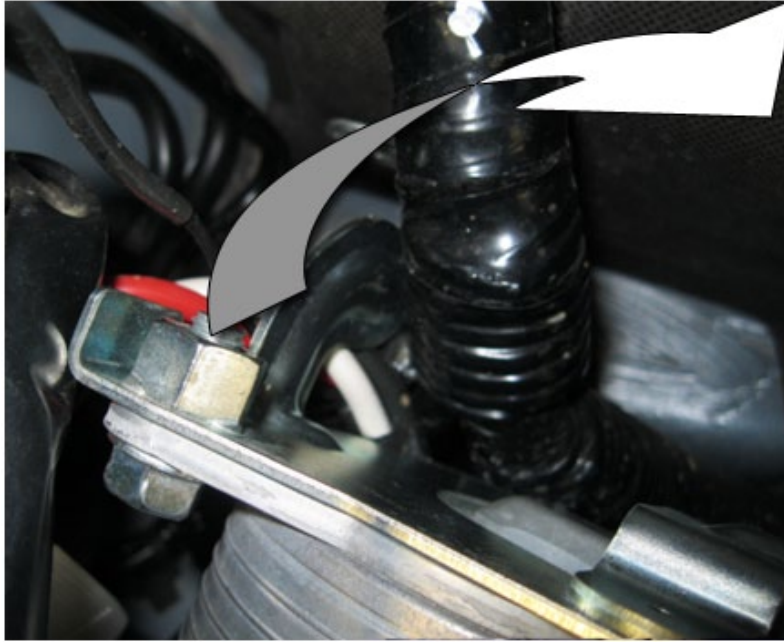
- When removing the CVT fluid cooler, leave it attached to the mounting bracket and remove it as an assembly (3 bolts) from the transmission. Disconnect just the engine coolant hoses from it and leave the 2 short CVT fluid lines alone. Hook one of the cooler's mounting bracket "ears" behind the bulkhead harness as shown in the photo below to keep the cooler assembly out of your way. Use a shop cloth between the "ear" and the bulkhead harness to prevent any chafing.

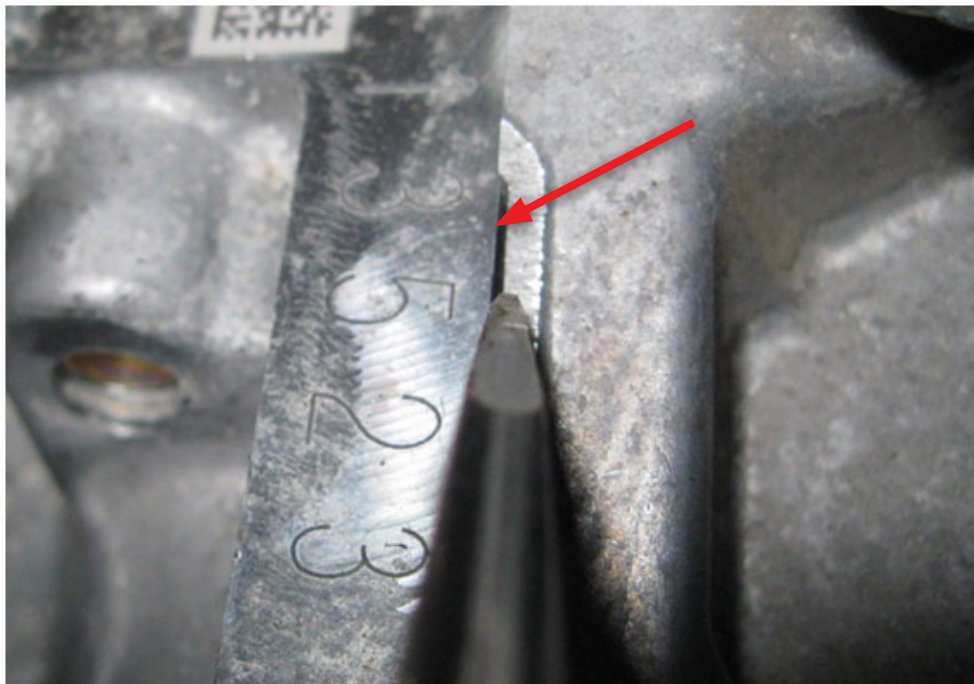
- To make separating the transmission (CVT) from the engine easier, there is a pry relief shown below in the machined mounting surface of the transmission case near the engine number. Use caution when applying any prying pressure and avoid twisting the tool to prevent case damage.

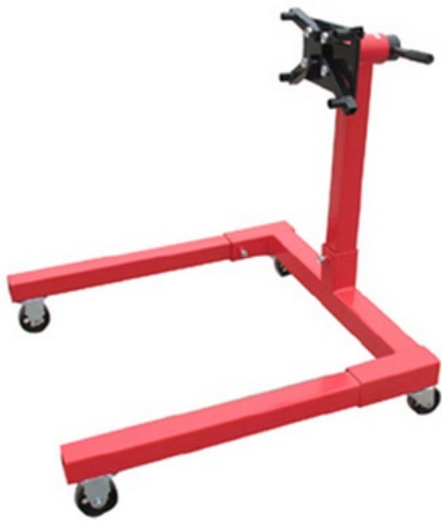
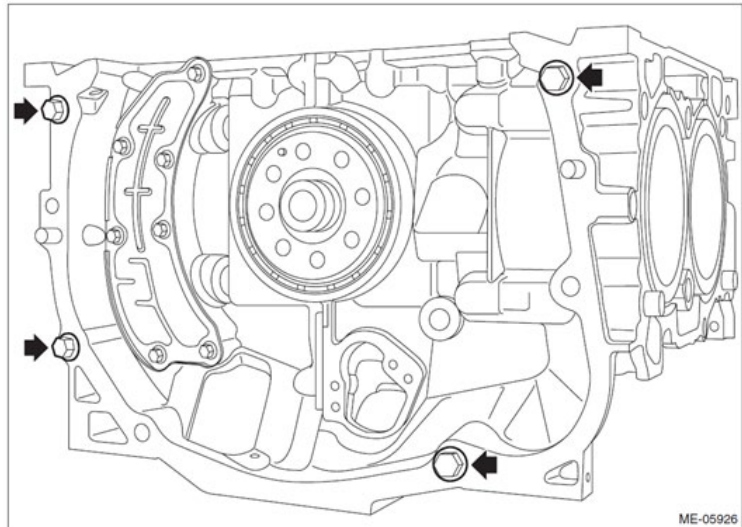
- Once the engine is removed, if you are using a generic engine stand (preferable since engine rotation is necessary), use the four mounting holes on the engine block shown below to mount it. Do not use the studs in the upper oil pan as the upper oil pan has to be removed to access the connecting rod bolts. **NOTE:** The connecting rod bolts are one-time-use and must be replaced.

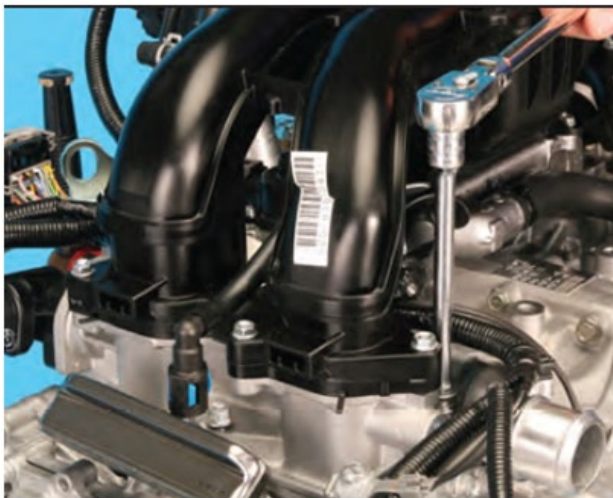
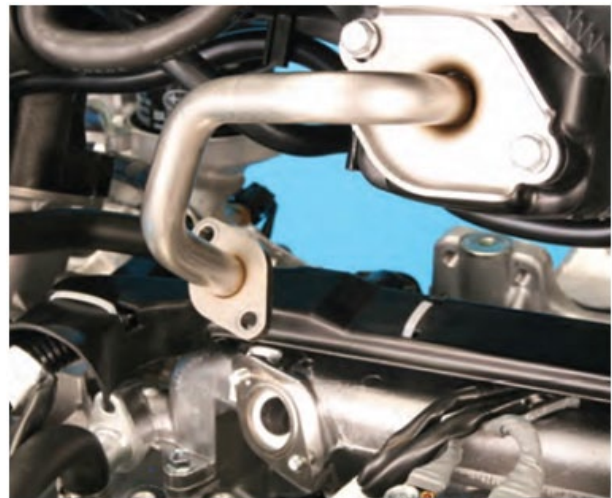
- When removing the intake manifold, as shown in the photos below, leave the TGV assemblies attached to the upper intake, remove the 2 nuts holding the EGR tube to the water pipe then remove the complete assembly from the cylinder heads as a unit.

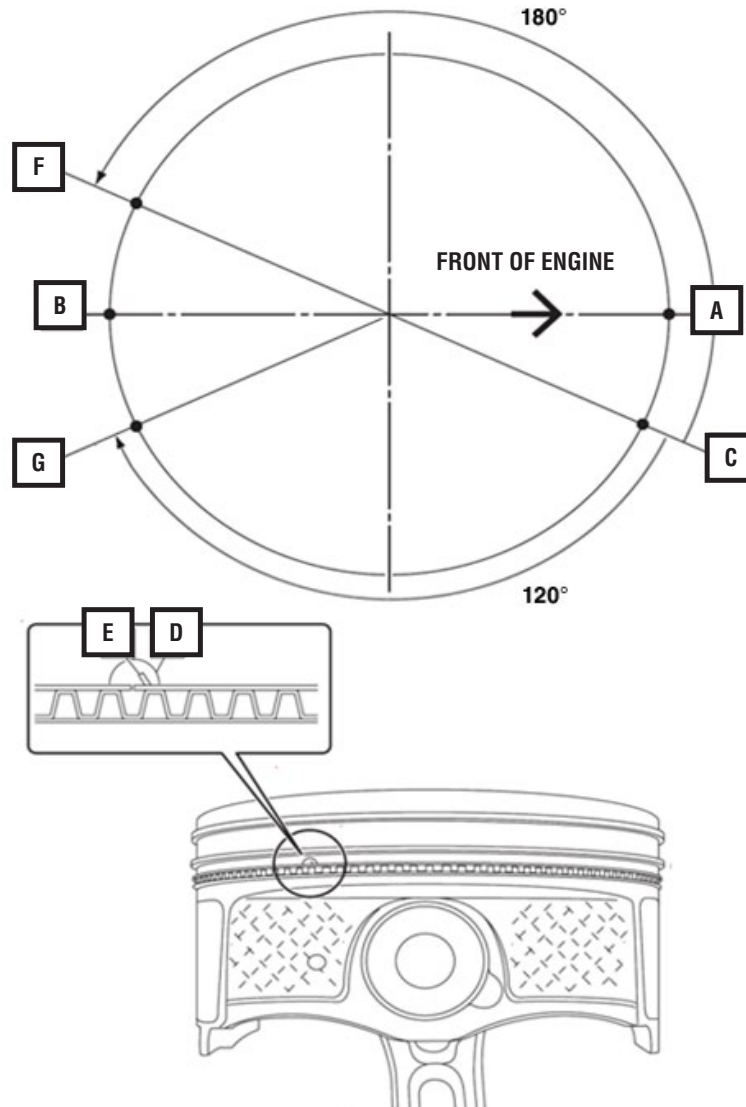
- “A”- Top compression ring end gap location
- “B”- Second compression ring end gap location (180 degrees away from “A”)
- “C”- Top oil control scraper ring end gap
- “D”- Recess in top of ring land to accept the “tang” of the upper oil control scraper ring - “E”
- “F”- Expander gap (180 degrees away from “C”)
- “G”- Bottom oil control scraper ring end gap (120 degrees away from “C”)

- When cleaning the pistons prior to installing the new rings, take care not to damage the anti-friction coating applied to the skirts. A mild parts cleaner may also be used with the Scotch-Brite Ultra-Fine #7448 (gray in color) to loosen and remove carbon deposits from the piston crown and from between the ring lands. Do not use Scotch-Brite to clean the piston skirts as it can damage the anti-friction coating. The ends of a removed compression ring may be used to carefully clean deposits from inside the ring lands. Rinse the piston / rod assemblies thoroughly and dry before installing the new rings onto the pistons. Refer to the Service Manual and the illustrations below for ring direction (marks facing upward) and end gap placements. Remember to lubricate the rings, piston skirts, cylinder walls, wrist pin areas, rod bearing surfaces and rod bolt heads and threads with engine oil before reassembly.
