## SERVICE BULLETIN

**APPLICABILITY:** 2013MY Legacy and Outback 2.5L Models  
 2012-13MY Impreza 2.0L Models  
 2013MY XV Crosstrek  
 2011-2014MY Forester NA Models Only  
 2013MY BRZ

**NUMBER:** 11-130-13  
**DATE:** 04/05/13

**SUBJECT:** Difficulty Starting, Rough Idle, Cam Position or Misfire DTCs  
 P0340, P0341, P0345, P0346, P0365, P0366, P0390, P0391,  
 P0301, P0302, P0303 or P0304

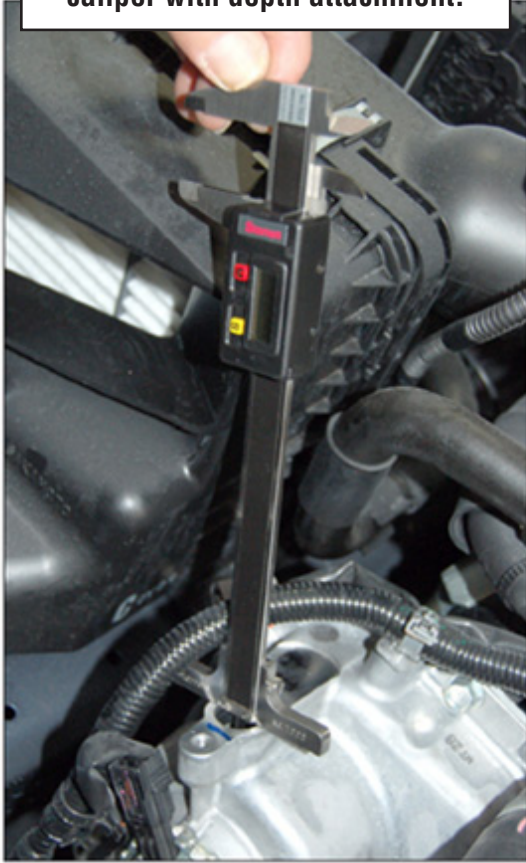
Measurement taken using digital caliper with depth attachment.
