Technical Bulletin

21 13 02 December 3, 2013 **2024061** Supersedes T.B. V211202 dated August 27, 2011 to include MY 2014 vehicle applicability.

Rattling Noises from Engine Compartment Area or Exhaust System

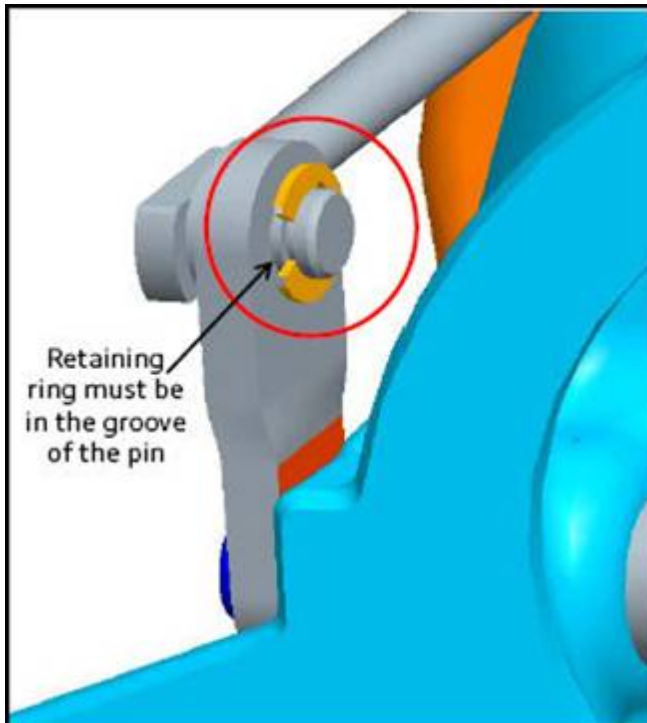
Customers may complain of a rattling noise from engine or exhaust area while accelerating from 1800-3000 RPM. In order to complete proper diagnosis and ensure that the noise is coming from the turbocharger, use the following procedure:

1. Ensure that there is no physical internal or external damage to the turbocharger. If damage is observed, continue diagnosis and repair as necessary. If no damage is observed, proceed to step 2.
