Service Bulletin

SUBJECT: Service Update for Inventory and Customer Vehicles
Rear Seat Entertainment DVD/CD Playback Mode Memory Loss
Expires with Base Warranty

MODELS: 2013 Cadillac SRX
Equipped with Rear Seat Entertainment Package (UWG)

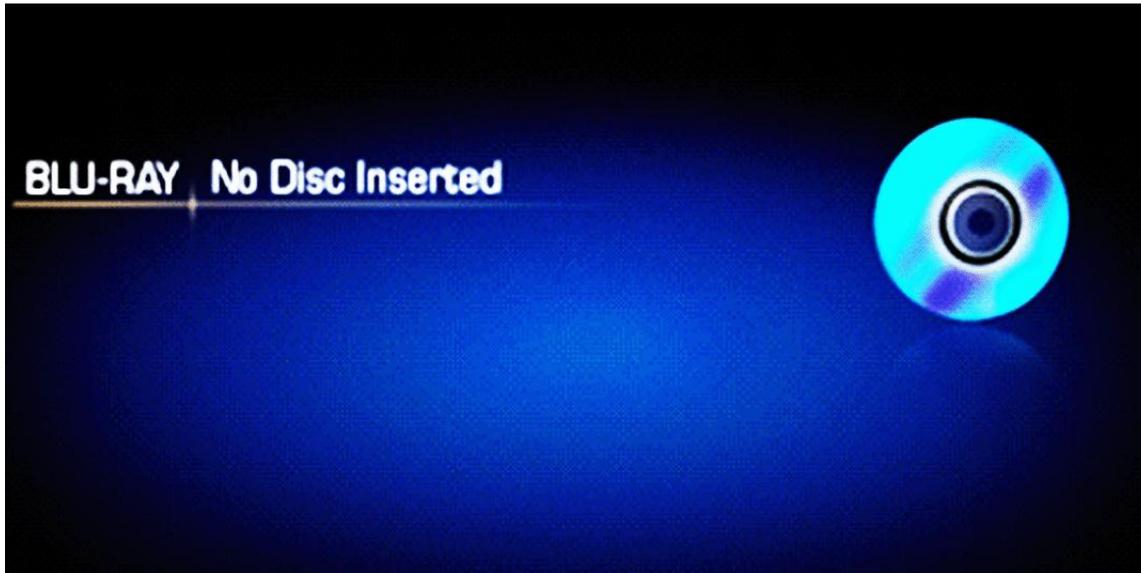
1. Determine the software version of the Media Disc Player.

- 1.1 Turn IGN ON and **wait** for the *Now Playing* screen to be displayed on the driver side display. The *Now Playing* screen may take up to 5 minutes to appear.
- 1.2 Press the MENU button on the remote control.
- 1.3 Select *Software Information* using the ARROW and ENTER buttons on the remote control.
- 1.4 Select *Version* using the ARROW and ENTER buttons on the remote control.
