EL03-031g

November 27, 2013

## EXTERIOR LAMP FOGGING

**APPLIED VEHICLES:** 2001-2014 Infiniti, All Models

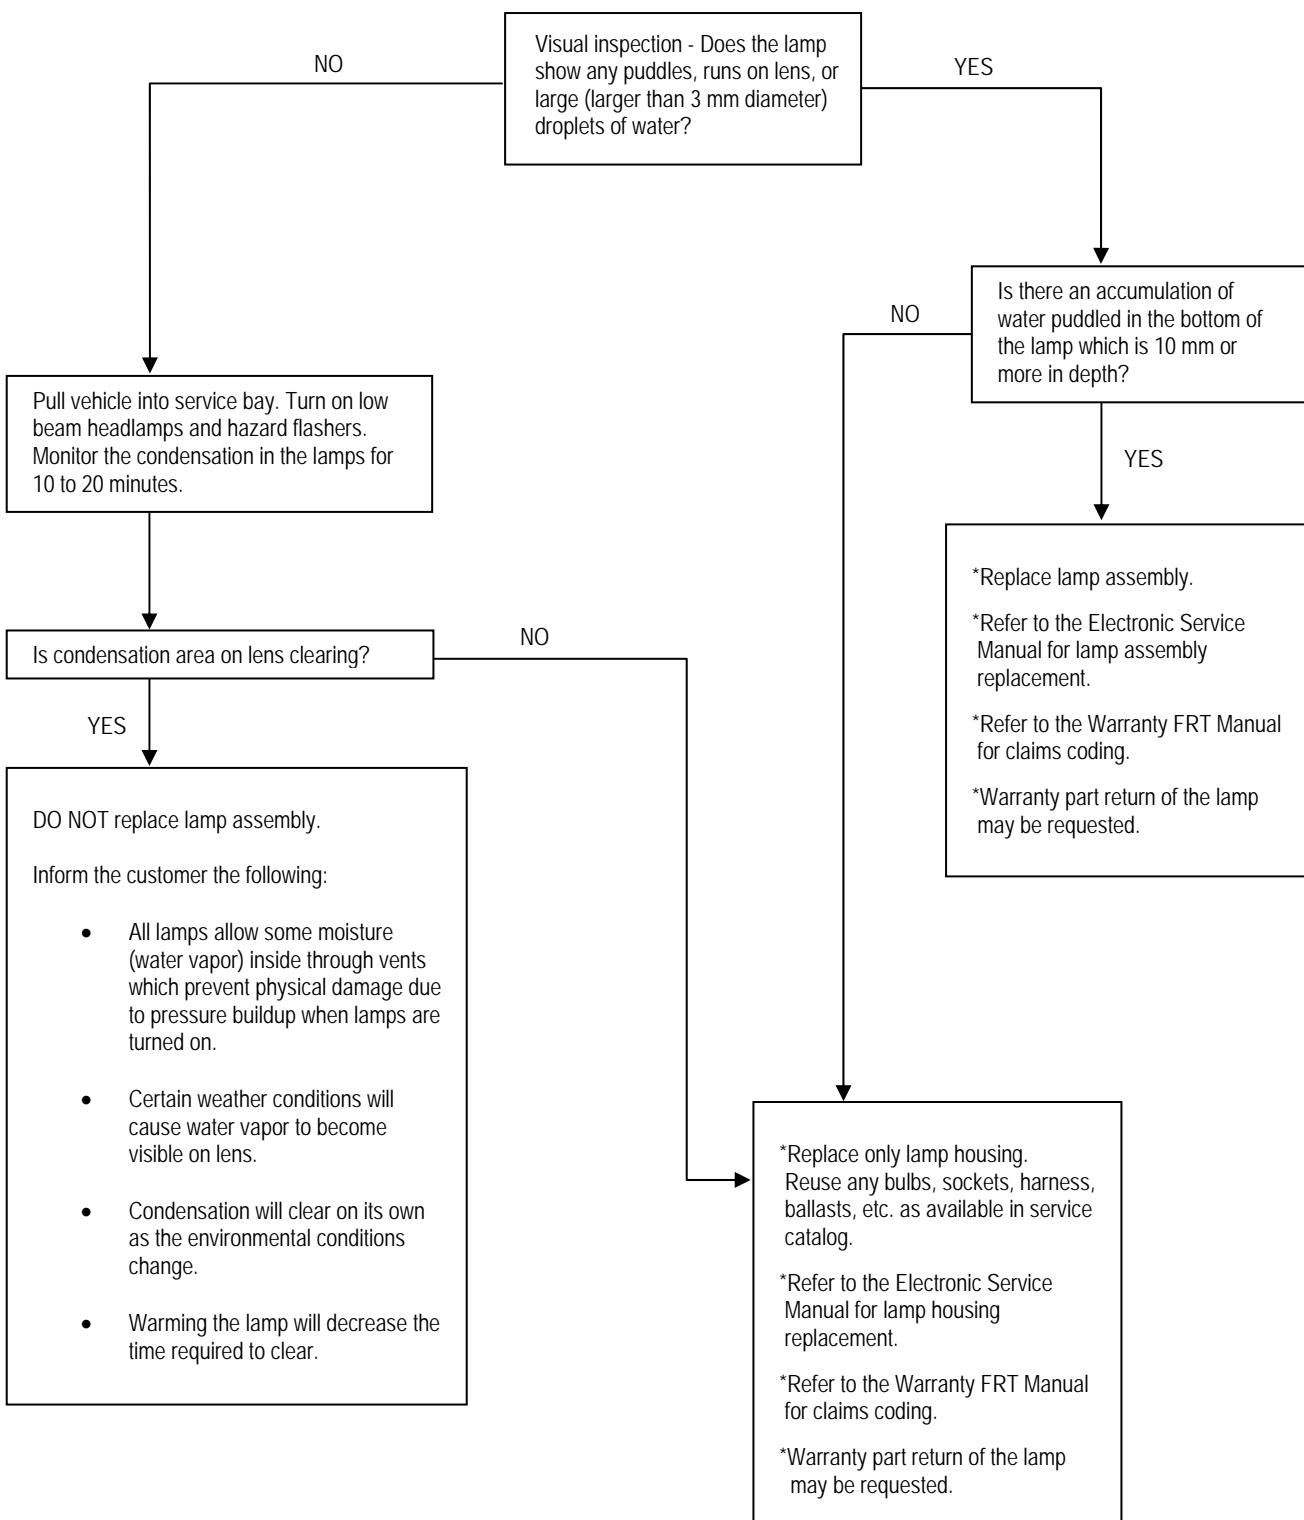
Should a customer note water in a lamp assembly, please use the following flow chart to determine if the condition is normal or requires lamp replacement.
