Applies To: **2009–11 Pilot** – Check the iN VIN Status for eligibility

Product Update: Parasitic Current Draw From Moonroof Control Unit Can Discharge the Battery

(Supersedes 10-030, *Product Update: Parasitic Current Draw From Moonroof Control Unit Can Discharge the Battery and/or Moonroof Reverses Itself While Closing*, dated August 26, 2010, to revise the information marked by the black bars)

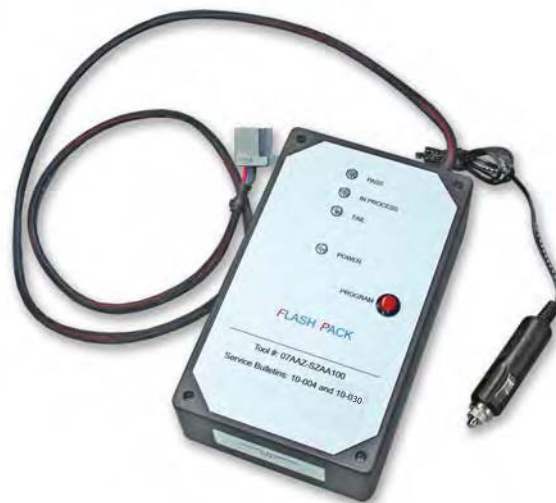
Each dealer was sent one Flash Pack in July 2010. *This tool's only use is for updating the software on moonroof control units in 2009–11 Pilots.*

Update the moonroof control unit software with the Flash Pack.
