ITB11-041c

**VOLUNTARY SERVICE CAMPAIGN  
1997-2003 QX4 IN NON SALT STATES  
LEFT FRONT STRUT HOUSING CORROSION**

CAMPAIGN ID #: R1110  
NHTSA #: 11V-244  
APPLIED VEHICLES: 1997- 2003 QX4 (JR50)

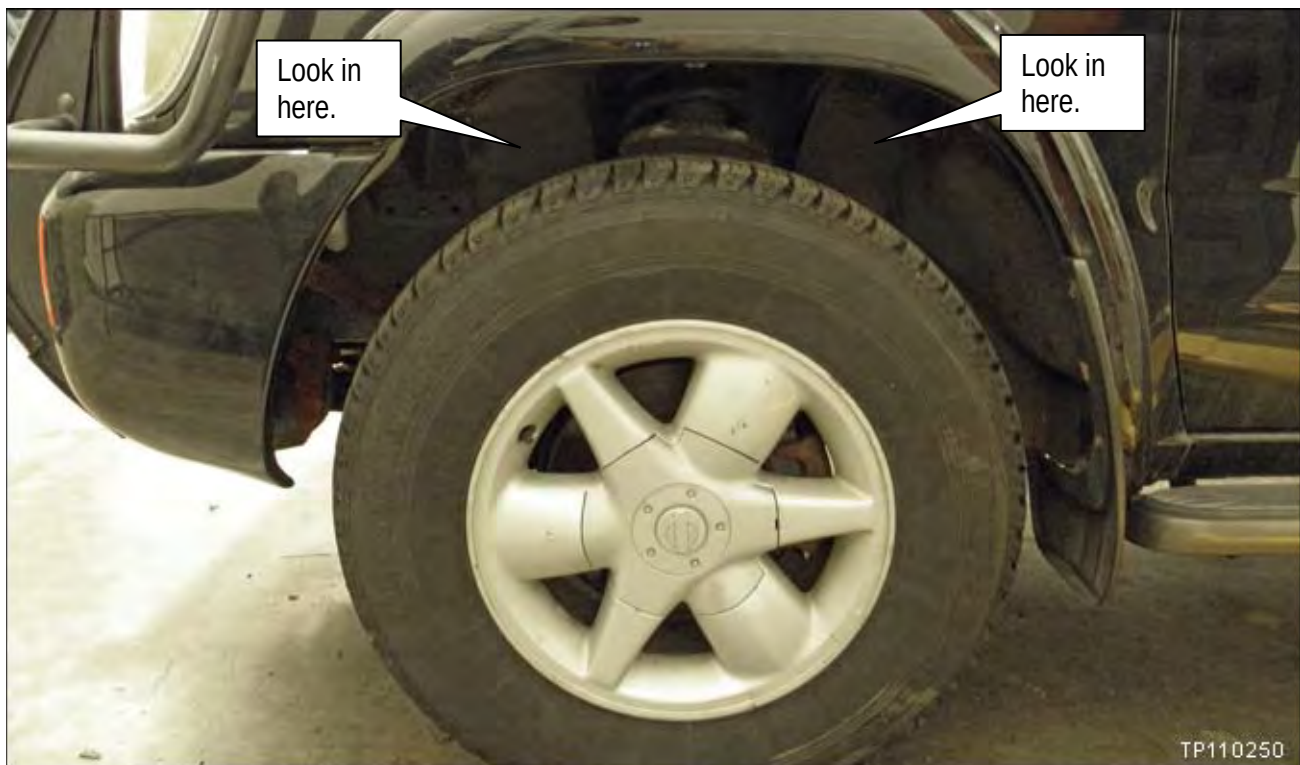
Figure A

4. Visually inspect for corrosion and rust on the wheel housing panel and the strut housing panel.

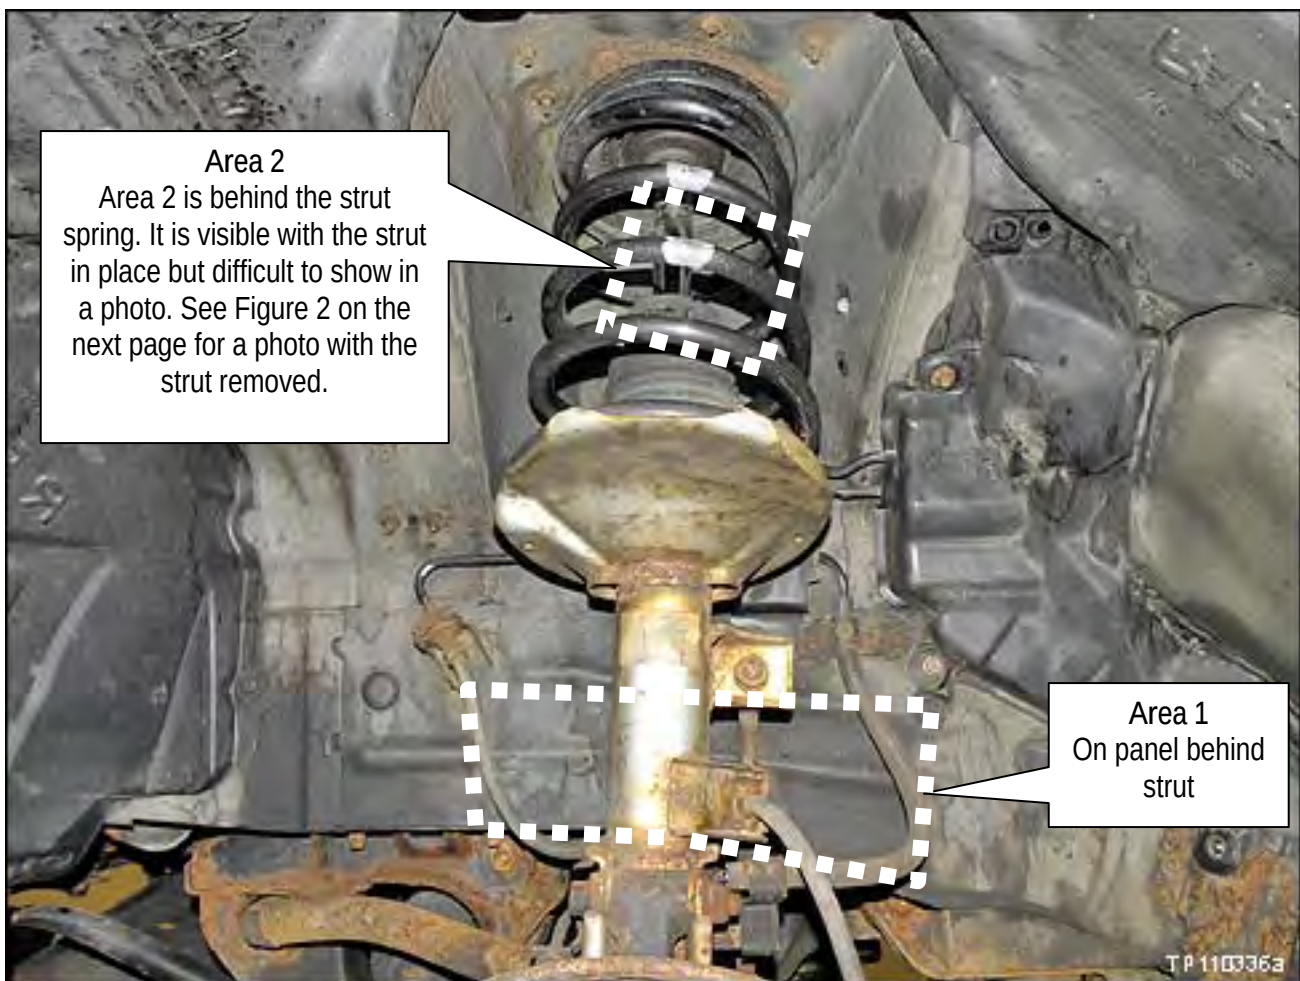
Figure 1

1. Lift the vehicle on a hoist.
2. Remove the left front wheel.
3. Inspect for corrosion on the driver side in the strut housing Area 1 and wheel house Area 2 (see Figures 1 through 4).

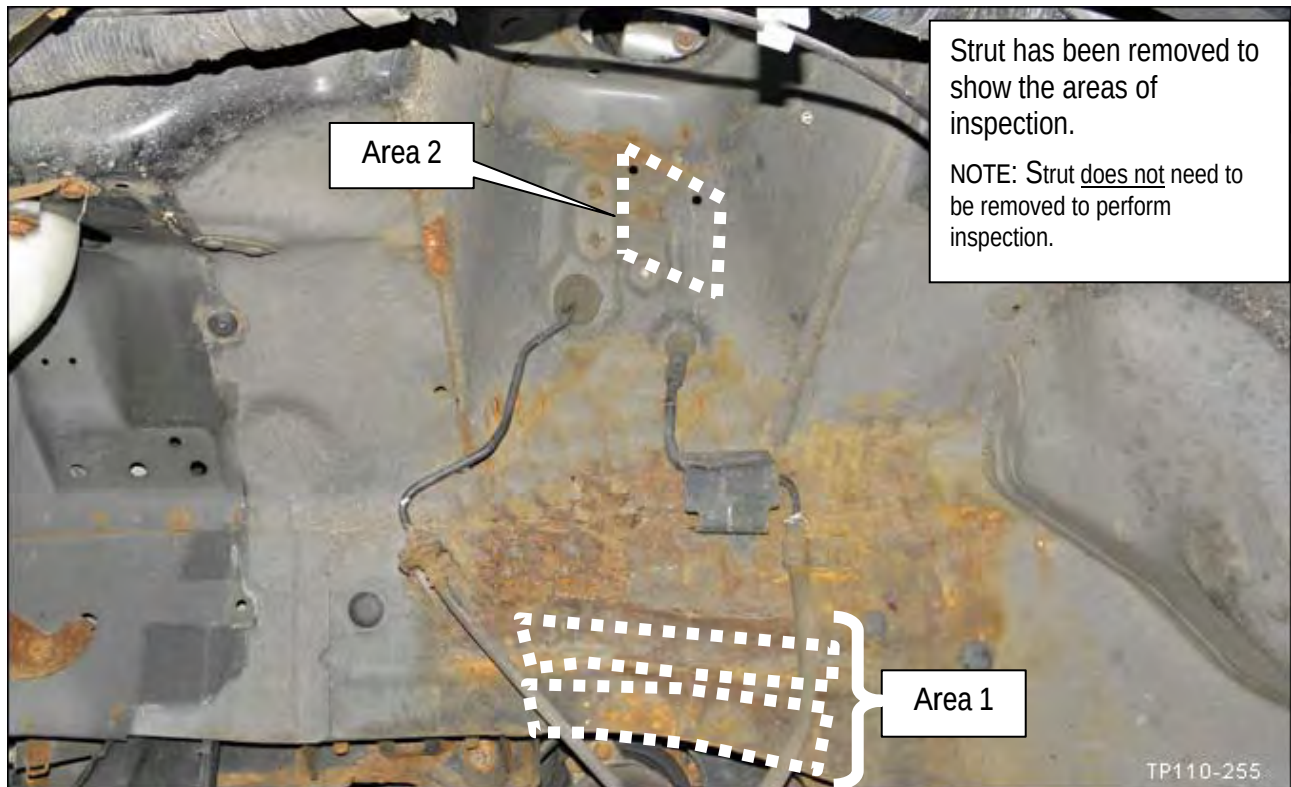
Figure 2

This photo shows the inspection areas in relation to the repair bracket installation.

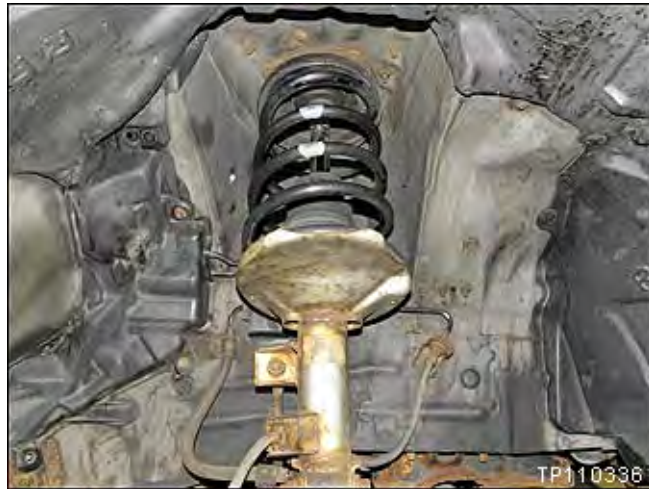
Figure 6

3. Visually inspect for corrosion and rust on the wheel housing panel and the strut housing panel.
  - Inspect for corrosion and rust on the panels only.

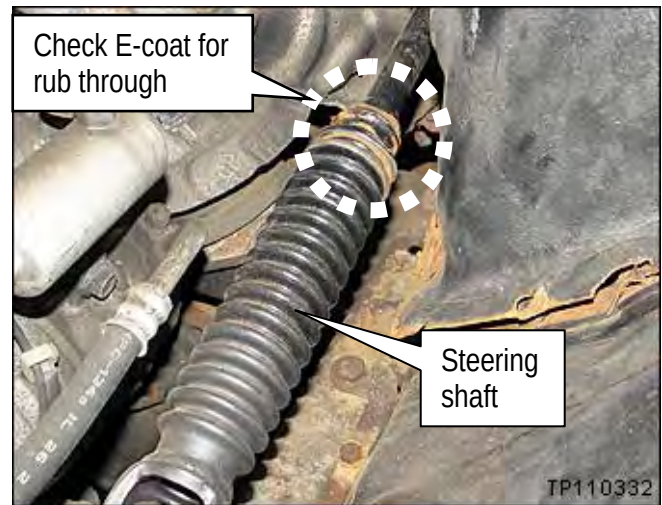
Figure RB4

Contact may have occurred if the strut housing separated from the wheel house.

- ONLY if the E-coat has been rubbed through to bare metal, the steering shaft will need to be replaced.
- If the steering shaft needs replacement, you will be instructed to replace it later in this procedure.

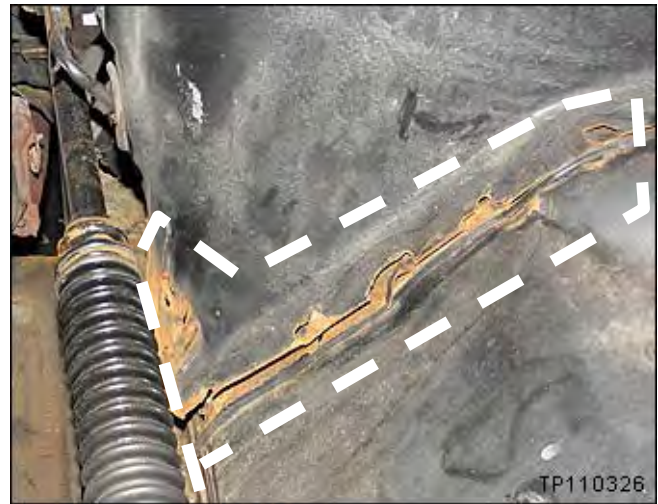
Figure RB5

7. Only if the strut housing panel is separated as show in Figure RB5:

Use a wire brush to clean any loose rust, paint, or other debris from the area shown with dashed line.

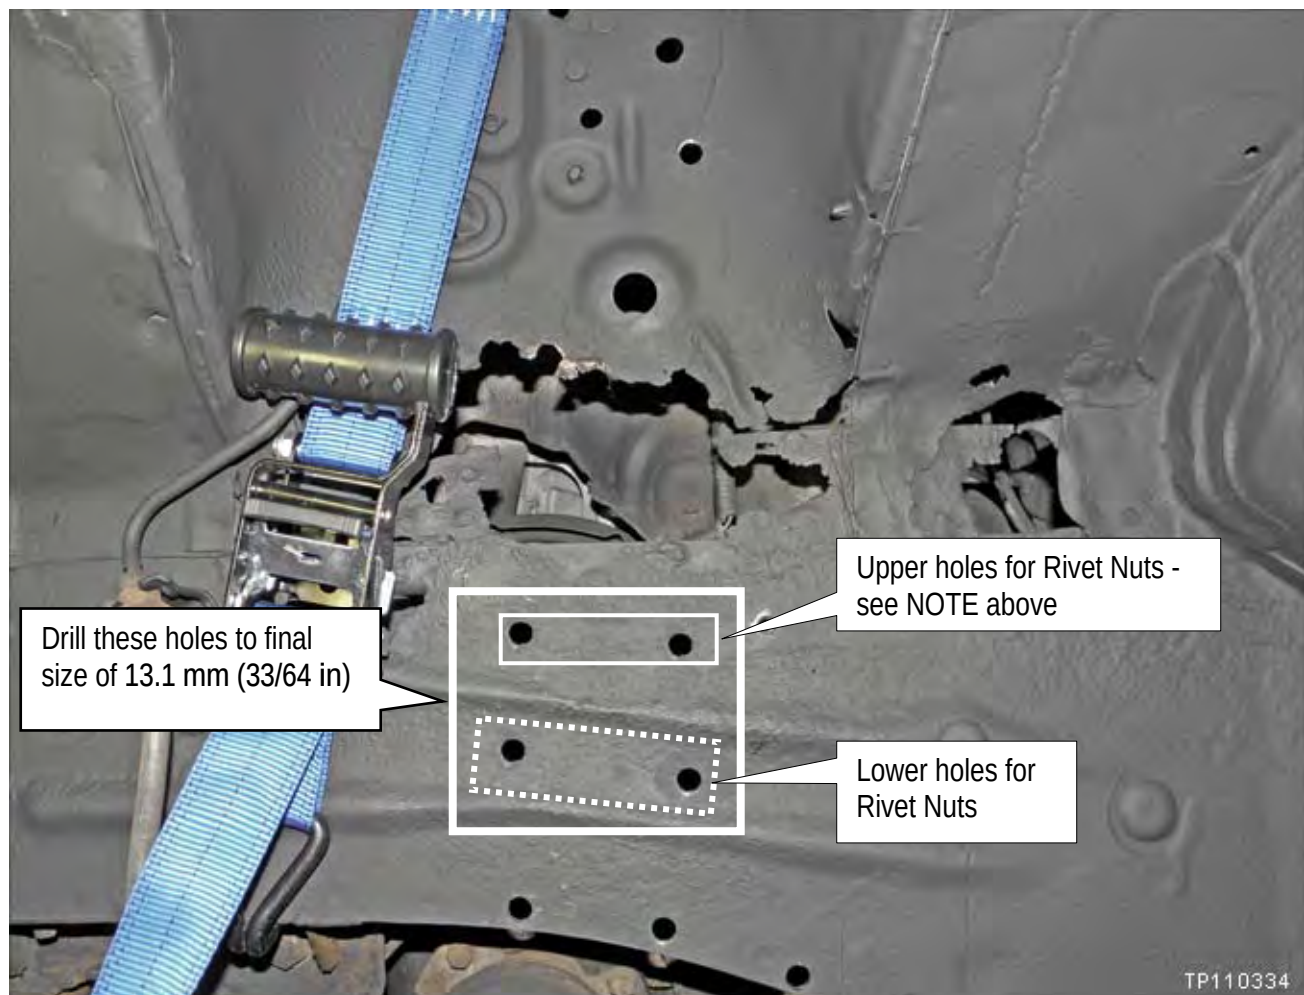
Figure RB10

If the metal in the area of the lower holes will not support the Rivet Nuts, then the vehicle is “not repairable”: Retain the vehicle at the dealer, supply the customer with a rental car, and Fax a completed Non-Repairable Report to Morley (see page 55).

NOTE: Upper holes – not required: If the metal in the area of the upper holes will not support Rivet Nuts, continue with the repair. Rivet Nuts are preferred but not required in the upper holes.

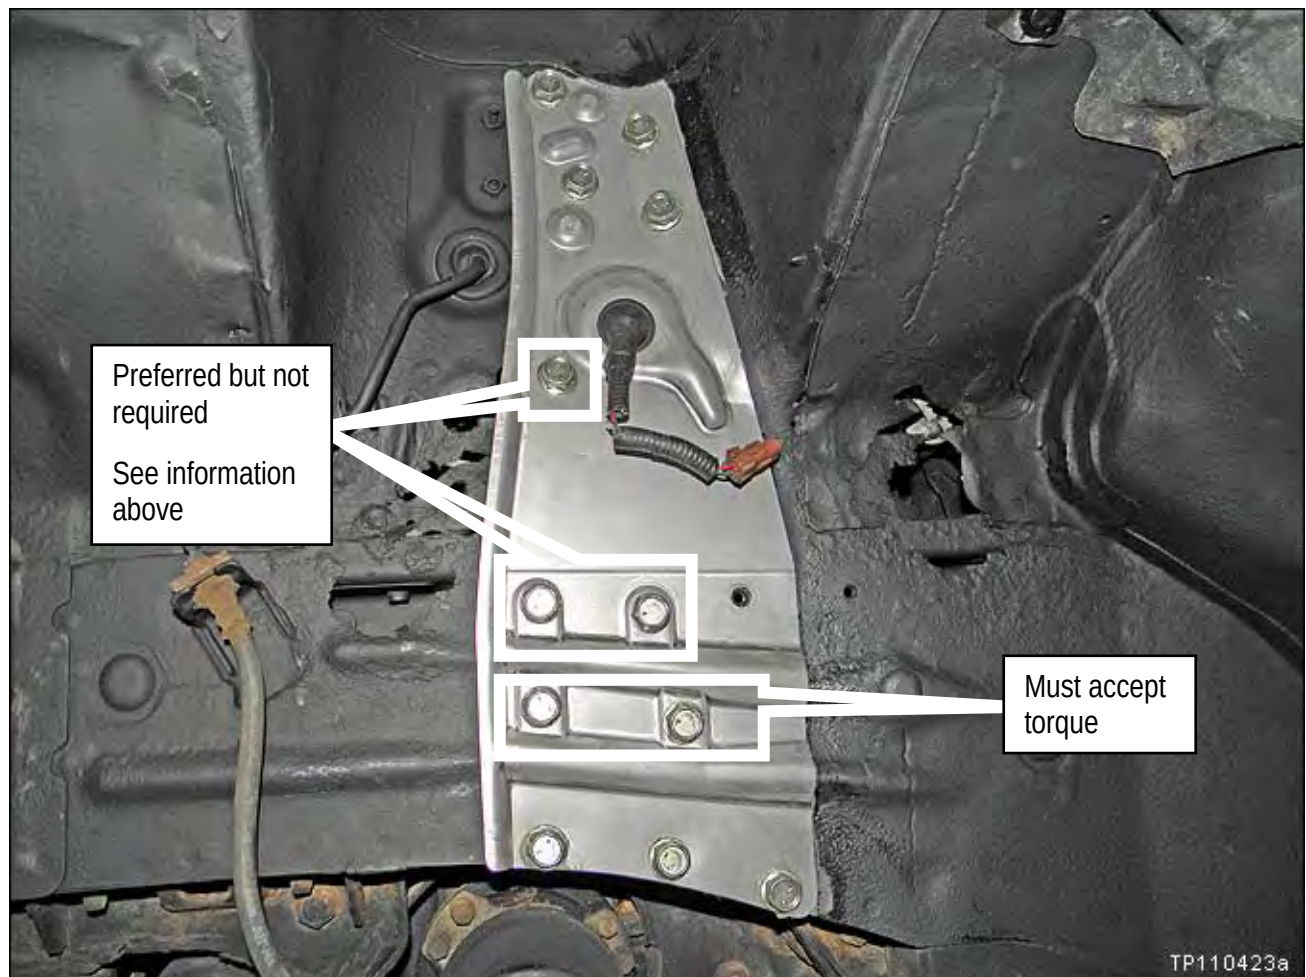
Figure RB25

Bolts with Rivet Nuts that Must accept the torque (see Figure RB25):

- These bolts are required and must accept the torque value of 50 N•m (5.1 kg-m, 37 ft-lb).
- If these bolts will not accept the specified torque value, the vehicle is not repairable:
  - a. Retain the vehicle at the dealer.
  - b. Supply the customer with a rental car.
  - c. Fax a completed Non-Repairable Report to Morley (see page 55).

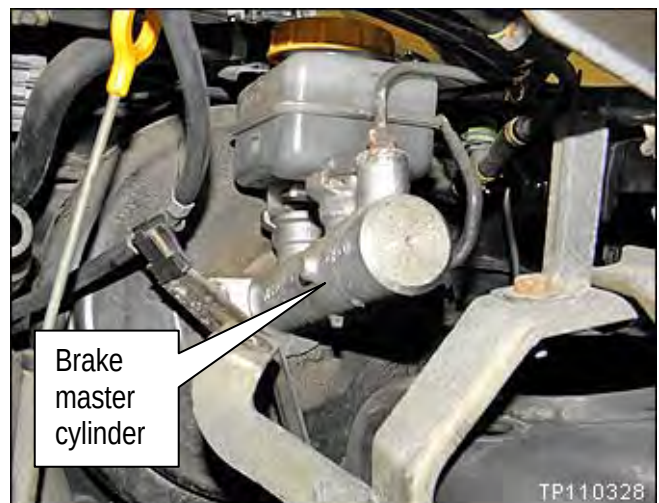
Figure RB28

Contact with the strut housing may have occurred if the strut housing separated from the wheel house.

31. If the strut housing was separated, inspect the brake master cylinder for damage.

- If there is damage, replace the master cylinder.
- Refer the appropriate Service Manual for brake master cylinder replacement information.
