ITB11-041a

September 1, 2011

**VOLUNTARY SERVICE CAMPAIGN  
1997- 2003 QX4 IN NON SALT STATES  
LEFT FRONT STRUT HOUSING CORROSION**

CAMPAIGN ID #: R1110  
NHTSA #: 11V-244  
APPLIED VEHICLES: 1997- 2003 QX4 (JR50)

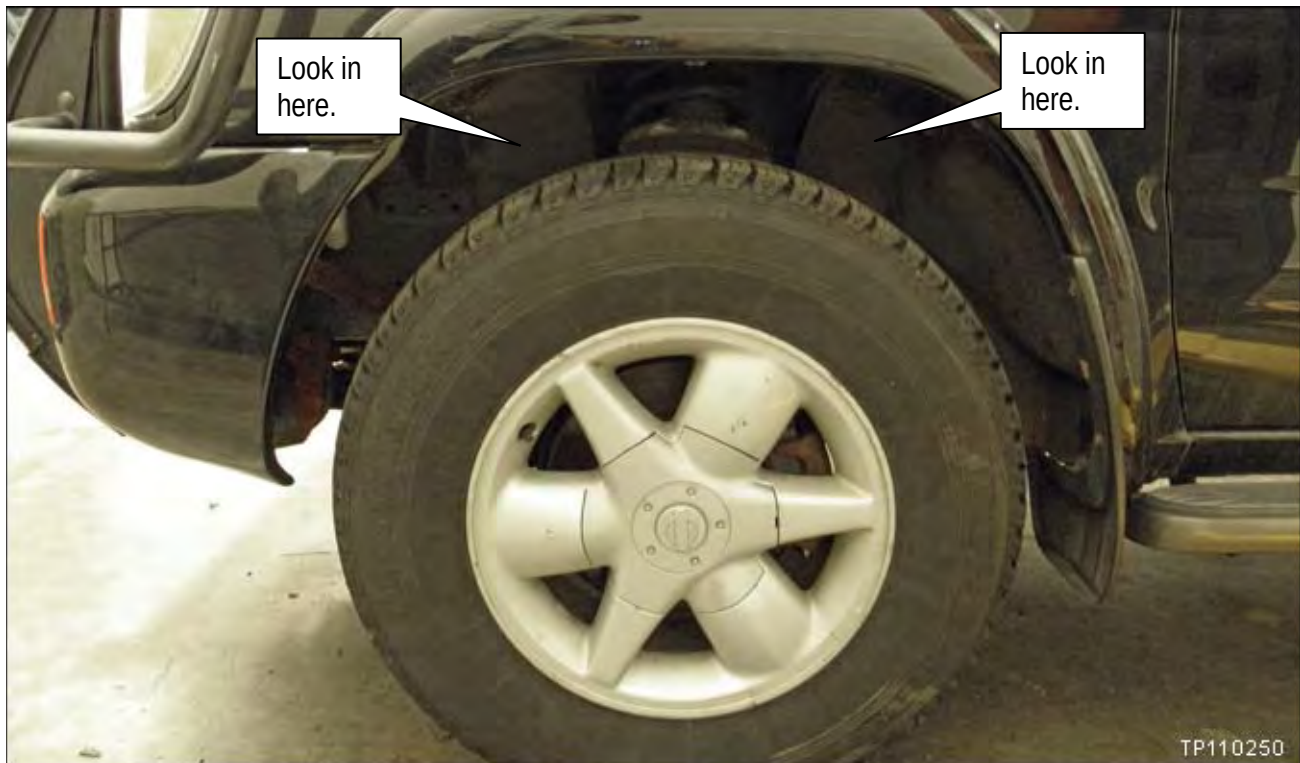
Figure A

4. Visually inspect for corrosion and rust on the wheel housing panel and the strut housing panel.

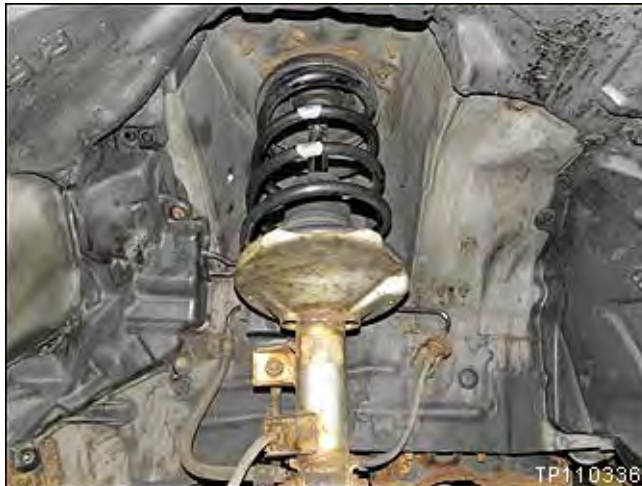
Figure 6

3. Visually inspect for corrosion and rust on the wheel housing panel and the strut housing panel.
  - Inspect for corrosion and rust on the panels only.

1. Remove the front passenger side wheel.
2. Use mild soap, water, and a brush to thoroughly wash the strut housing and the wheel housing in the area shown in Figure 6.

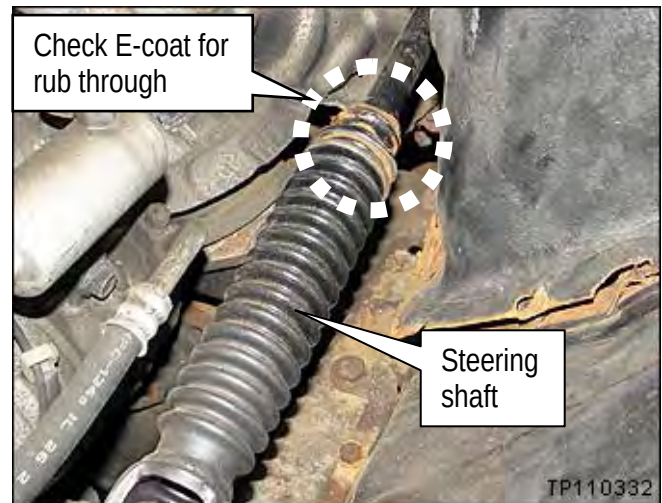
Figure RB4

Contact may have occurred if the strut housing separated from the wheel house.

- ONLY if the E-coat has been rubbed through to bare metal, the steering shaft will need to be replaced.
- If the steering shaft needs replacement, you will be instructed to replace it later in this procedure.

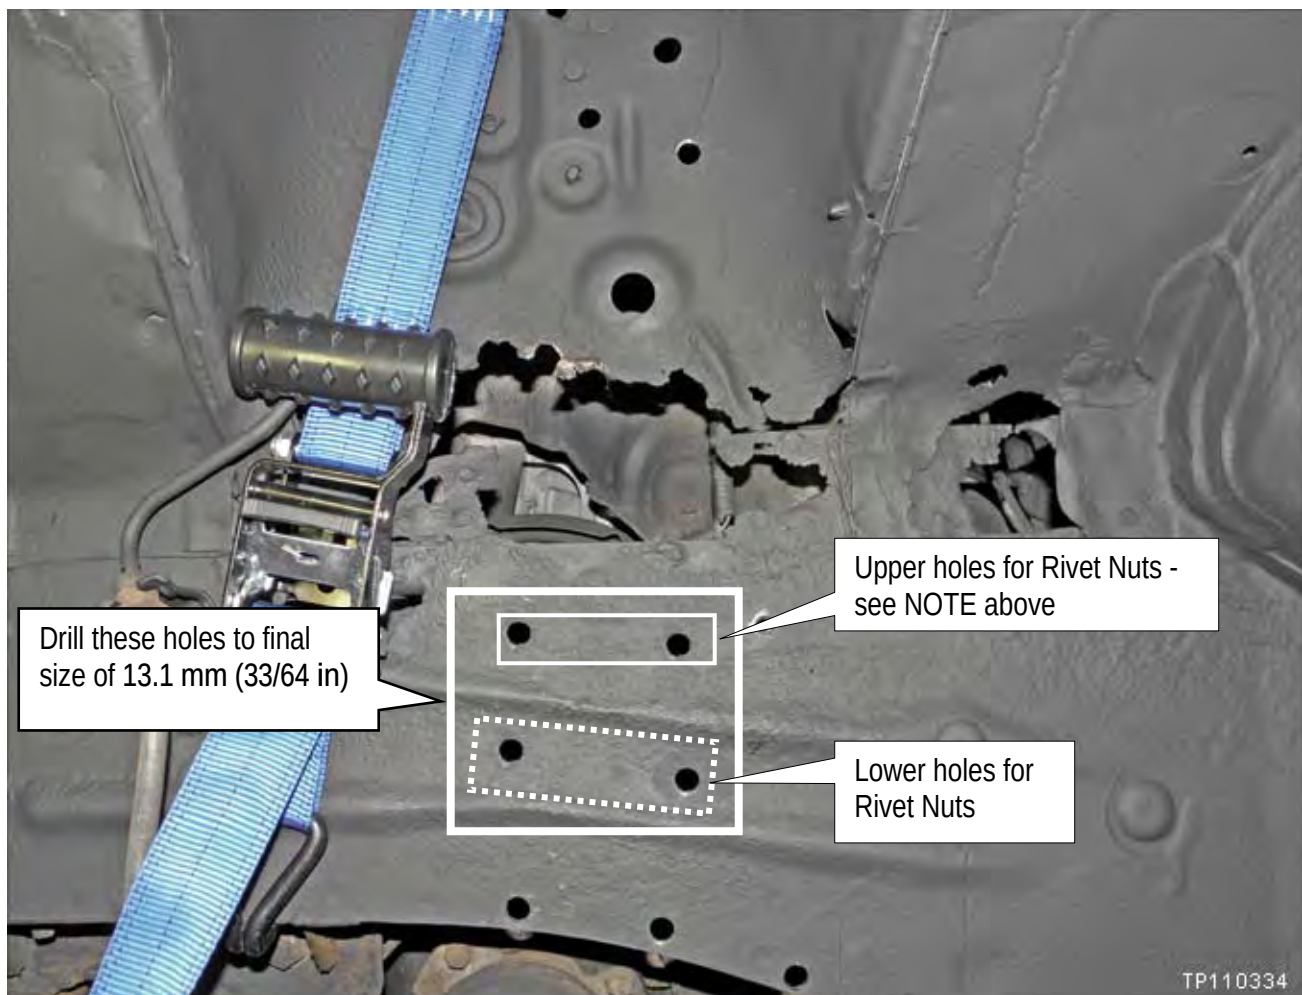
Figure RB10

If the metal in the area of the lower holes will not support the Rivet Nuts, then the vehicle is “not repairable”: Retain the vehicle at the dealer, supply the customer with a rental car, and Fax a completed Non-Repairable Report to Morley (see page 55).

NOTE: Upper holes – not required: If the metal in the area of the upper holes will not support Rivet Nuts, continue with the repair. Rivet Nuts are preferred but not required in the upper holes.

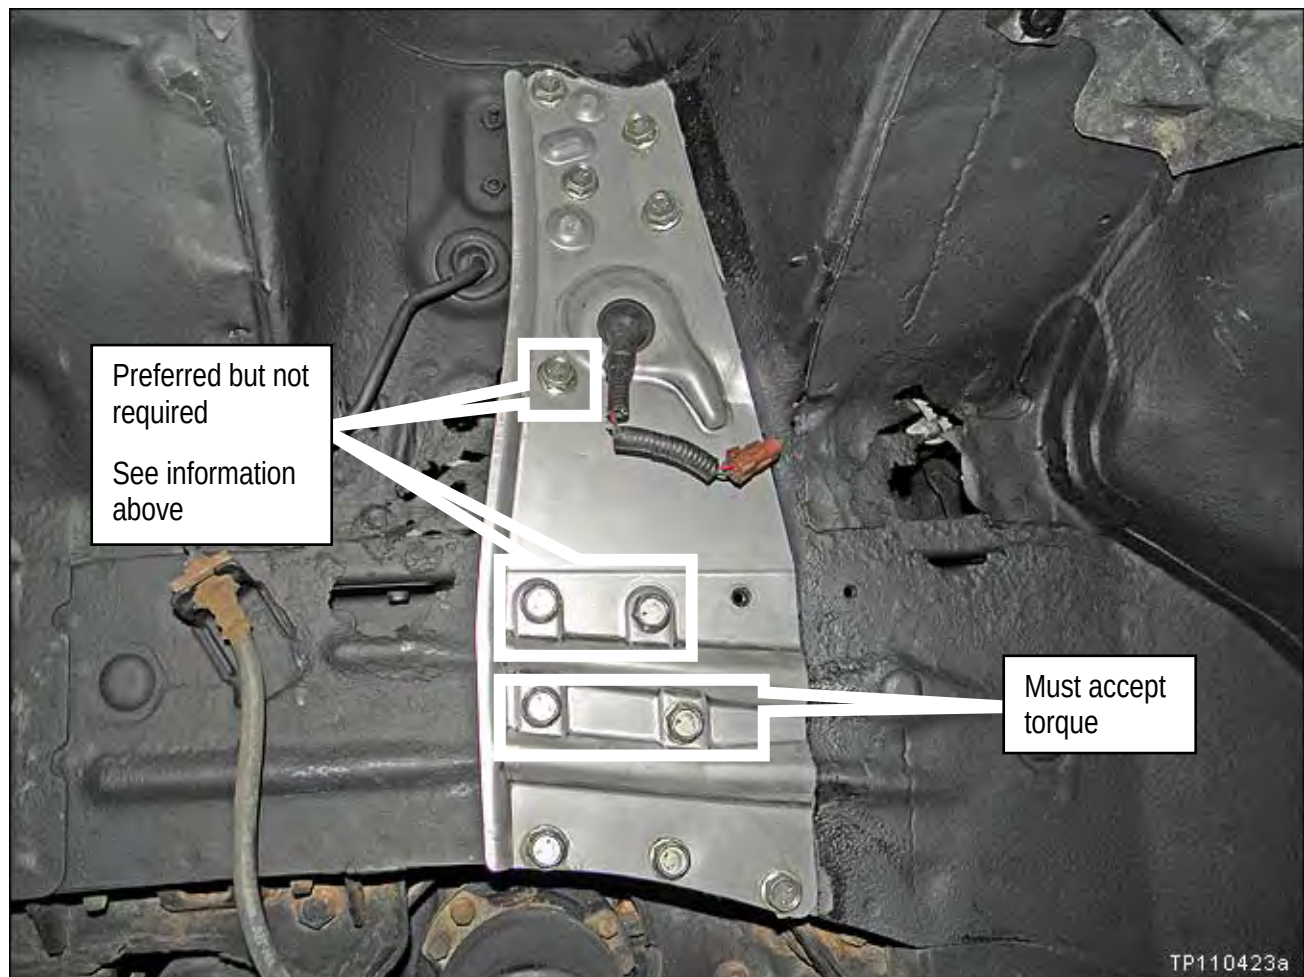
Figure RB25

- These bolts are required and must accept the torque value of 50 N•m (5.1 kg-m, 37 ft-lb).
- If these bolts will not accept the specified torque value, the vehicle is not repairable:
  - a. Retain the vehicle at the dealer.
  - b. Supply the customer with a rental car.
  - c. Fax a completed Non-Repairable Report to Morley (see page 55).
