ITB11-041

August 11, 2011

**VOLUNTARY SERVICE CAMPAIGN  
1997- 2003 QX4 IN NON SALT STATES  
LEFT FRONT STRUT HOUSING CORROSION**

CAMPAIGN ID #: R1110  
NHTSA #: 11V-244  
APPLIED VEHICLES: 1997- 2003 QX4 (JR50)

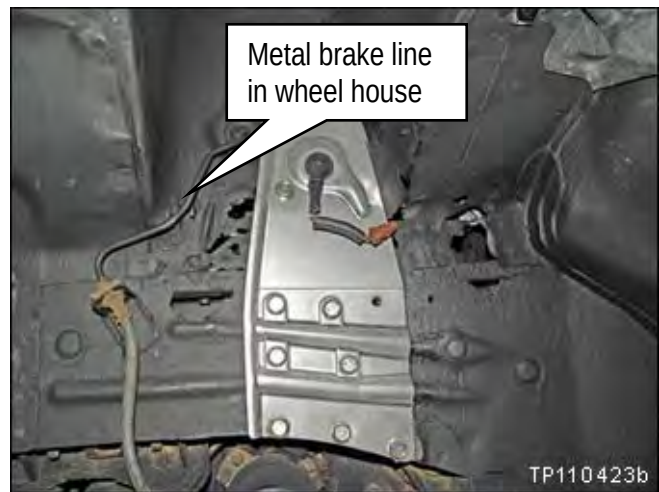
Figure RB26

30. Inspect the metal brake line for damage. If there is damage, replace the line.

- Inspect the line in the wheel house area (see Figure RB26).

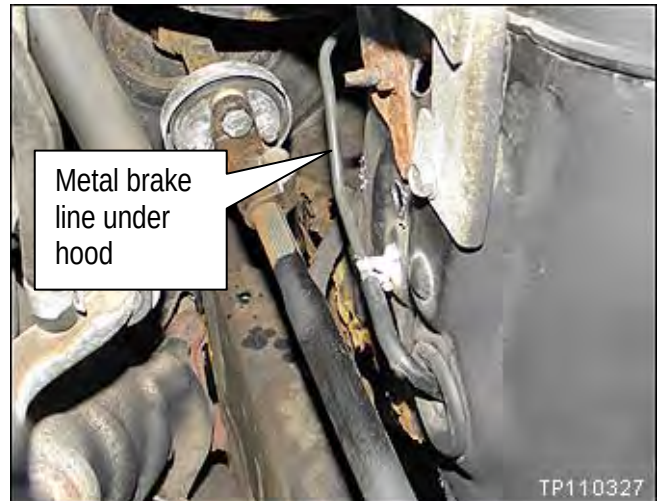
Figure RB27

- Inspect the line under the hood (see Figure RB27)
- Scratches or nicks of the E-coat are not considered damage that requires brake line replacement.
- Refer to the appropriate Service Manual for brake line replacement information.
