ITB11-041d

June 8, 2012

**VOLUNTARY SERVICE CAMPAIGN  
1997-2003 QX4 IN NON SALT STATES  
LEFT FRONT STRUT HOUSING CORROSION**

CAMPAIGN ID #: R1110  
NHTSA #: 11V-244  
APPLIED VEHICLES: 1997- 2003 QX4 (JR50)

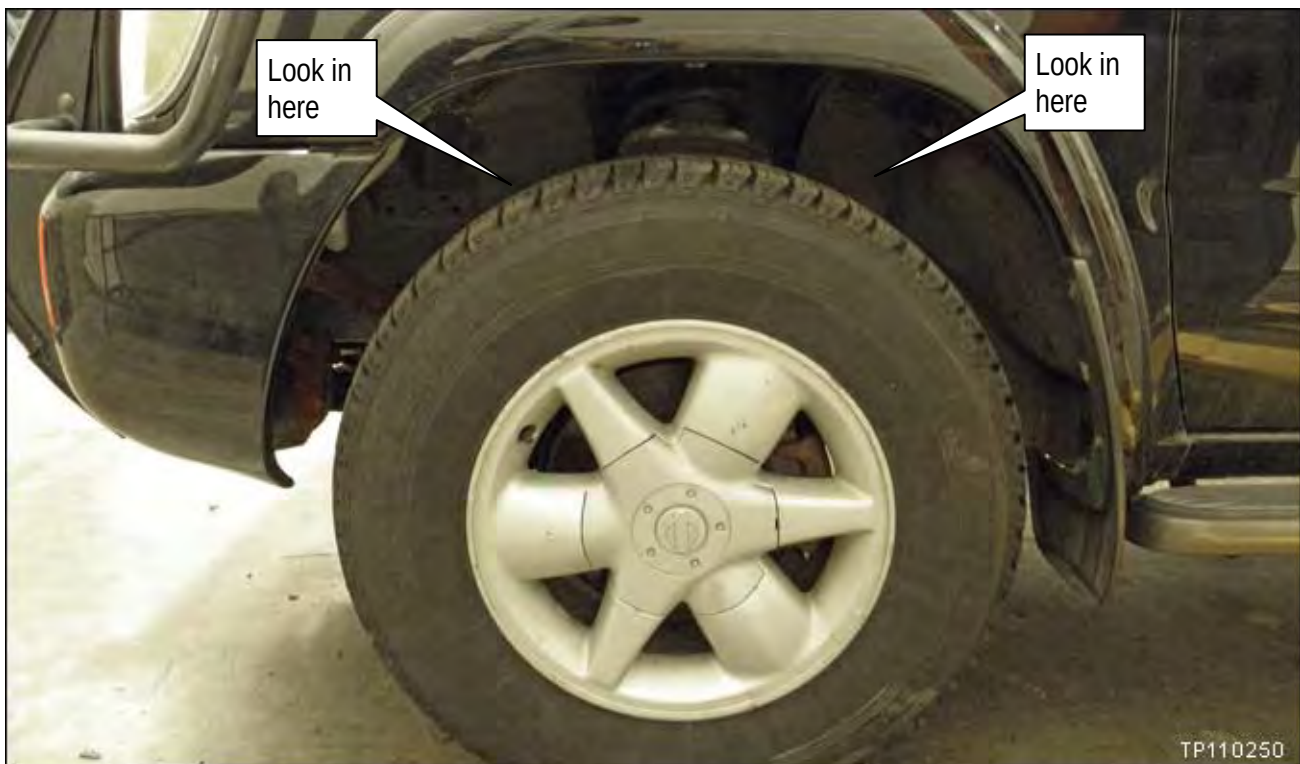
Figure A

1. Turn the ignition OFF.
2. Set the parking brake.
3. Look behind both front tires (see Figure A).

4. Visually inspect for corrosion and rust on the wheel housing panels and the strut housing panels.

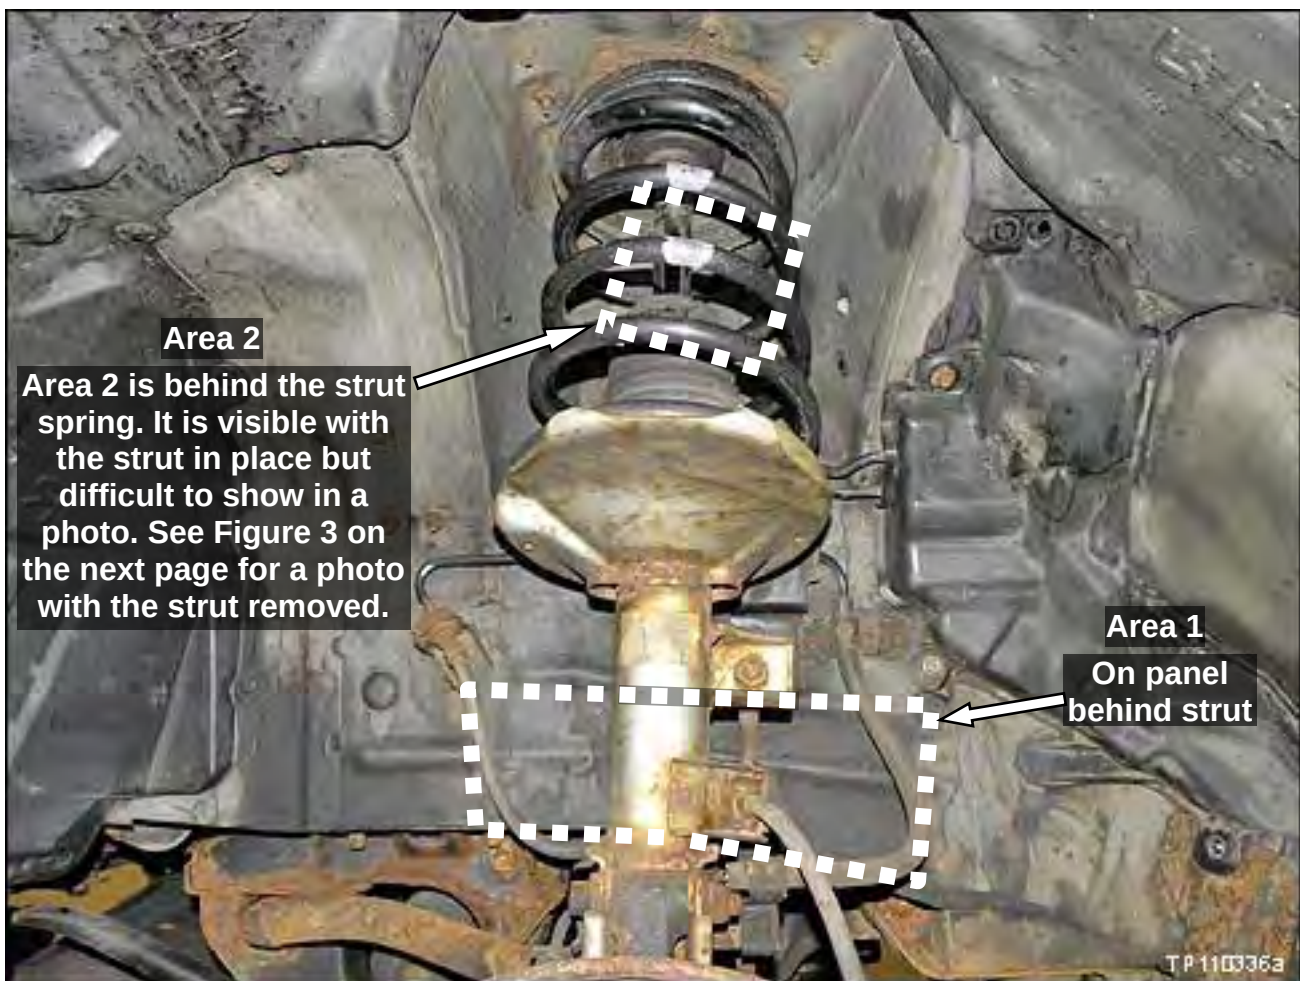
Figure 1

1. Lift the vehicle on a hoist.
2. Remove both front wheels.
3. Inspect for corrosion ON BOTH SIDES in the strut housing Area 1 and wheel house Area 2 (see Figures 1 through 4).

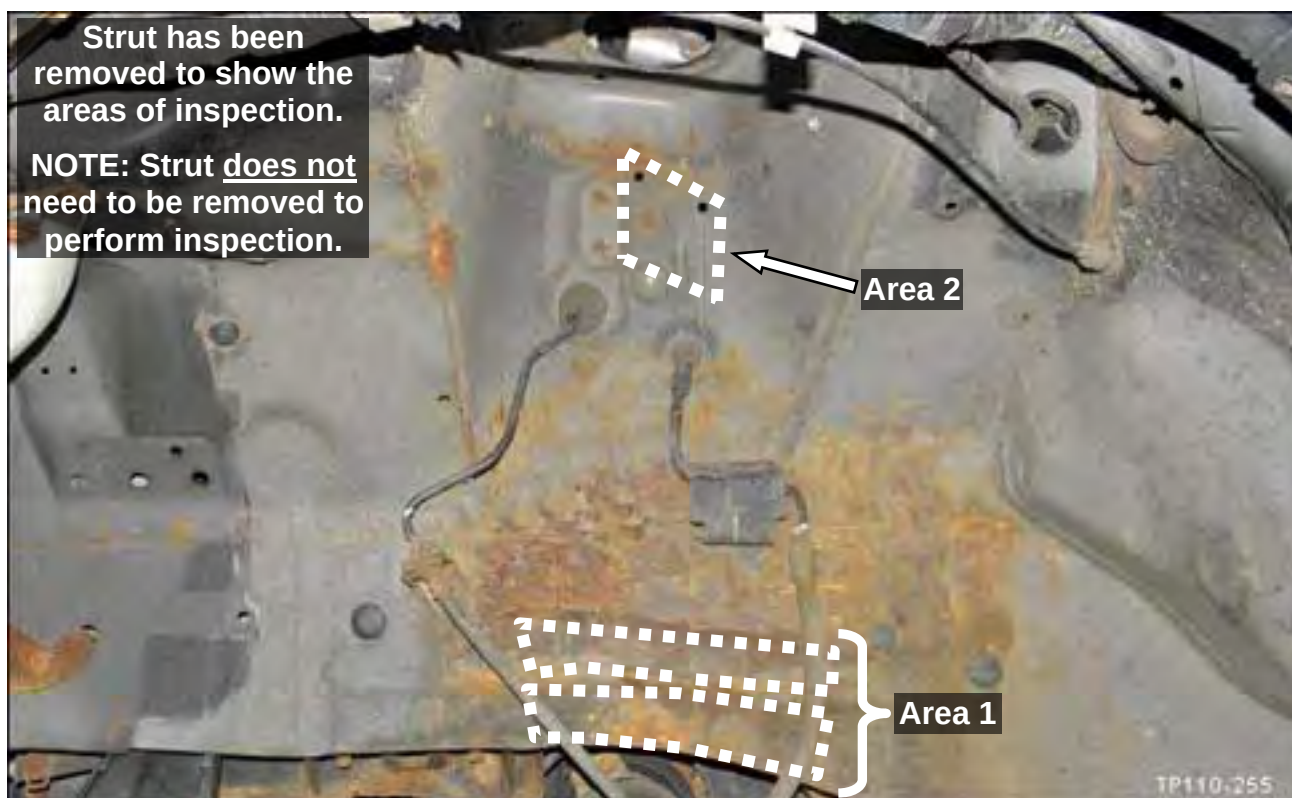
Figure 2

This example photo shows the inspection areas in relation to the repair bracket installation.

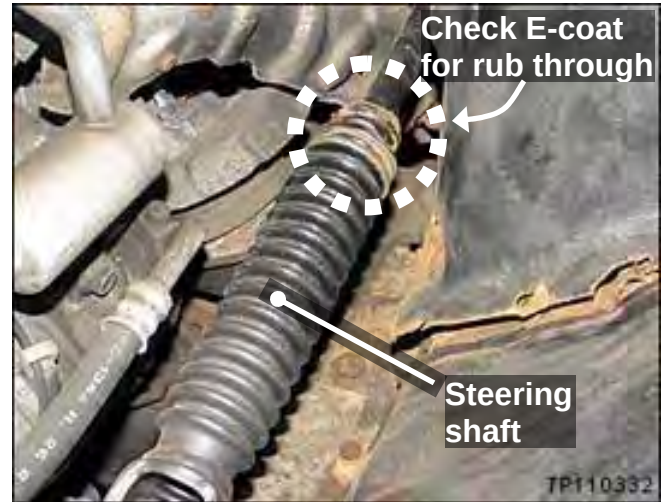
Figure RB5

Contact may have occurred if the strut housing separated from the wheel house.

- ONLY if the E-coat has been rubbed through to bare metal, the steering shaft will need to be replaced.
- If the steering shaft needs replacement, you will be instructed to replace it later in this procedure.

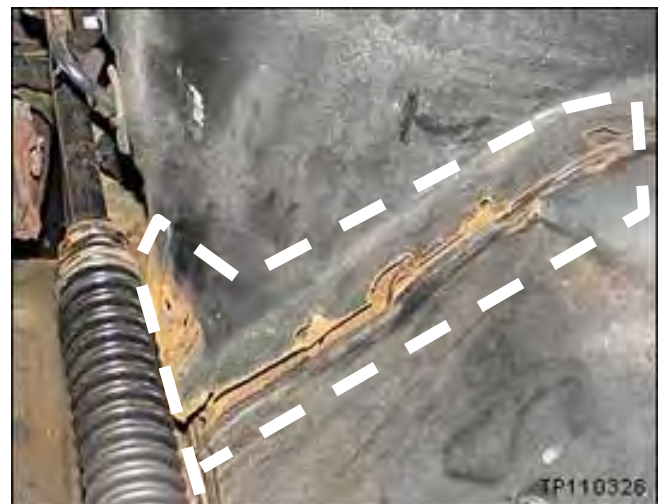
Figure RB6

- 7a. Only if the strut housing panel is separated as shown in Figure RB6:

Use a wire brush to clean any loose rust, paint, or other debris from the area shown with dashed line.

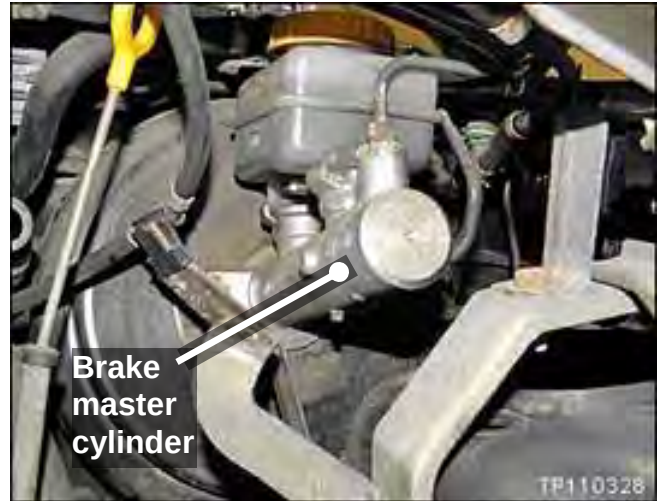
Figure RB28

32. Driver side: Inspect the brake master cylinder for damage due to contact with the separated strut housing.

Contact with the strut housing may have occurred if the strut housing separated from the wheel house.

- If there is damage, replace the master cylinder.
- Refer to the appropriate Service Manual for brake master cylinder replacement information.
