## SB-10040905-4360 Technical Bulletin

NTB11-066d June 8, 2012

## VOLUNTARY SERVICE CAMPAIGN 1996-2004 PATHFINDER IN NON SALT STATES FRONT STRUT HOUSING CORROSION

**CAMPAIGN ID #**: R1108 **NHTSA #**: 11V-244

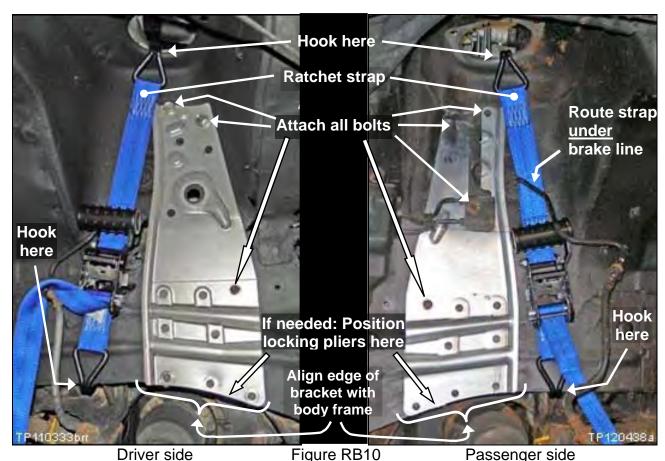
### 15. Only if the strut housing panel is separated:

- a. Attach the ratchet strap as shown in Figure RB10.
- b. Use the ratchet strap to pull the strut housing panel down until the existing threaded hole(s) is aligned with the matching hole in the repair bracket (see Figure RB10).
- 16. Install all bolts as shown in Figure RB10, and make them finger tight.
- 17. Align the bottom edge of the repair bracket with the edge of the body frame.
  - The bracket will have some movement in all directions. Move it (align it) the best possible.
- 18. Once the bottom edge is aligned, securely tighten all bolts (see Figure RB10).
  - At this time, a pair of locking pliers or equivalent tool may be used to further support the repair bracket (see Figure RB10).
  - Bolts need to be tight enough to hold the bracket in place while center punching and drilling holes in the next step.
