**SB-10049579-7351**

**Title:** Horton Stratis Fan Hub Diagnostics

**Applies To:** Prostar, LoneStar, TranStar, WorkStar, IBB

Horton VMaster Ultra (Stratis) Viscous Fan Drive Troubleshooting Guide  
 Engine feature code 12THX

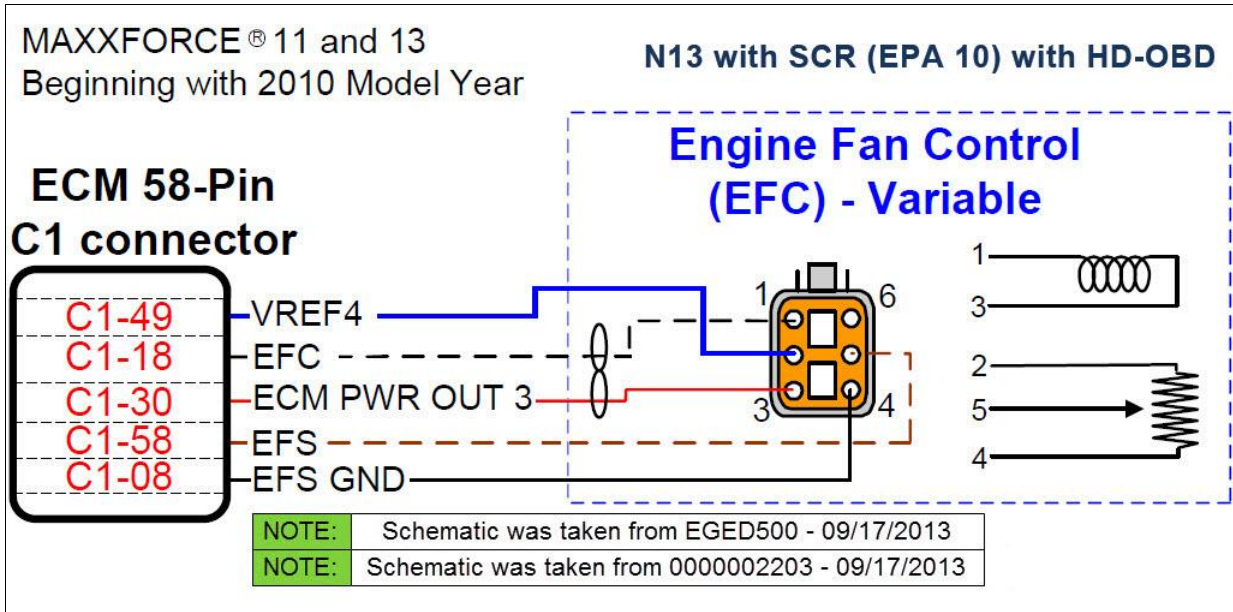
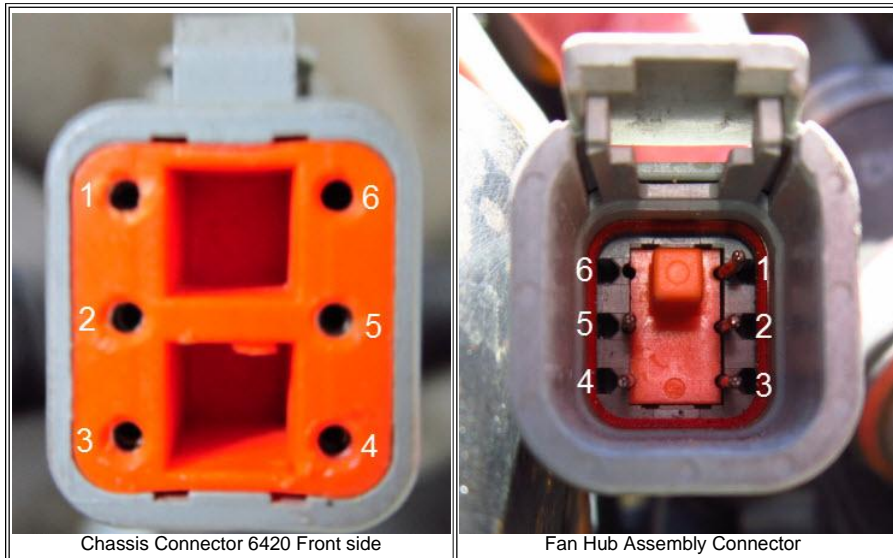
- The default state of the fan is ON. Ground is required to turn the fan OFF.
- ECM C1-18 controls the fan by supplying a Ground PWM signal.
- ECM C1-58 is feedback for the fan speed.

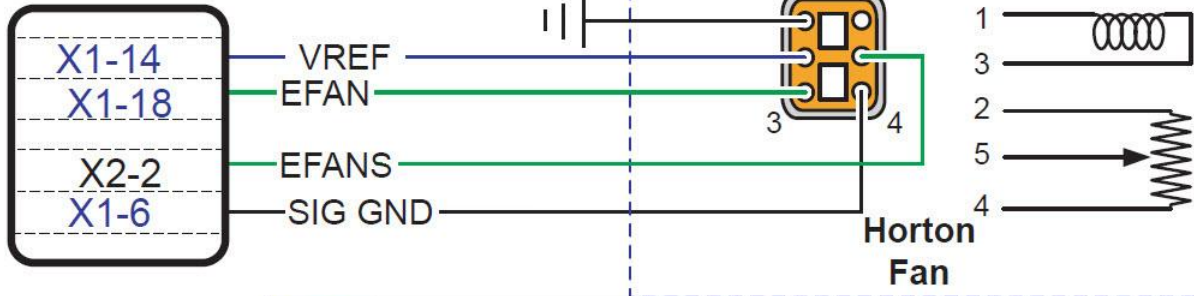
**Variable**  
**Electronic Fan Control**

**NOTE:** Schematic was taken from EGED430 - 09/17/2013
