SERVICE BULLETIN

Classification: EC12-034a	Reference: NTB13-001a	Date: February 27, 2013
-------------------------------------	---------------------------------	-----------------------------------

2013 SENTRA; ENGINE HAS HESITATION OR STOPS RUNNING AT IDLE OR VERY LOW SPEEDS

APPLIED VEHICLE: 2013 Sentra (B17)

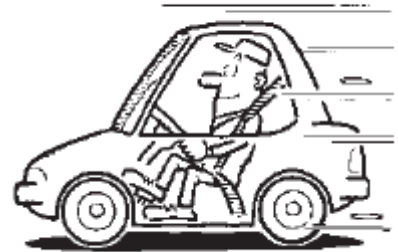
Figure A

- Take the vehicle for a 10 minute drive in order to meet the following Idle Air Volume Learn (IAVL) conditions:
 - Engine coolant temperature: 70 -100°C (158 -212°F)
 - Battery voltage: More than 12.9V (At idle)
 - Transmission: Warmed up
