GRAND VITARA

Technical Bulletin

Section Title: Restraints
 TSB No. TS 05 01140R

SUBJECT: COUNTER-MEASURE PROCEDURE FOR DTC B1318
MODEL(S): GRAND VITARA (JB424W/JB632W)
YEAR: 2009
VIN BREAKS: JB424W: ~JS3TD042494101207 May 26, 2009
 JB632W: ~JS3TD148494100441 May 28, 2009

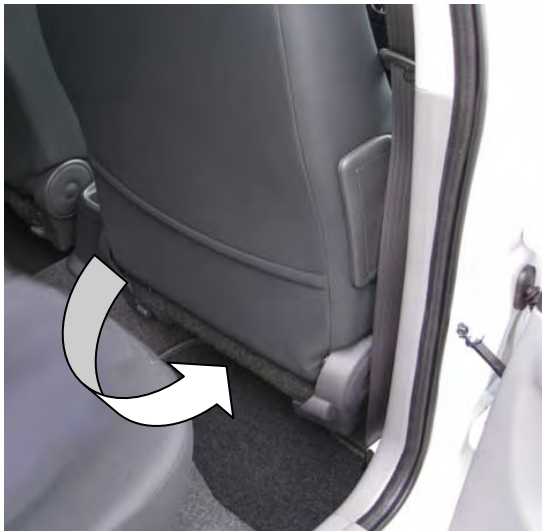
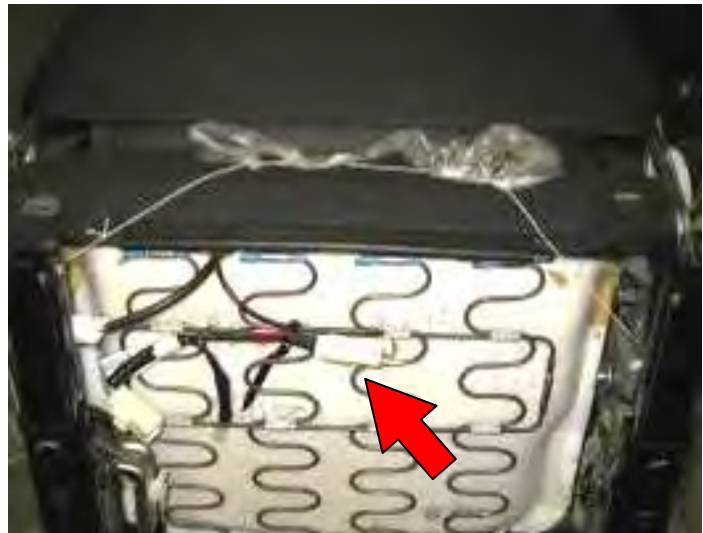
10. Make sure the ignition switch is turned off. If the ignition is turned on, or left on, while the reprogramming procedure is performed, DTC(s) indicating circuit problems may be stored in the SDM.
11. Find the OCS connector, located under the Passenger Seat Cushion, and disconnect it.
Note: You should not need to remove the strap securing the harness.
