Technical Bulletin

Section Title: Restraints
 TSB No. TS 01 02260R2

SUBJECT: COUNTER-MEASURE PROCEDURE FOR DTC B1318
MODEL(S): SX-4 (RW420)
YEAR: ALL MY 2009 (except where VIN breaks indicate production change)
VIN BREAKS: ~JS2YA413396202055 May 27, 2009
 ~JS2YA411596200564 May 27, 2009
 ~JS2YB413496206032 May 26, 2009
 ~JS2YB417096203342 May 27, 2009
 ~JS2YC415896200927 May 26, 2009
 ~JS2YC412696204318 May 27, 2009

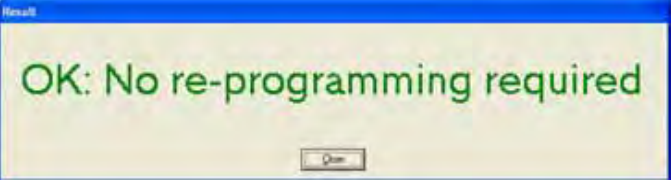
<p>If the “OK: No reprogramming required” window has opened, there was no need to reprogram, likely due to the vehicle being previously reprogrammed, or it not falling within the affected VIN range. Continue to the next step in the instructions.</p>
