SERVICE CAMPAIGN BULLETIN

NTB13-002

VOLUNTARY SERVICE CAMPAIGN 2013 PATHFINDER TCM REPROGRAM

APPLIED VEHICLES: 2013 Pathfinder (R52)

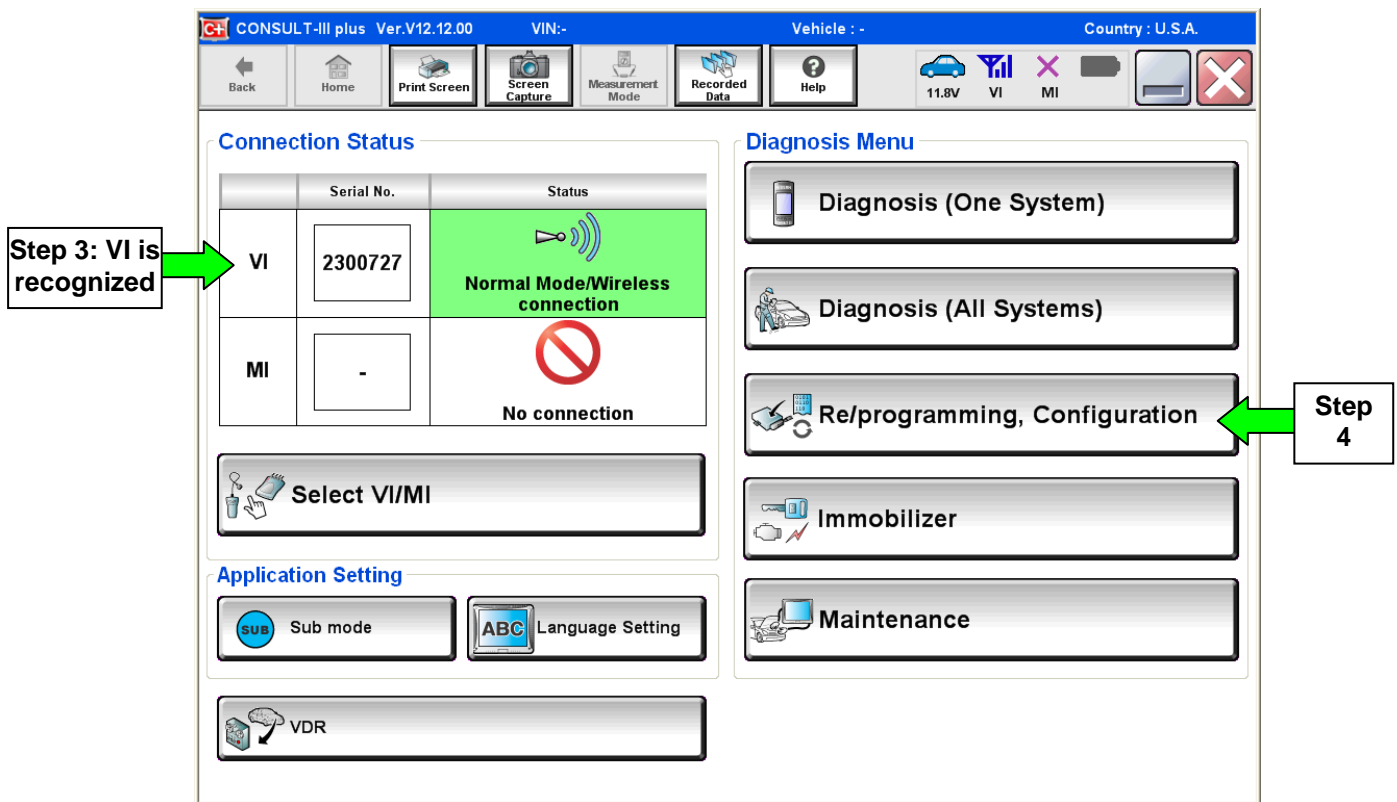
Figure 1

1. **Connect the CONSULT PC** to the vehicle to begin the reprogramming procedure.
2. Open ASIST on the CONSULT PC and start C-III plus.
3. Wait for the plus VI to be recognized / connected.
 - Serial number will display when the plus VI is recognized / connected.
4. Select **Re/programming, Configuration**.

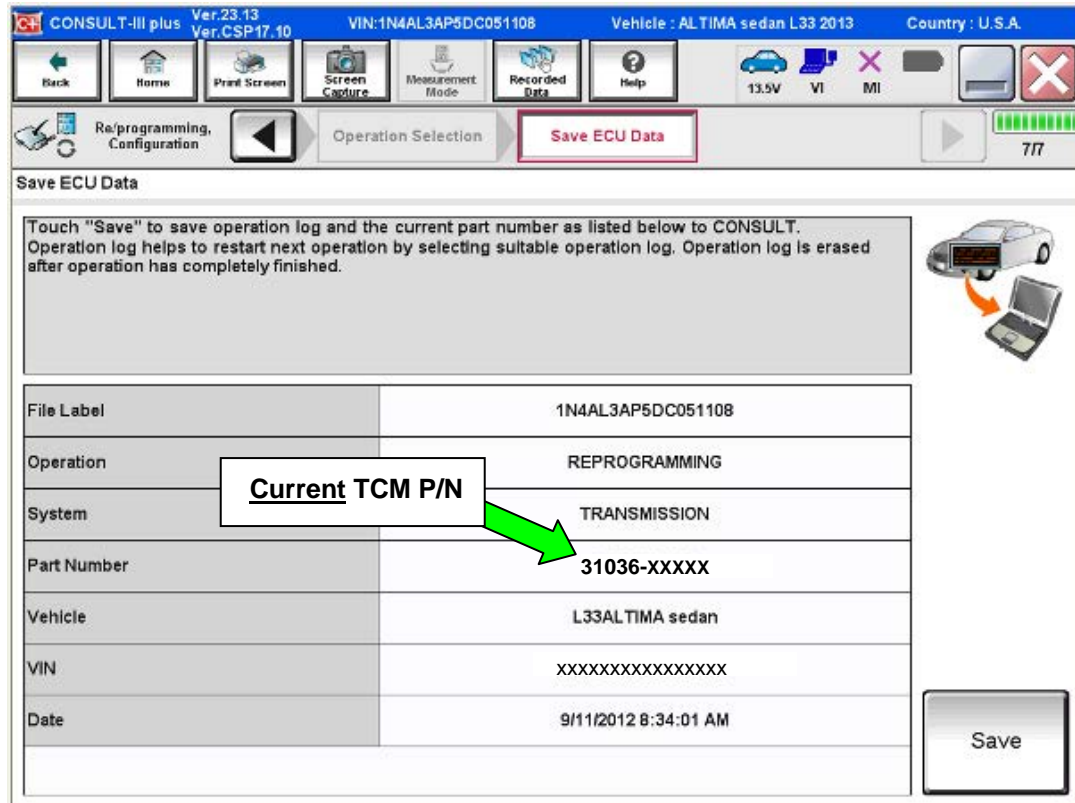
6. When you get to the screen shown in Figure 2, confirm this bulletin applies as follows:

A. Find the TCM **Part Number** and write it on the repair order.

NOTE: This is the current TCM Part Number (P/N).

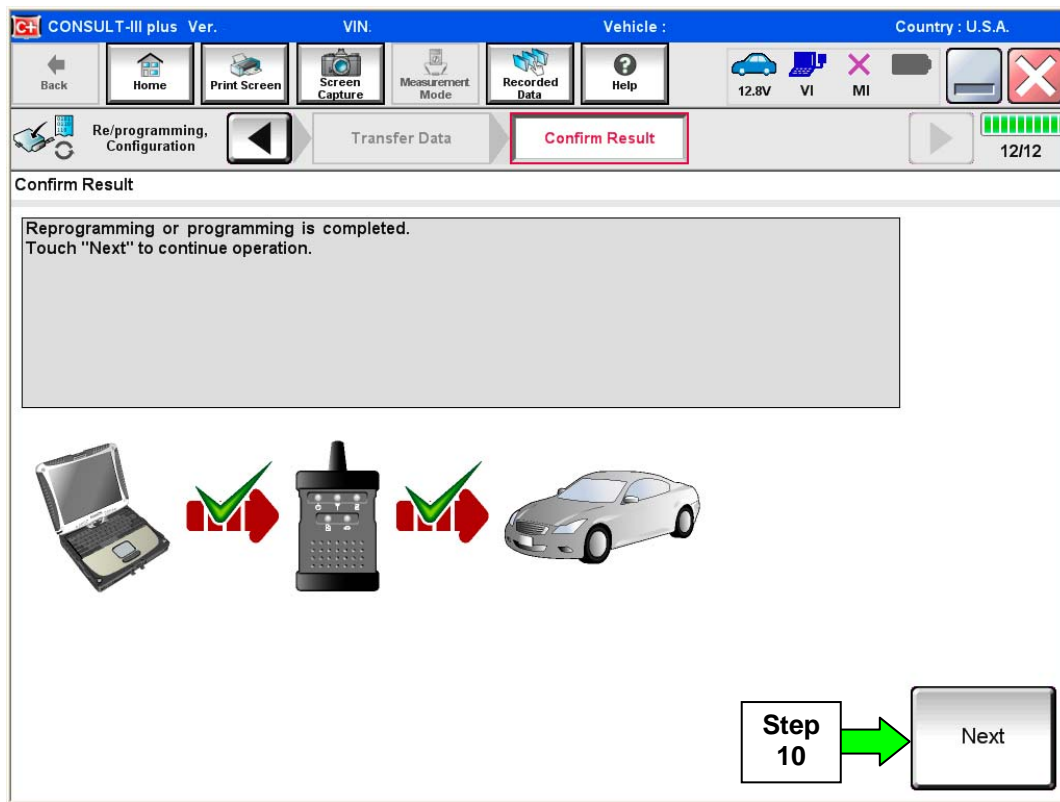
8. When the screen in Figure 4 displays, reprogramming is complete.

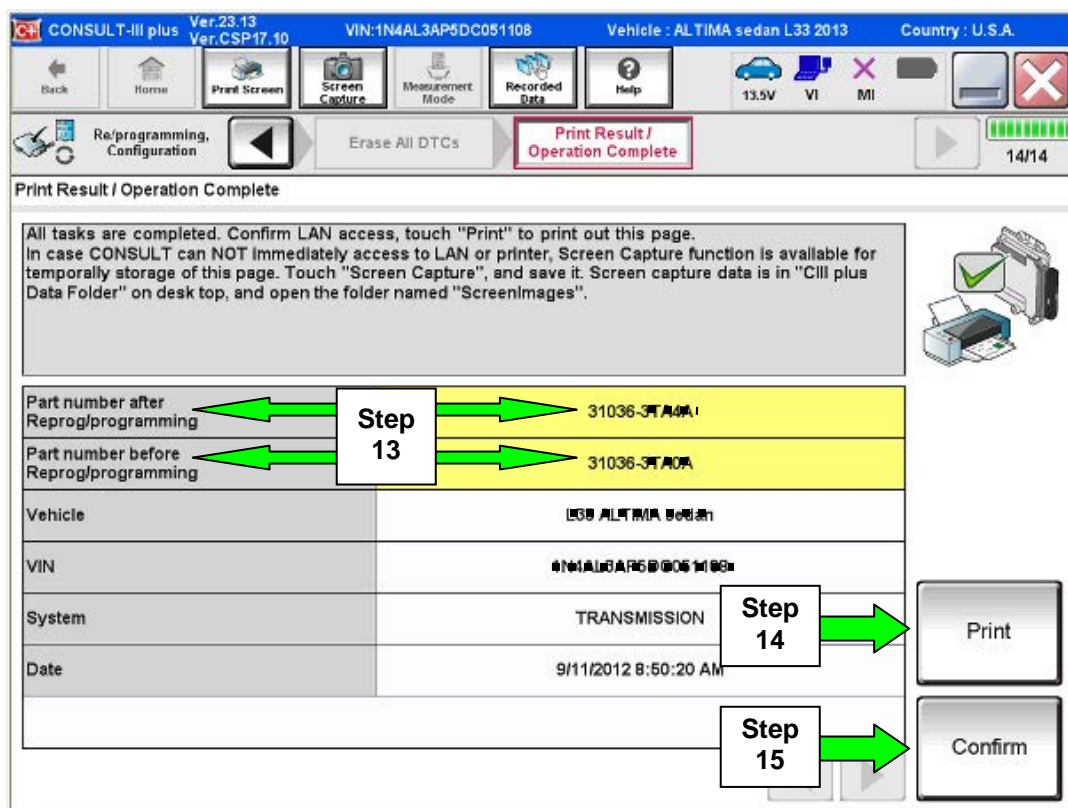
12. When the entire reprogramming process is complete, the screen in Figure 7 will display.

13. Verify the before and after part numbers are different.

14. Print a copy of this screen (Figure 7) and attach it to the repair order for warranty documentation.
