SERVICE CAMPAIGN BULLETIN

NTB13-022

VOLUNTARY SERVICE CAMPAIGN 2013 SENTRA COLD IDLE ECM AND TCM REPROGRAM

CAMPAIGN ID #: P3212

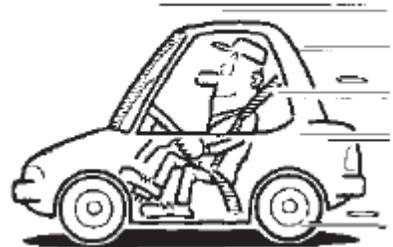
Figure A

- Take the vehicle for a 10 minute drive in order to meet the following Idle Air Volume Learn (IAVL) conditions:
 - Engine coolant temperature: 70 -100°C (158 -212°F)
 - Battery voltage: More than 12.9V (At idle)
 - Transmission: Warmed up

- After ECM reprogramming is complete, you will be required to perform Throttle Valve Closed Position, Idle Air Volume Learn (IAVL), and Accelerator Closed Position.
- The above conditions are required for the IAVL to complete.

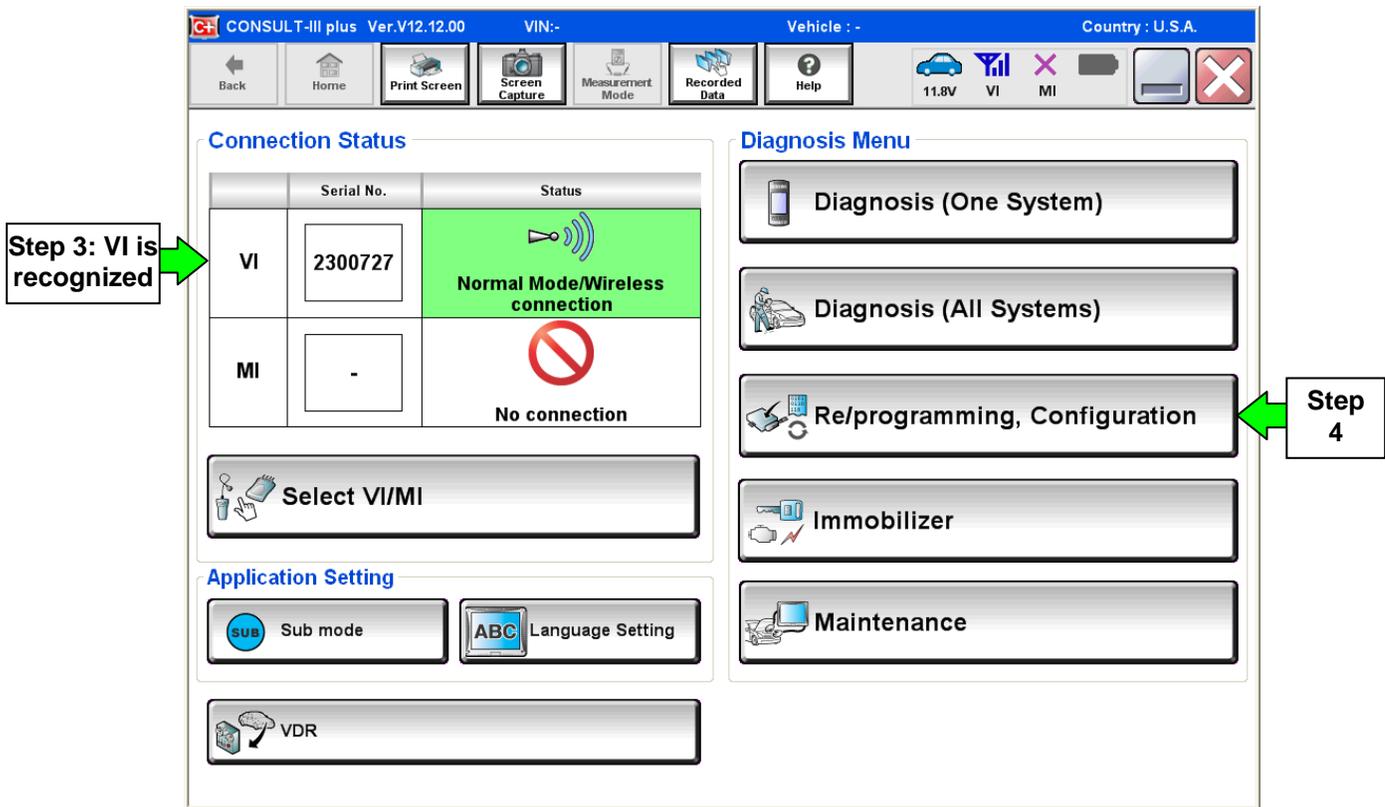
Figure 1

1. **Connect the CONSULT PC** to the vehicle to begin the reprogramming procedure.
2. Open ASIST on the CONSULT PC and start C-III plus.
3. Wait for the plus VI to be recognized / connected.
 - Serial number will display when the plus VI is recognized / connected.
4. Select **Re/programming, Configuration**.

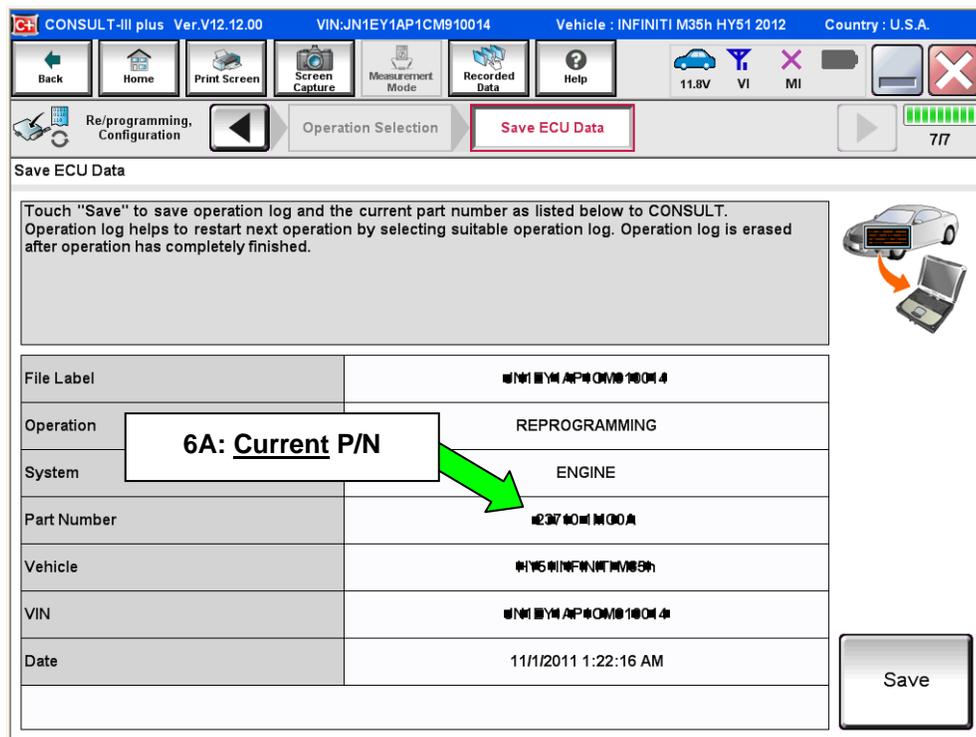
Figure 2

6. When you get to the screen shown in Figure 2, confirm this bulletin applies as follows:

A. Find the ECM or TCM **Part Number** and write it on the repair order.

NOTE: This is the current ECM or TCM Part Number (P/N).
ECM preprogramming must be performed first.

B. Compare the P/N you wrote down to the numbers in the **Current ECM (or TCM) Part Number** column in **Table A** (or **Table B**) on next page.

- If there is a **match**, this bulletin **applies**. Continue with the reprogramming procedure.
- If there is **not a match**, reprogramming **does not apply**. Make sure to check both ECM and TCM for a match.

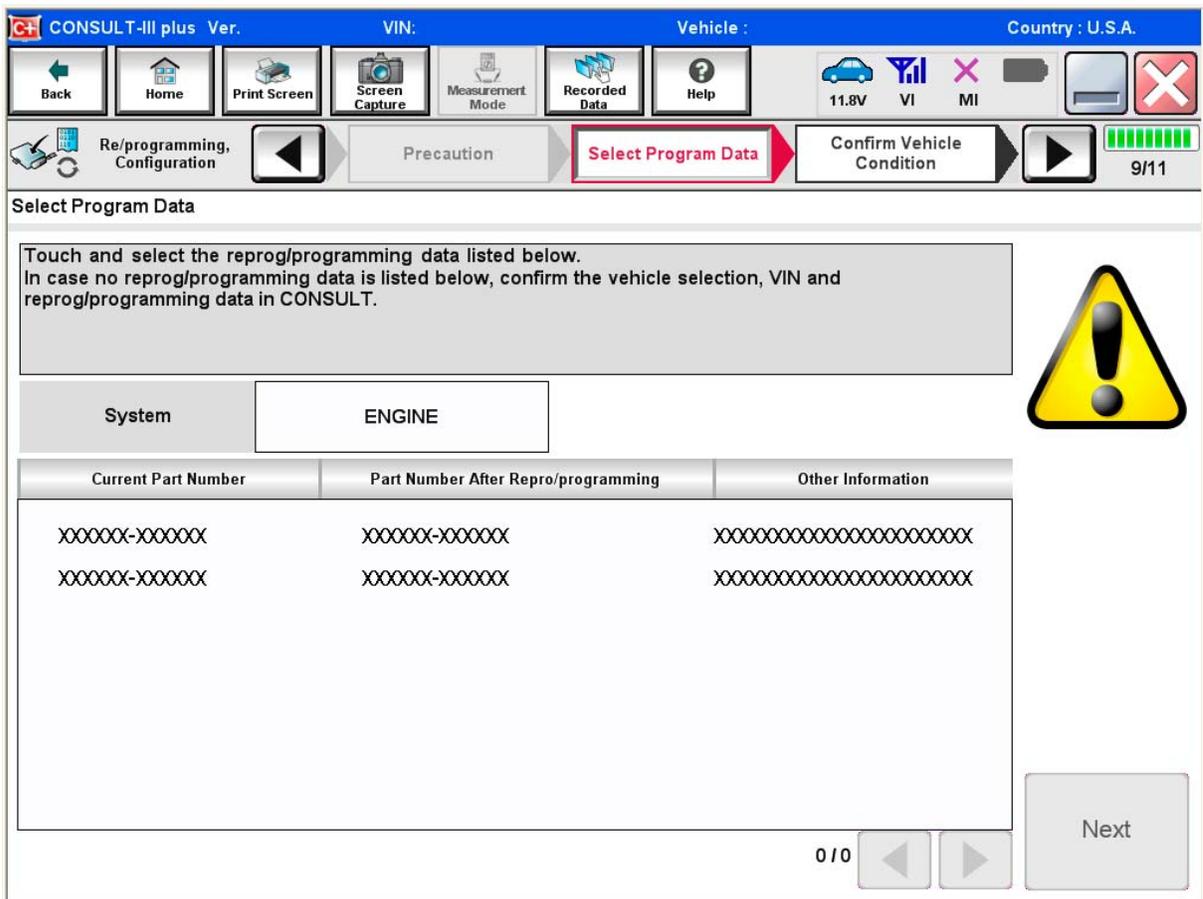
- In some cases, more than one new P/N for reprogramming is available.
 - In this case, the screen in Figure 3 displays.
 - Select and use the reprogramming option that **does not** have the message “Caution! Use ONLY with NTBXX-XXX”.
- If you get this screen and it is blank (no reprogramming listed), it means there is no reprogramming available for this vehicle.

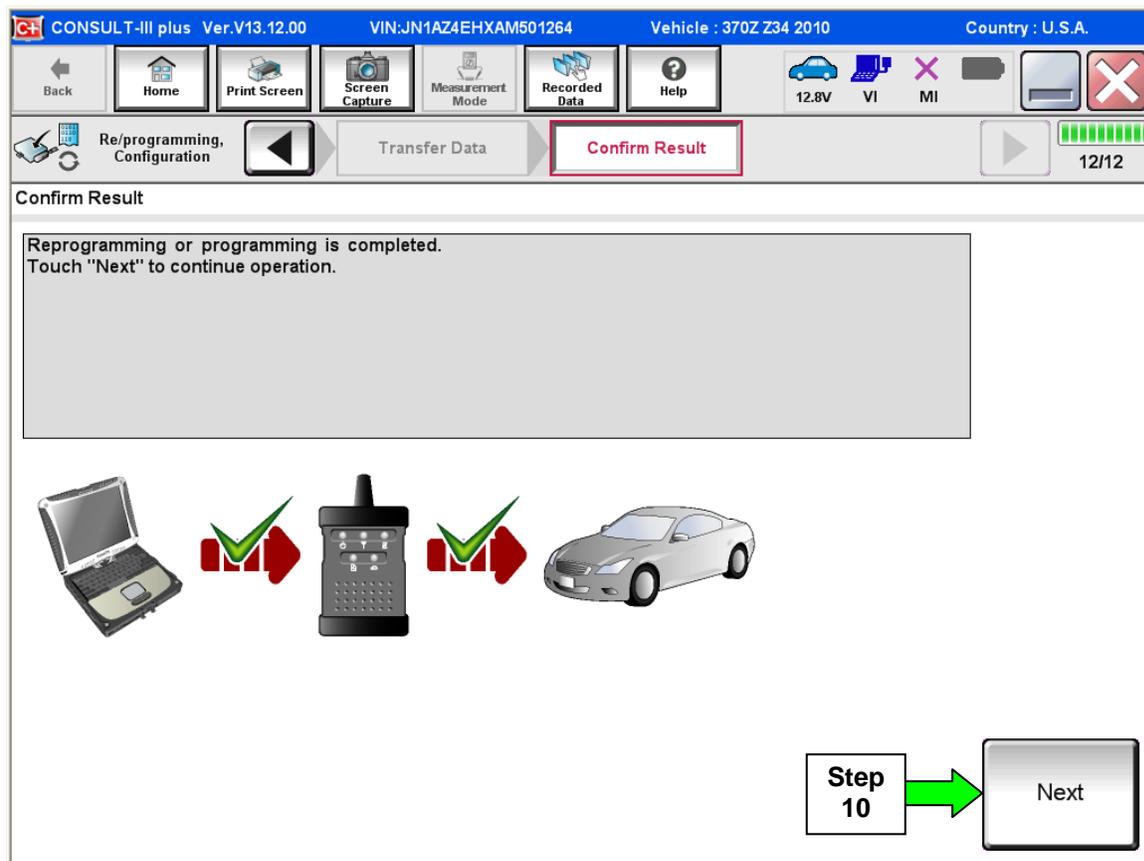
8. When the screen in Figure 4 displays, reprogramming is complete.

NOTE: If the screen in Figure 4 does not display (reprogramming does not complete), refer to the information on the next page.

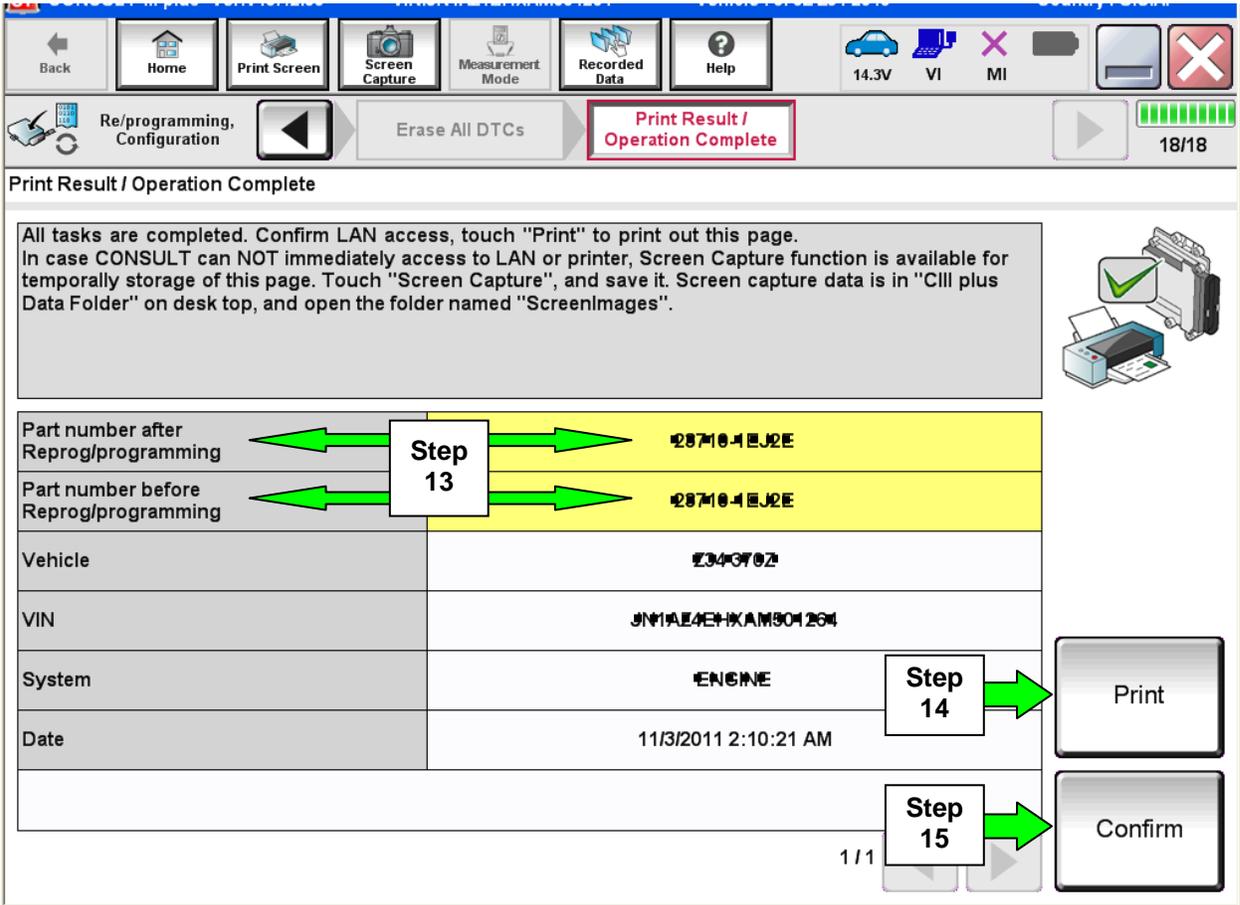
- 12. When the entire reprogramming process is complete, the screen in Figure 7 will display.
- 13. Verify the before and after part numbers are different.
- 14. Print a copy of this screen (Figure 7) and attach it to the repair order for warranty documentation.
- 15. Select **Confirm**.
