Technical Service Bulletin

94 Headlight Flickering or Warning On in Cluster (All Xenon Headlights)

94 13 03 2029194/3 February 1, 2013. Supersedes Technical Service Bulletin Group 94 number 12-99 dated November 30, 2012 for reasons listed below.

Model(s)	Year	VIN Range	Vehicle-Specific Equipment
Q7	2010	All	Premium Plus and Prestige
	2011	All	
	2012	All	
	2013	All	
	2014	All

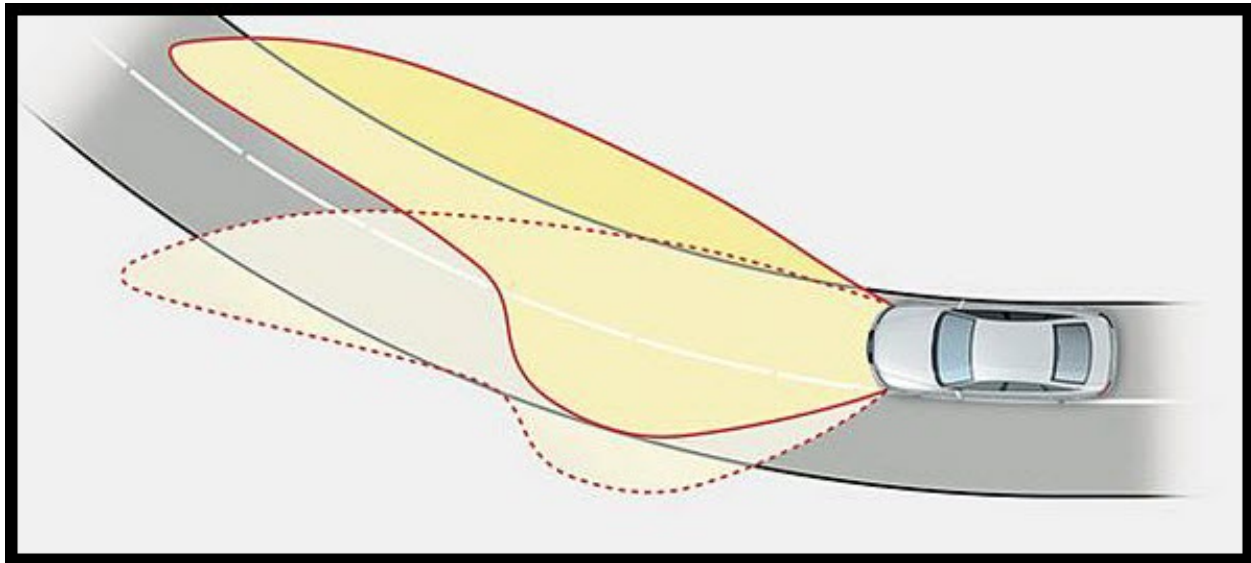
Figure 5. Audi Adaptive Lighting illustration showing the maximum 15° curve of the light beam at speeds greater than 6mph.
