Michael A. Berardi
Director
Service Engineering Operations
Ford Customer Service Division

June 17, 2013

SUBJECT: **DELIVERY HOLD - Customer Satisfaction Program 13B02 – Supplement #1**
Certain 2013 Model Year Fusion Vehicles Equipped with a Moon Roof
Headliner Wrinkles

CERTAIN 2013 MODEL YEAR FUSION VEHICLES EQUIPPED WITH A MOON ROOF — HEADLINER WRINKLES

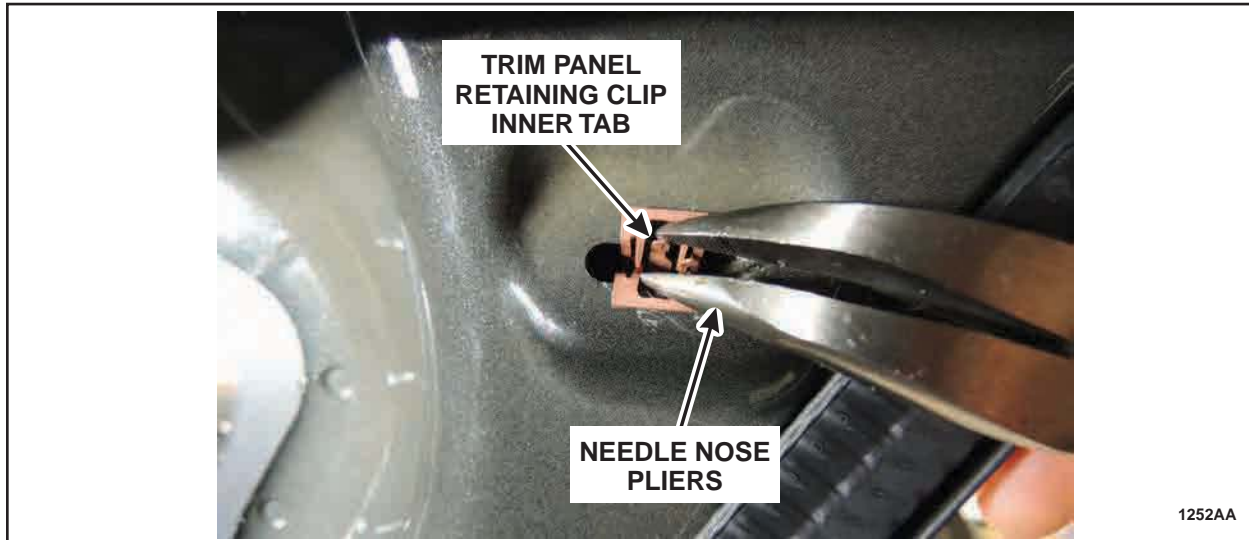
FIGURE 2

NOTE: When removing trim panels, the retaining clips may remain engaged in the vehicle sheet metal. Using a pair of needle nose pliers, compress the inner tabs of the clip and pull back to remove. If there is no damage to the trim panel or clip, reinstall the clip onto the trim panel. See Figure 2.

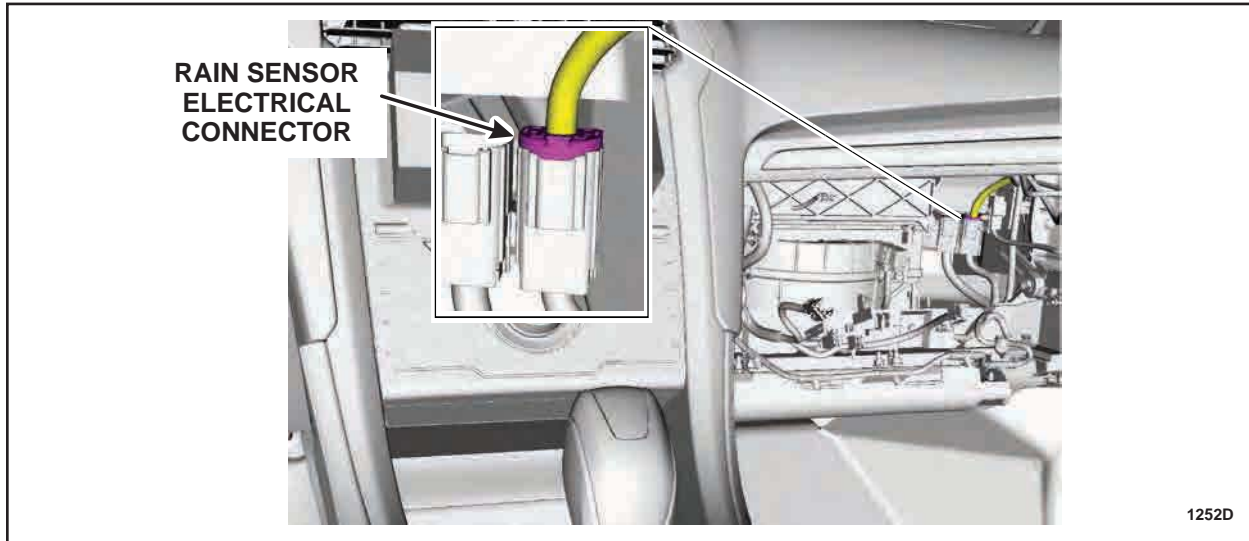
FIGURE 3

3. Disconnect the rain sensor and/or auto dimming mirror electrical connectors. See Figure 3.

32. Connect the rain sensor and/or auto dimming mirror electrical connectors. See Figure 3.
33. Install the glove compartment. For additional information, refer to WSM Section 501-12.

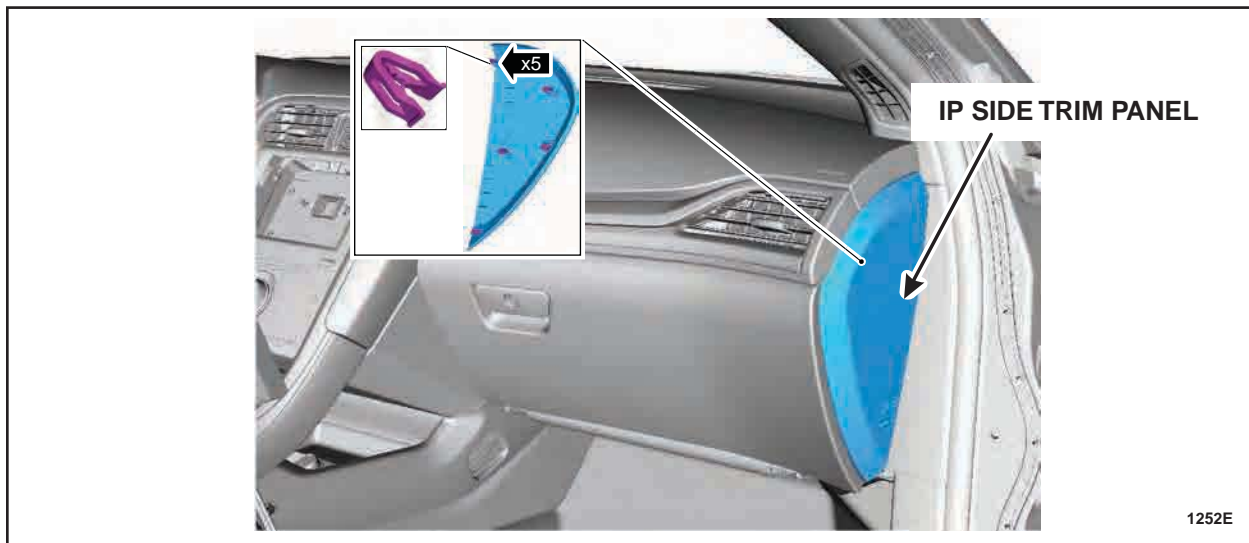
FIGURE 4

Remove the RH and LH IP side trim panels. See Figure 4.

34. Install the RH and LH IP side trim panels. See Figure 4.
35. Return the vehicle to the customer.

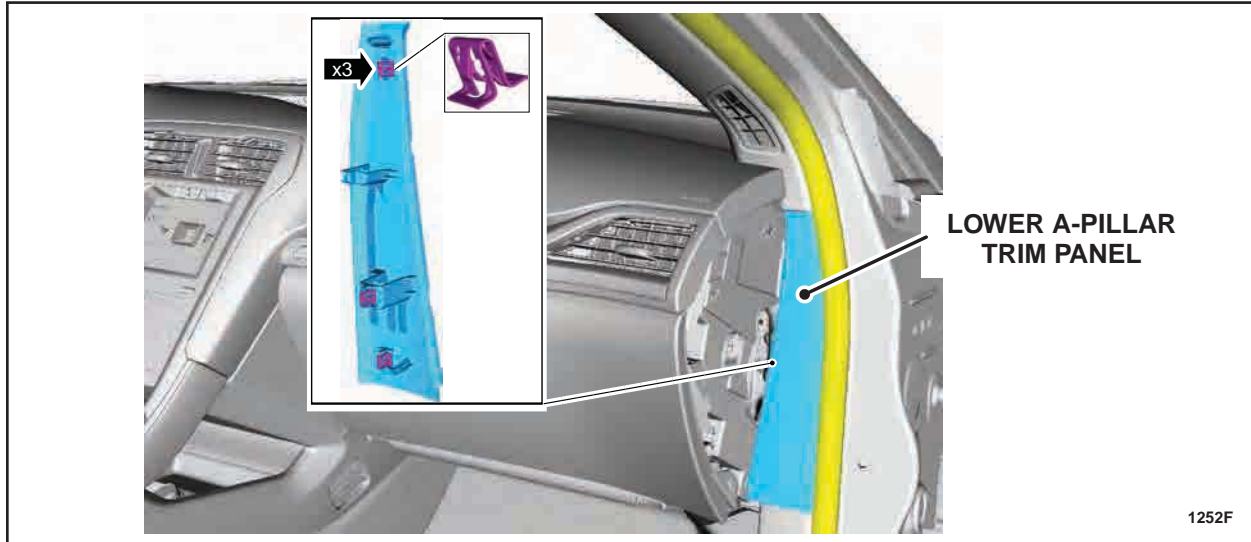
FIGURE 5

5. Remove the RH and LH lower A-pillar trim panels. See Figure 5.

31. Install the RH and LH lower A-pillar trim panels. See Figure 5.

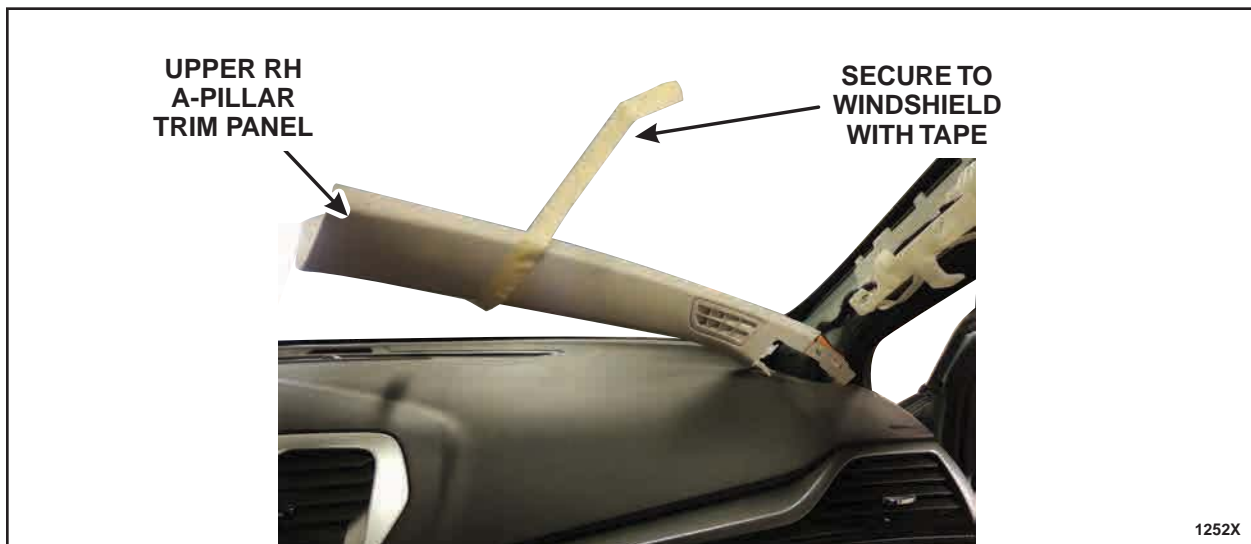
FIGURE 6

6. Partially remove the upper RH and LH A-pillar trim panels leaving the forward clip engaged. Secure the trim panels to the windshield with tape. See Figure 6.

NOTE: Tape A-pillar trim panel to the windshield as indicated in Figure 6 to reduce the stress in the area around the forward clip attachment.

29. Position the vehicle seats back to the customers original position.
30. Remove the tape and position back the RH and LH upper A-pillar trim panels. See Figure 6.

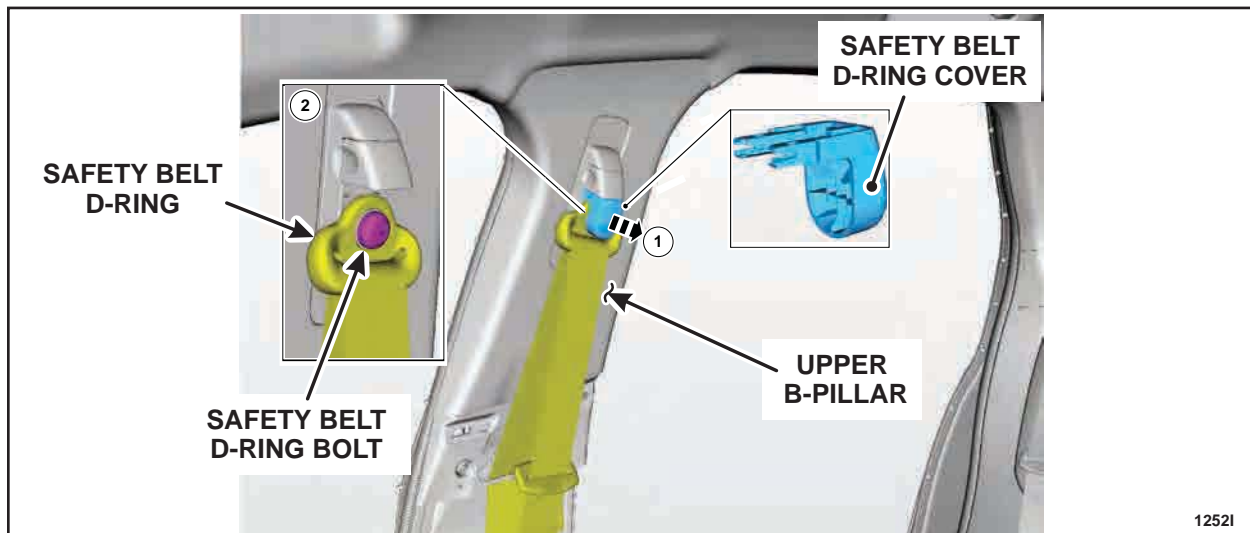
FIGURE 7

12. Remove the safety belt D-ring cover and bolt from the RH and LH upper B-pillar. See Figure 7. Position the safety belts away from the upper B-pillars.

25. Reposition the RH and LH safety belts to the upper B-pillars and install the D-ring bolts. See Figure 7.
 - Tighten D-ring bolts to 40 Nm (30 lb-ft) and install the safety belt D-ring covers.

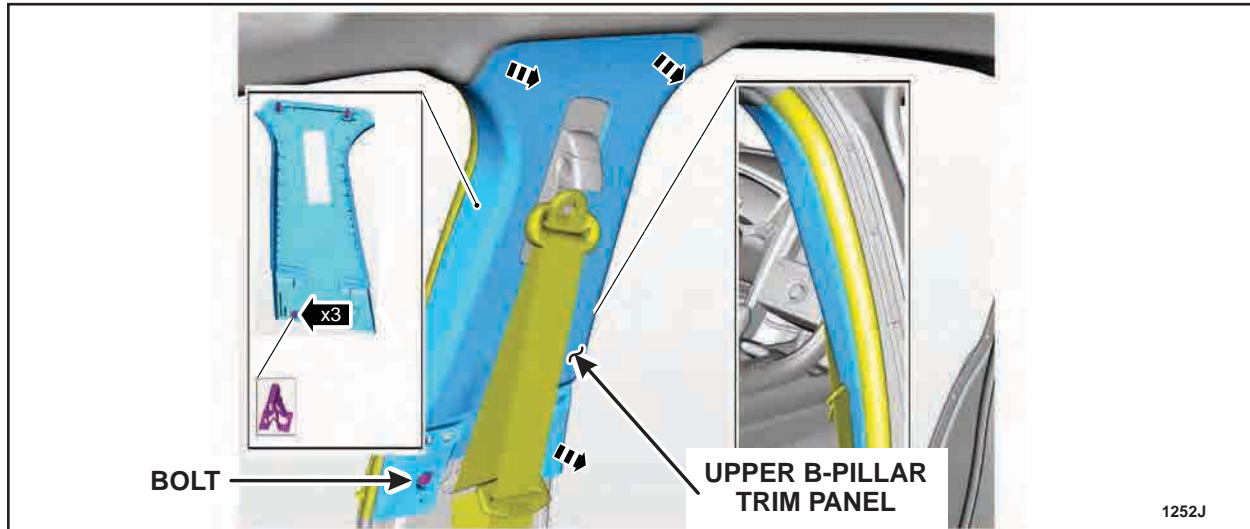
FIGURE 8

13. Remove the bolts and the RH and LH upper B-pillar trim panels. See Figure 8.

24. Install the RH and LH upper B-pillar trim panels and install the bolts. See Figure 8.
 - Tighten upper B-pillar trim panel bolts to 9 Nm (80 lb-in).

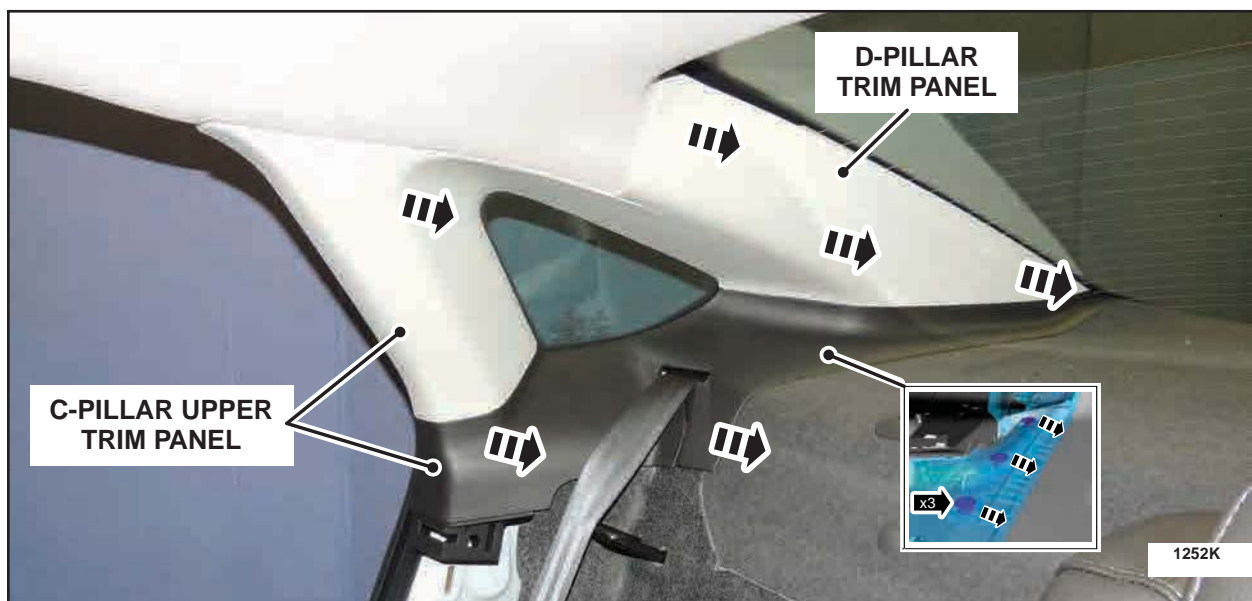
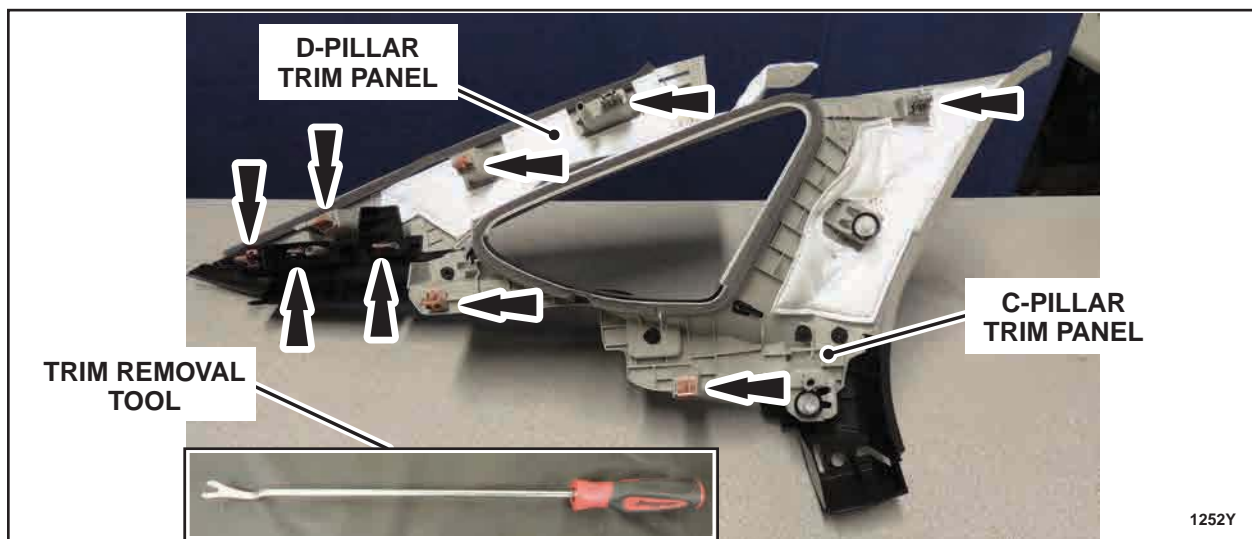
NOTICE: Do not separate the RH and LH D-pillar trim panels from the upper C-pillar trim panels. They should be removed as an assembly to prevent damage to the retaining clips.

16. Remove the RH and LH upper C-pillar and D-pillar trim panels together. See Figure 9 and 10.

NOTE: The upper C-pillar and D-pillar trim panels are difficult to remove. Using a trim removal tool like the one shown in Figure 10 to release the clips will aid in the removal process.

21. Install the RH and LH upper C-pillar and D-pillar trim panels. See Figure 9 and 10.
 - Reposition the safety belts into the opening in the C-pillar upper trim panels.

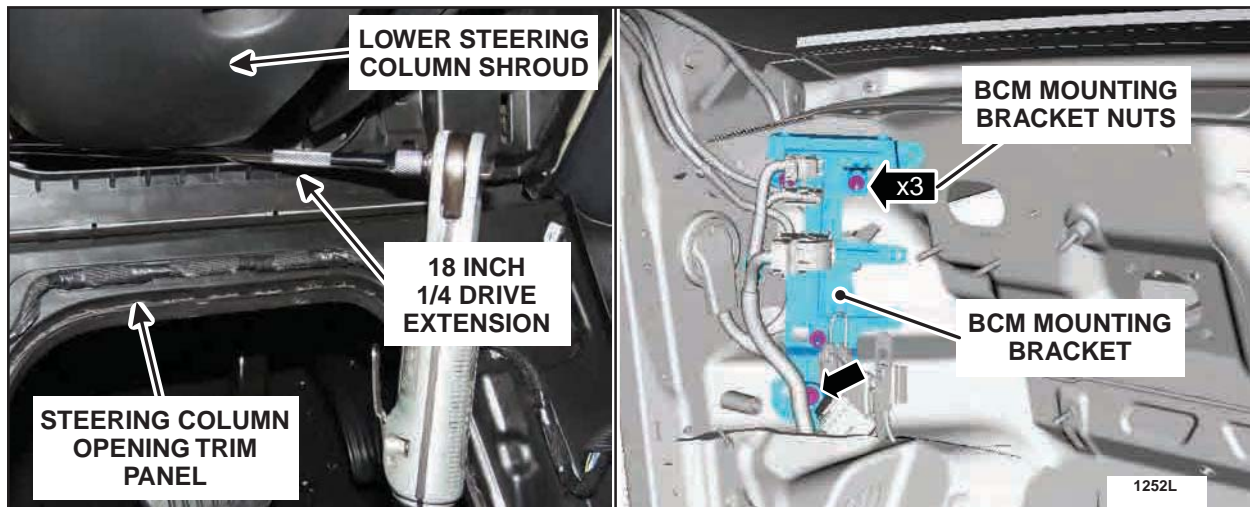
FIGURE 11

21. **NOTE:** The use of an 18 inch, 1/4 drive extension between the steering column opening trim panel and lower steering column shroud will aid in the removal of the BCM mounting bracket nuts. See Figure 11.

Position aside the BCM mounting bracket by removing the three bracket nuts. Only position aside far enough to access the electrical connector behind the bracket. See Figure 11.

14. Install the floor console. For additional information, refer to WSM Section 501-12.
15. Connect the headliner electrical connector behind the BCM mounting bracket location. See Figure 12.
16. Reposition the BCM mounting bracket. Install and tighten the three bracket nuts. See Figure 11.
17. Install the Body Control Module (BCM). For additional information, refer to WSM Section 419-10.
18. **NOTE:** Only connect the negative battery cable to temporarily restore vehicle power, do not re-install battery hold down or torque the battery cable at this time.

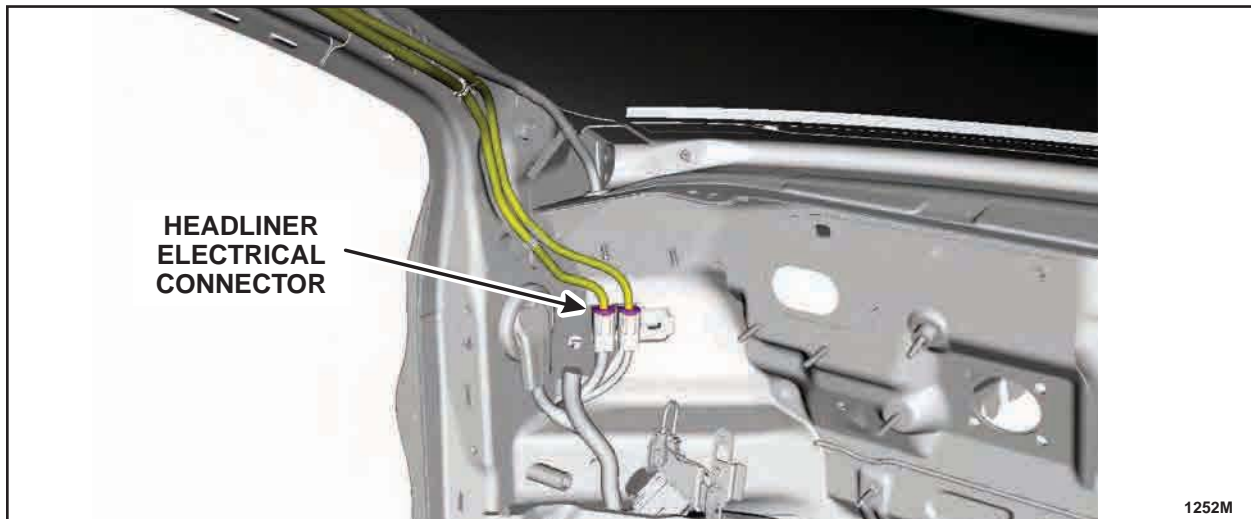
FIGURE 12

22. Disconnect the headliner electrical connector (closest to the LH front door opening) behind the BCM mounting bracket. See Figure 12.

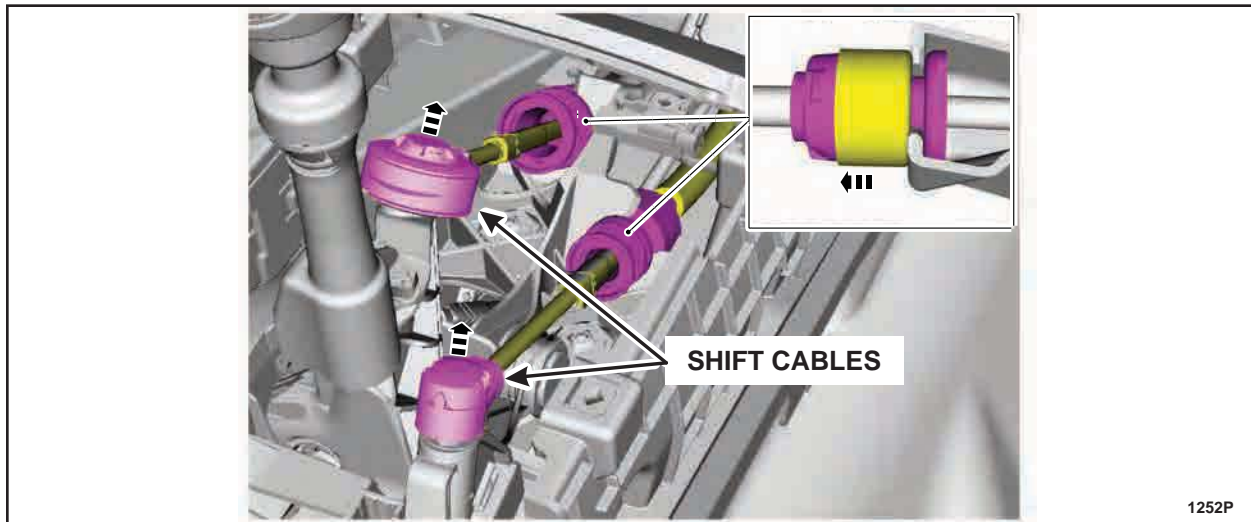
FIGURE 13

24. Remove the shift cables from the gearshift lever. See Figure 13.

12. Install the gearshift lever and tighten the four bolts. See Figure 14.
 - Tighten gearshift lever bolts to 9 Nm (80 lb-in).
13. Install the shift cables onto the gearshift lever. See Figure 13.

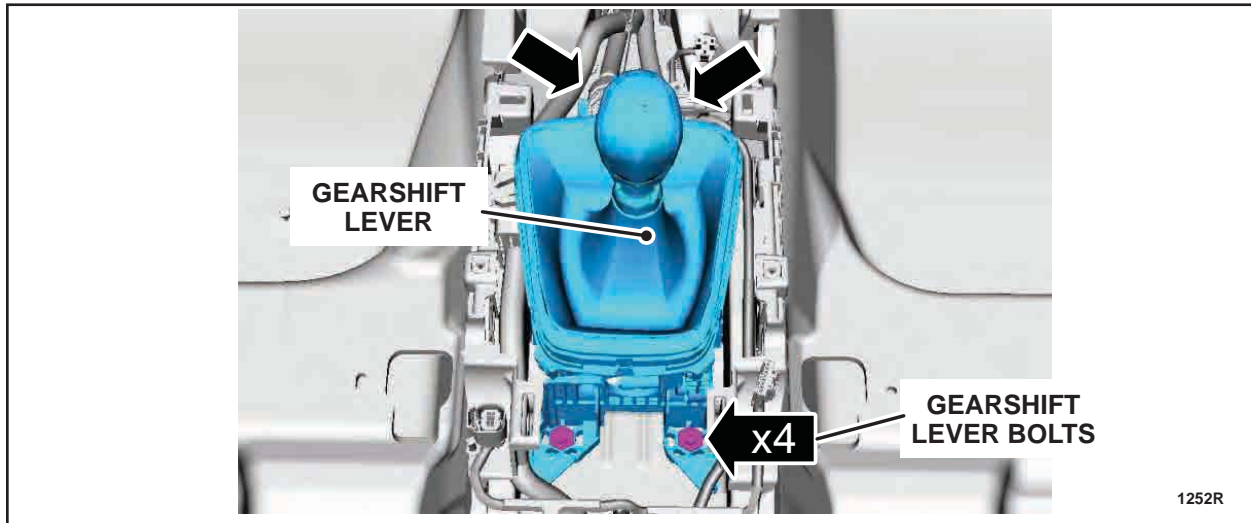
FIGURE 14

25. Remove the four bolts and the gearshift lever. See Figure 14.

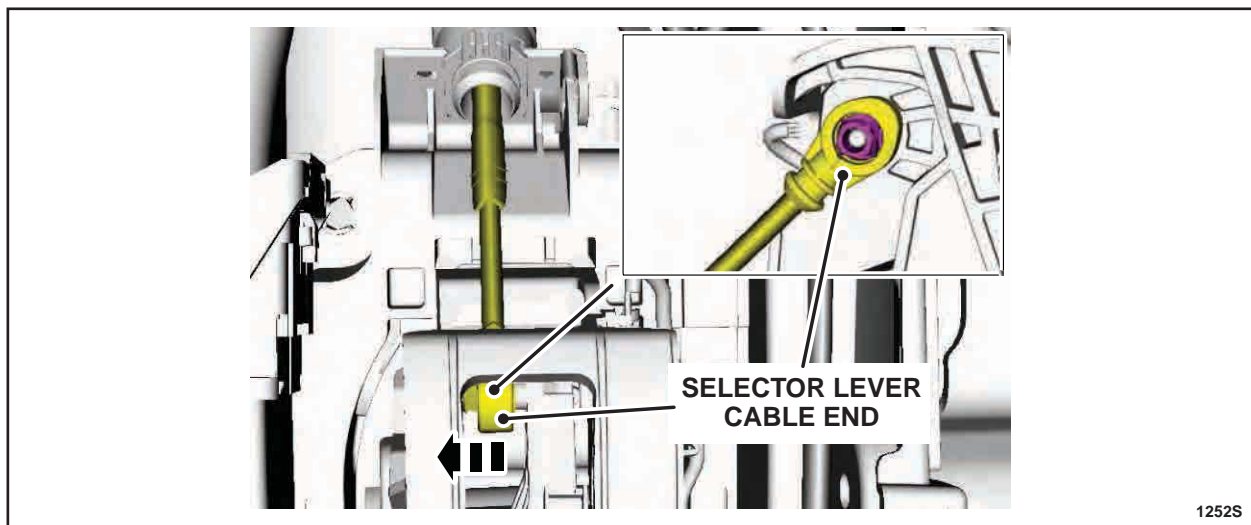
FIGURE 15

26. Disconnect the selector lever cable end from the selector lever. See Figure 15.

9. Install the selector lever and tighten the four bolts. Connect the selector lever electrical connector. See Figure 17.
 - Tighten selector lever bolts to 9 Nm (80 lb-in).
10. Reposition the selector lever cable and install the retaining bracket. See Figure 16.
 - Tighten cable retaining bracket bolt to 7 Nm (62 lb-in).
11. Connect the selector lever cable end from the selector lever. See Figure 15.

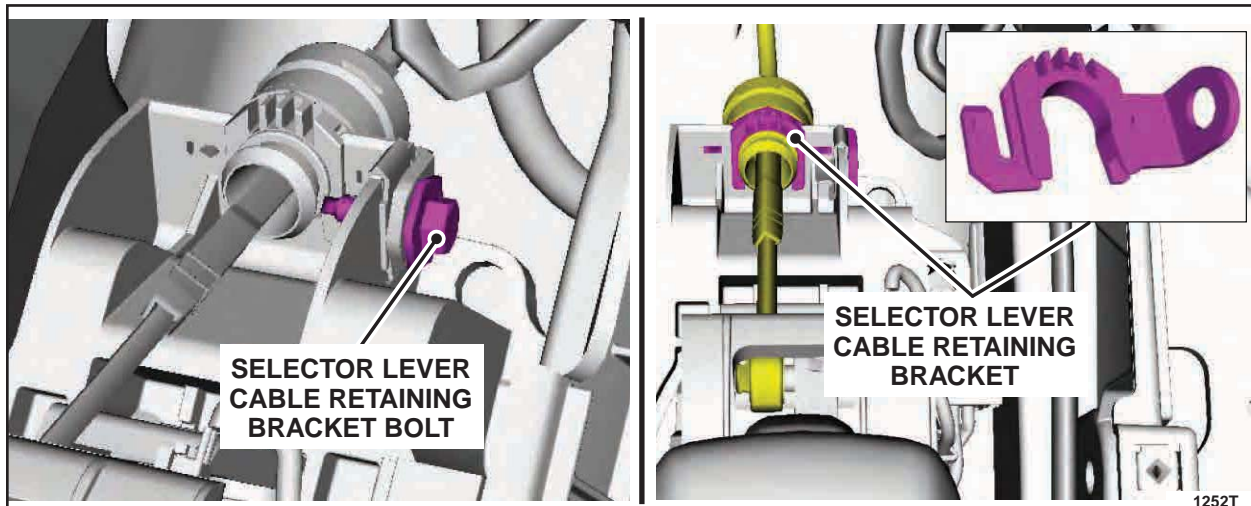
FIGURE 16

27. Remove the bolt from the selector lever cable retaining bracket. Remove the bracket and position the selector lever cable aside. See Figure 16.

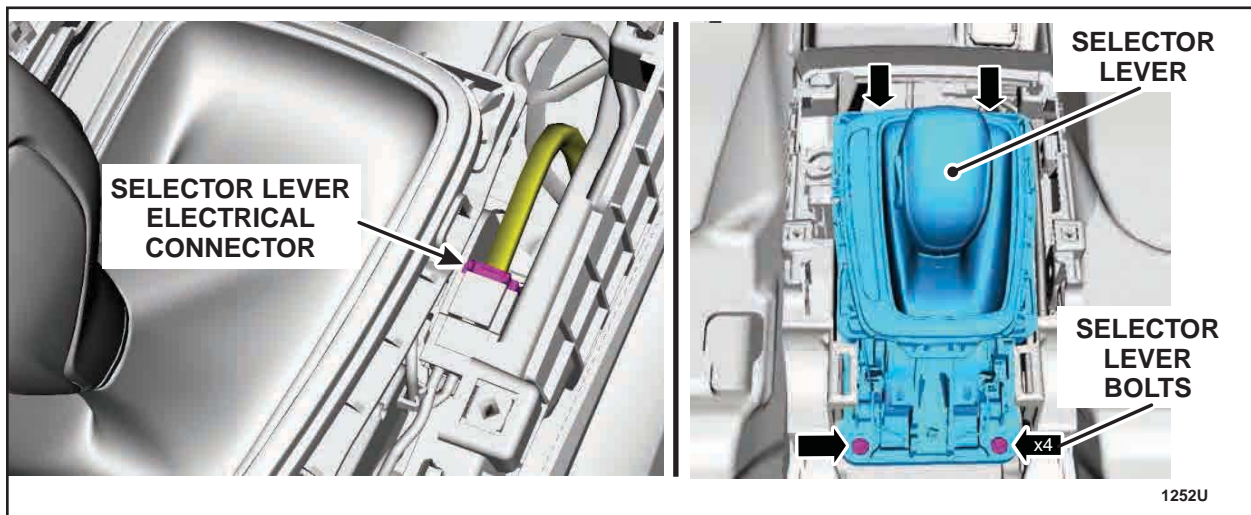
FIGURE 17

28. Disconnect the selector lever electrical connector. Remove the four bolts and remove the selector lever. See Figure 17.

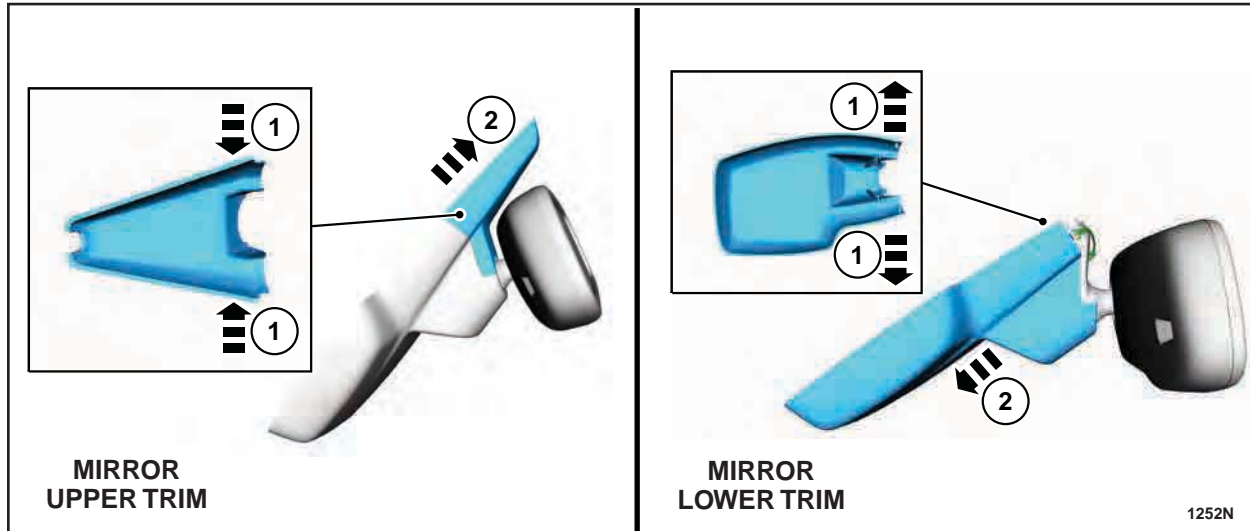
FIGURE 18

29. If equipped, remove the rear view mirror trim. See Figure 18.

7. If equipped, connect the rain sensor and/or auto dimming mirror electrical connectors behind the rear view mirror.
8. If equipped, install the rear view mirror trim. See Figure 18.

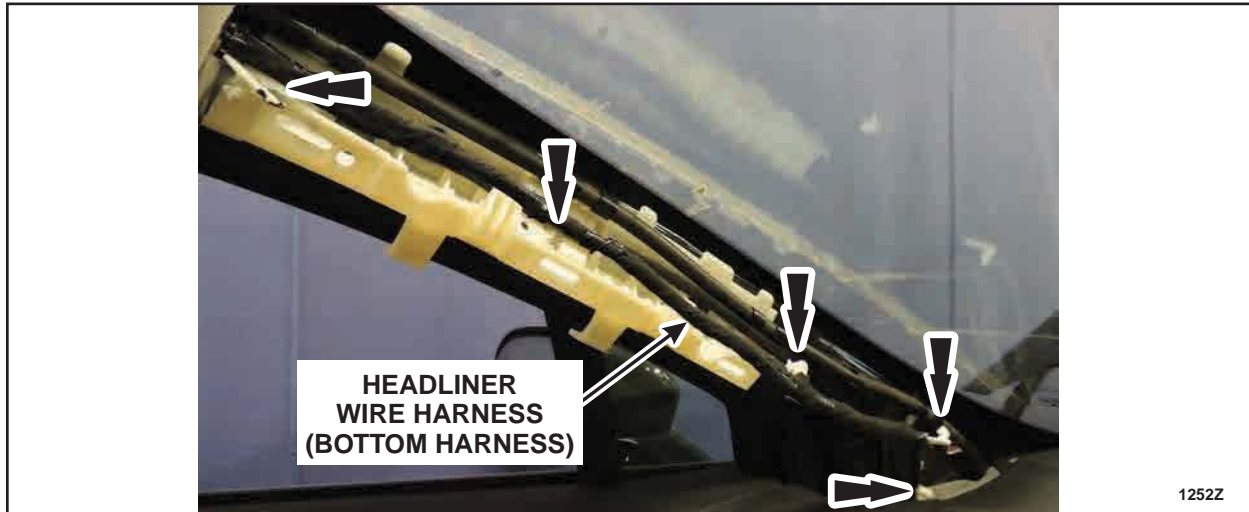
FIGURE 19

34. Disconnect the five headliner wire harness to body retainers along the LH A-pillar. If equipped, disconnect the five rain sensor and/or auto dimming mirror wire harness to body retainers from the RH A-pillar. See Figure 19. Carefully route both wire harnesses up through the instrument panel.

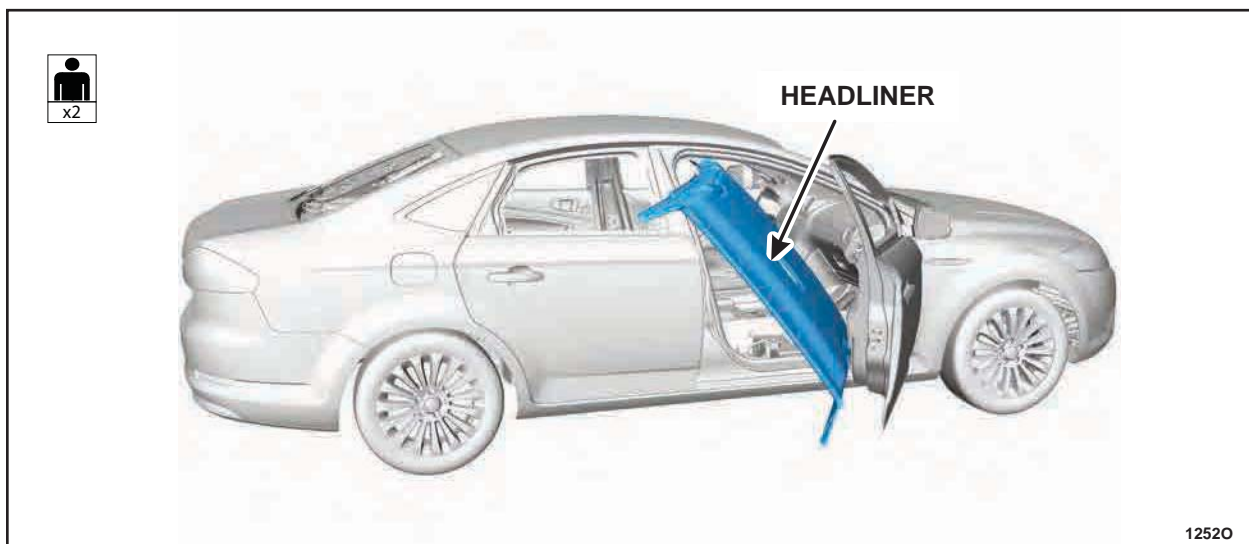
FIGURE 20

1. With the help of an assistant, remove the headliner through the front passenger side door. See Figure 20. [Click here for headliner removal instruction video](#) (removal shown, installation similar).

1. With the help of an assistant, install the headliner through the front passenger side door, reversing direction from the removal instruction video. See Figure 20.
2. Raise the headliner and engage the nine magnets and two guide pins.
3. Carefully route the headliner and rain sensor/auto dimming mirror wire harnesses down through the instrument panel. Connect the five headliner wire harness to body retainers along the LH A-pillar. If equipped, connect the five rain sensor and/or auto dimming mirror wire harness to body retainers to the RH A-pillar. See Figure 19.
4. Install all four assist handles.
5. Install the RH and LH sunshade hooks.
 - Tighten fasteners.
6. Install the RH and LH sunshades.
 - Connect the electrical connector. Install the clip and clip cover.

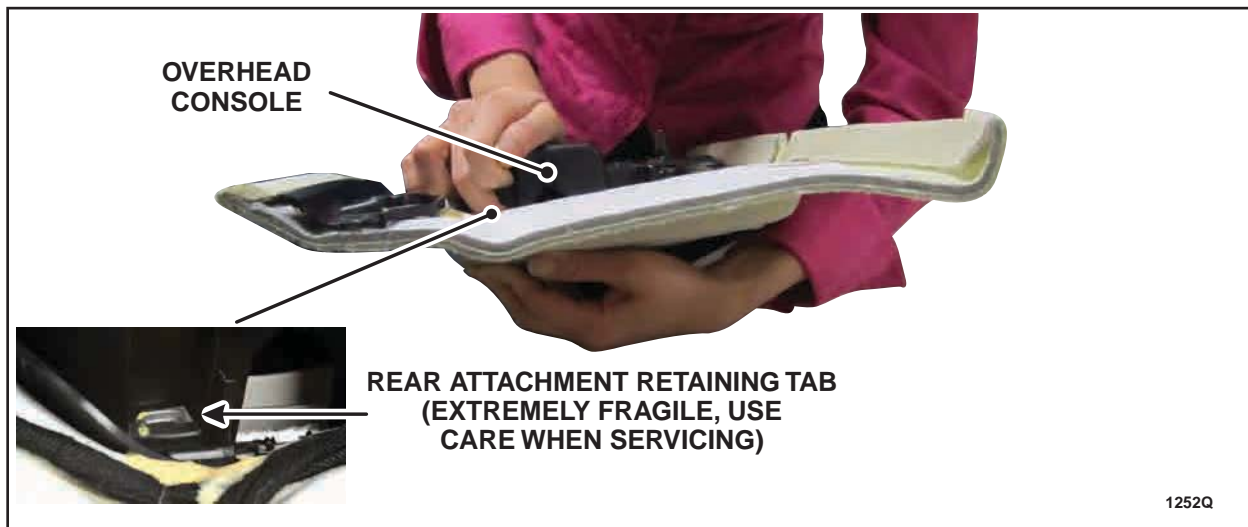
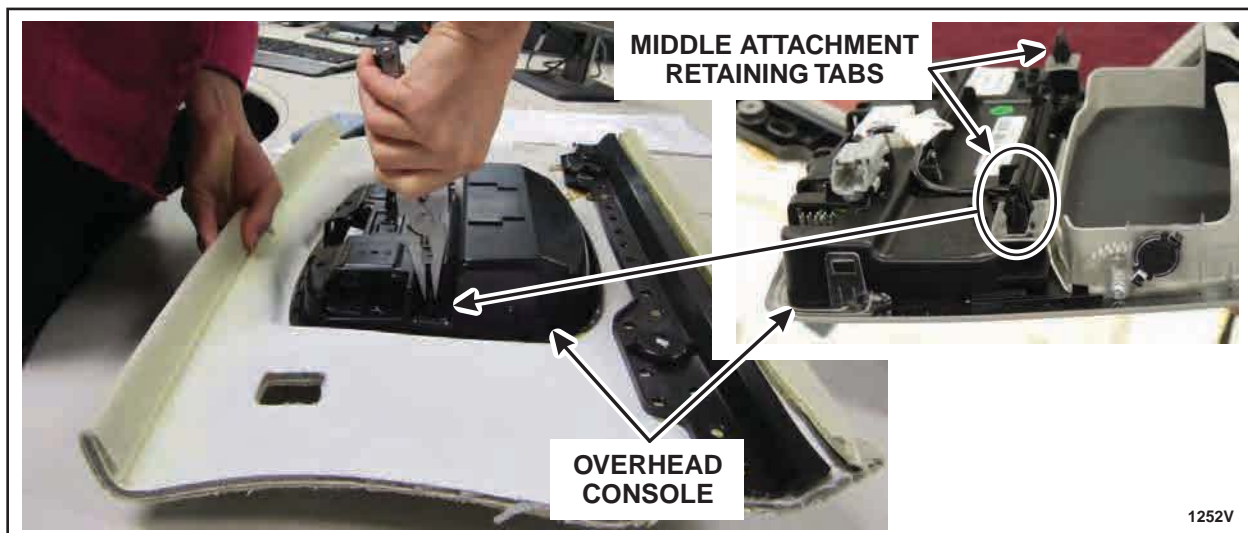
2. **NOTICE:** Special care needs to be taken while removing the overhead console. The rear attachment retaining tabs are extremely fragile. See Figure 21a and 21b.

Remove the overhead console from the headliner. See Figure 21a and 21b (headliner cutaway view shown for clarity).

- a. Disengage the rear overhead console attachments by pushing up on the console from the interior side while holding the headliner bracket in place. Slowly press the retaining tab inboard to release.
- b. Support the overhead console from the interior side and use a set of pliers to release the middle retaining tabs.
- c. Pry down gently to free the overhead console. Rotate the rear of the console downward to access the electrical connectors.
- d. Disconnect and remove the overhead console.

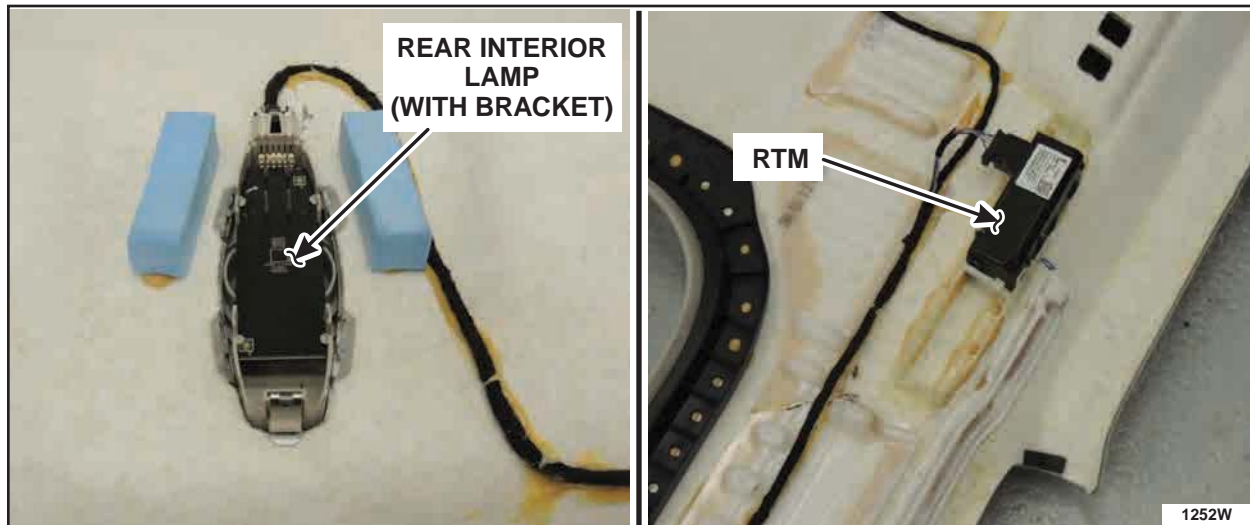
FIGURE 22

3. Transfer the wire harness in the following sequence:
 - a. Using a suitable marking tool, mark the new headliner with the routing and exit points of the wire harness from the original headliner.
 - b. Carefully remove the wire harness from the original headliner.
 - c. Position the wire harness onto the new headliner and check that the harness has enough length to make all connections.
 - d. Apply the 3M™ Super-Fast Repair Adhesive (04747) in the same location as the factory installed adhesive along the full length of the wire harness-to-headliner.
4. Transfer the rear interior lamp, Radio Transceiver Module (RTM) and brackets to the *new* headliner. See Figure 22.
