Service Bulletin

Bulletin No.: PI0916A

Subject: Floor/Carpet Wet at Front Passenger Side Under Dash, or at Any Front/Rear Footwell Area

Models: 2012-2013 Chevrolet Caprice PPV

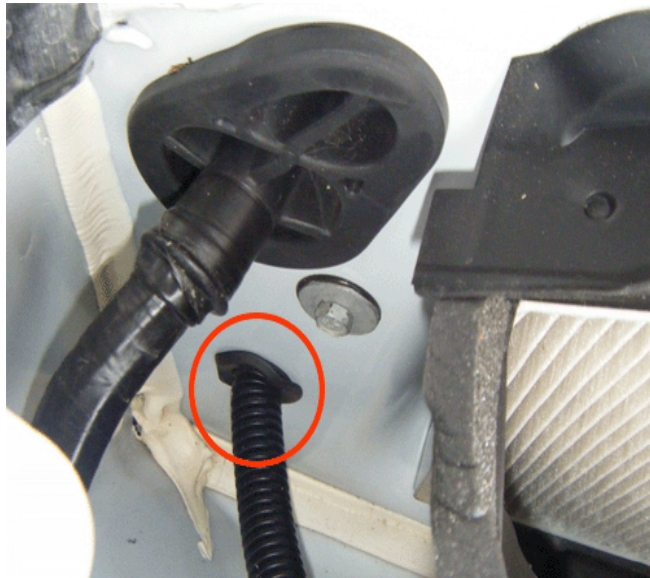
3291074

4. Inspect the cowl area outside the HVAC case for the possible existence of a wiring harness associated with certain police equipped vehicles. If equipped, the grommet/hole location for the harness will be just below the bolt (1) shown in the graphic above.

5. If equipped with the additional harness, complete the following repair steps:
