## PRODUCT SAFETY RECALL

**SUBJECT:** Power Window Master Switch Failure

**MODELS:** 2009 Pontiac Vibe

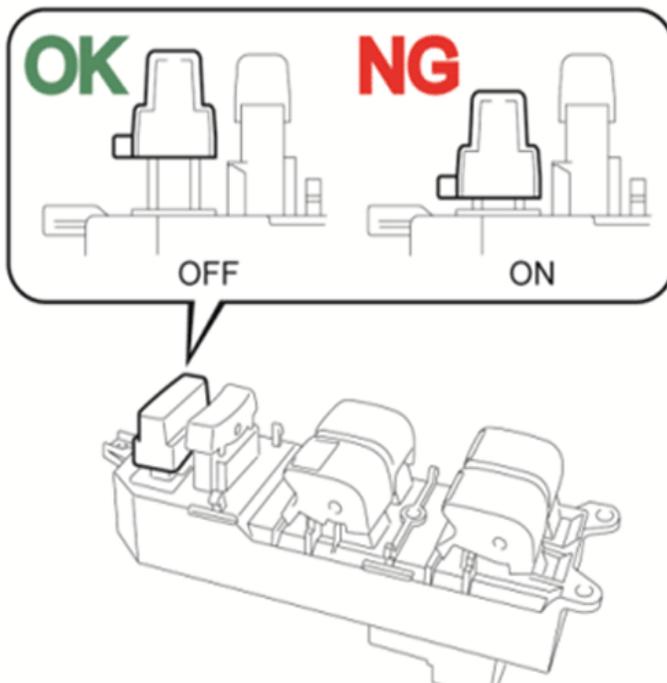
3021150

- Removing the lock button while it is turned ON may damage the switch.
- To prevent damage, Do Not use tools.

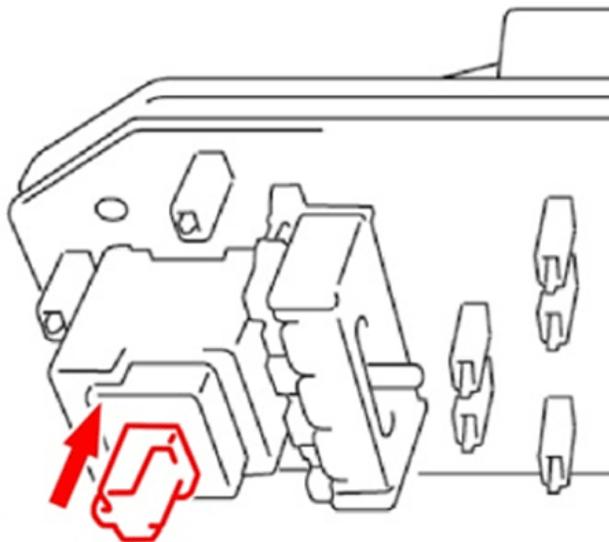
3021155

- If the AUTO switches are not aligned correctly, the readings may be inaccurate
- The switches MUST be in this position when checking the resistance. This is the OFF position. If the switch is in any other position, the readings will be incorrect.
- ALL switches that ARE NOT AUTO MUST be checked.
