Special Instruction**Air Control Valve (ACV) Connector with Plugs Installed Backwards in Empty Connector Cavities{7000}**

Media Number -REHS8421-00

On Highway Truck:

CT660 (S/N: TRK1-UP; TKL1-UP; TGT1-UP)

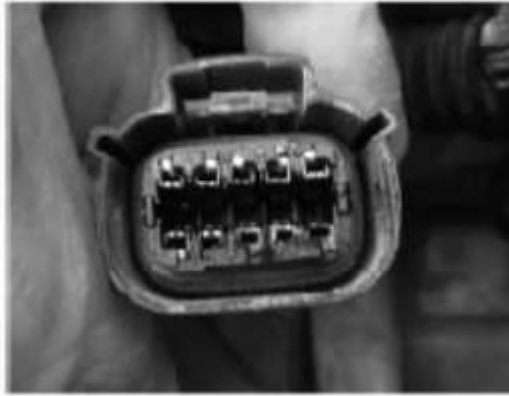
Illustration 4 g03380628

7. Inspect plugs in ACV connector to determine if the connector has been inserted backwards (2). If installed incorrectly, plugs must be reinstalled to proper orientation (3) following this procedure.

Engine Harness Side.

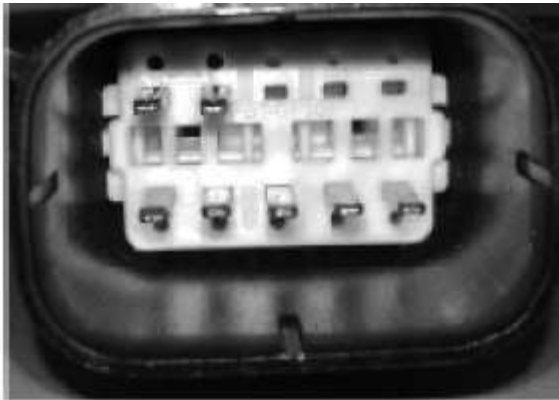
Illustration 5 g03380629

ACV Harness Side.
