Authorized Field Change

AFC 13903

Subject: Inspection of Air Control Valve (ACV) Connector / Engine Harness Connection for proper plug orientation and corrosion.

Engine Family: MaxxForce[®] 11 and 13

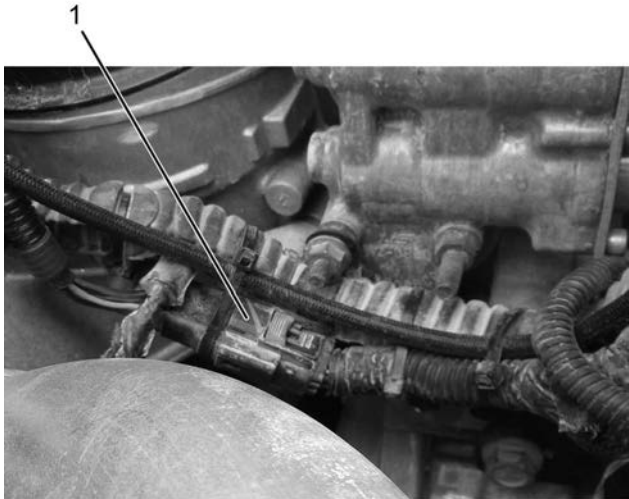
Figure 2. ACV Connector on Sensor Harness.

1. ACV connector
4. Locate ACV connector (Figure 2, Item 1) on sensor harness secured to coolant control valve (CCV) near front on passenger side of engine.

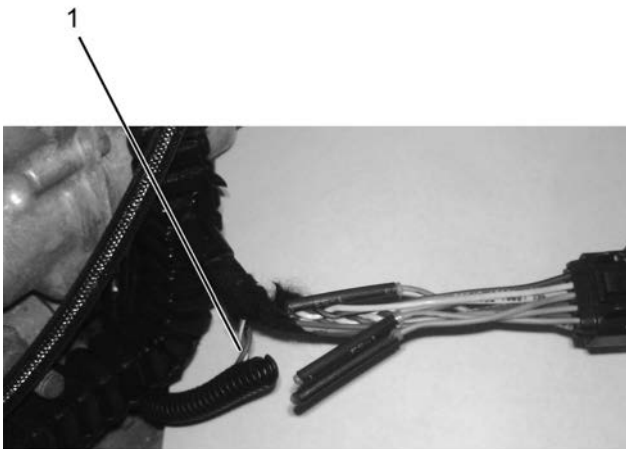
Figure 17. Coolant Flow Valve Harness.

NOTE: Do not cut the two-pinned coolant flow valve harness (Figure 17). It is not included in the kit.
