Program Bulletin

CUSTOMER SATISFACTION PROGRAM

SUBJECT: Front Strut - Noise

MODELS: 2012-2013 Chevrolet Colorado

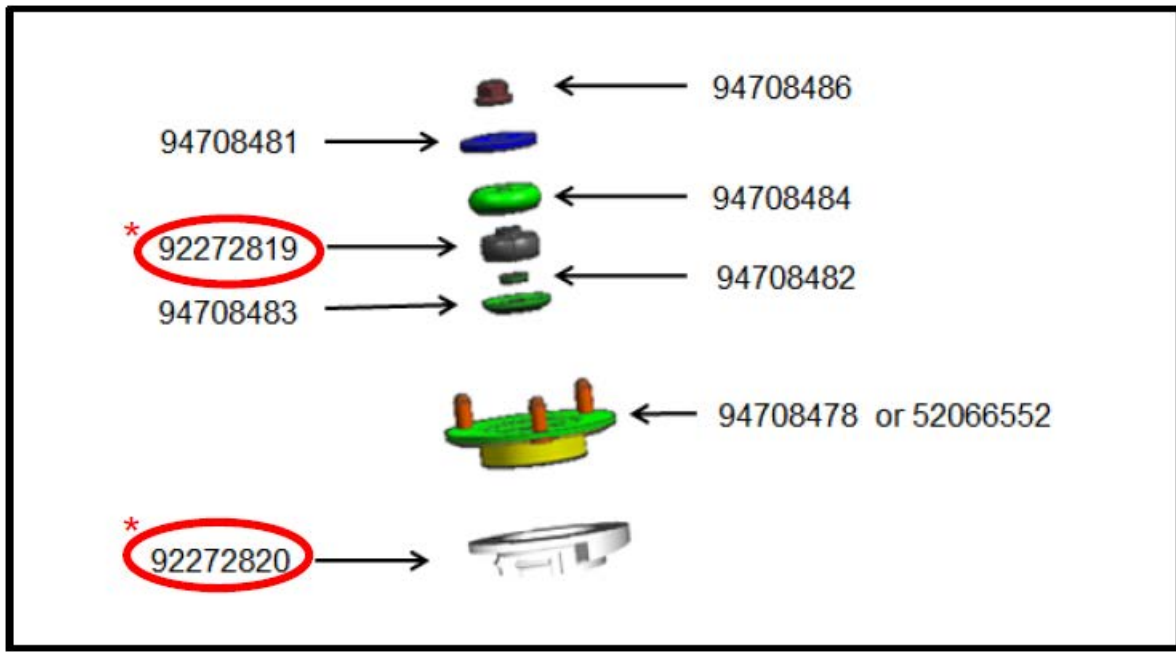
4. Remove the top mount plate. Ensure SI procedures are followed as the spring is under tension and injury could occur if incorrectly disassembled.
5. Refer to figure 1 - the lower bush (9) will be replaced as well as the spring seat isolator (not shown in figure 1). In addition, inspect the top mount bracket (4), cup washer (7), upper bush (8), and shocker absorber rod (1) for damage. Follow these guidelines to determine if these parts should be replaced:
 - Place a straight edge along the shocker absorber rod as shown in figure 4.
 - Measure the depth of wear on the shaft. If the wear is greater than 1mm, replace the shock absorber.
 - Inspect the steel washer (silver) that is pressed into the centre of the top mount bracket. If the washer has worn through to the black steel mount bracket, then replace the top mount bracket, refer figure 5.

- Inspect the upper bush (8), if the bush is out of shape or is damaged, replace the bush. In most cases it is expected that the upper bush can be reused. Do not replace it unless necessary.
- Inspect the cup washer (7) for distortion or other damage. Replace only if required.

Change the Spring Seat Isolator (Improved part – Part no 92272820) and BUMPER, FRT S/ABS UPR (LOWER) (Improved part – Part no 92272819) and other damaged part as necessary.
